Expertise

Protocol number: 48505759
Order No. / Reference: 27135676
Inspection date: 3 Nov 2026

Manufacturer: Opel	Model: Corsa-e Edition
VIN: VXKUHZKXZM4301522

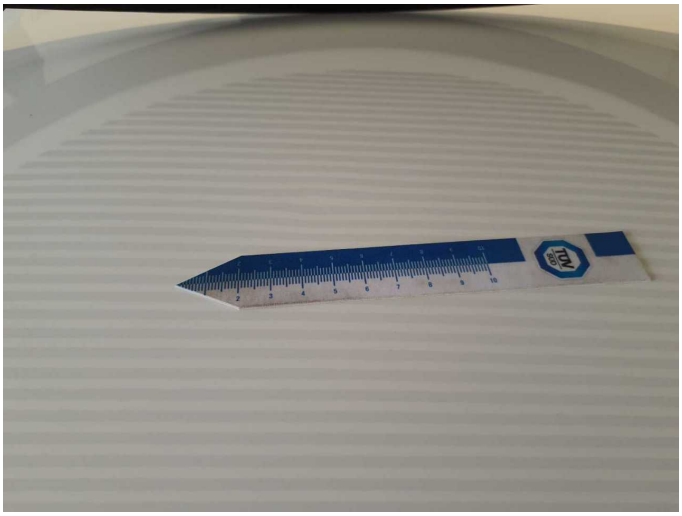
Damage 7: Roof: Roof - dent(s) - Smooth repair work

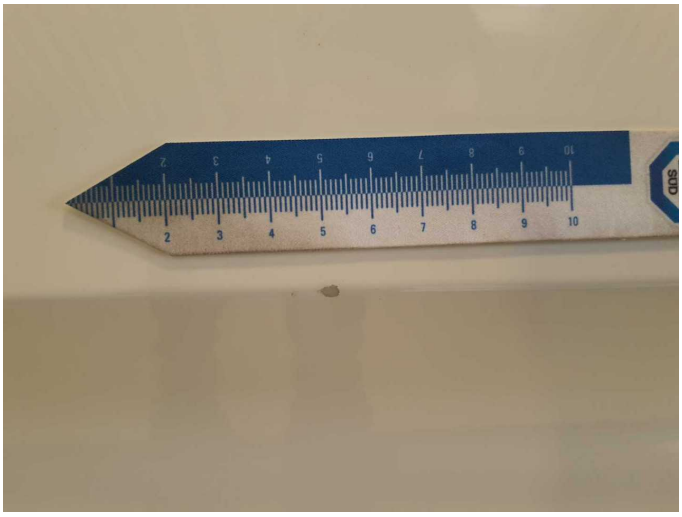
Damage 7: Roof: Roof - dent(s) - Smooth repair work

Damage 8: Door - rear left side: Door - Scratch(es) - Paint

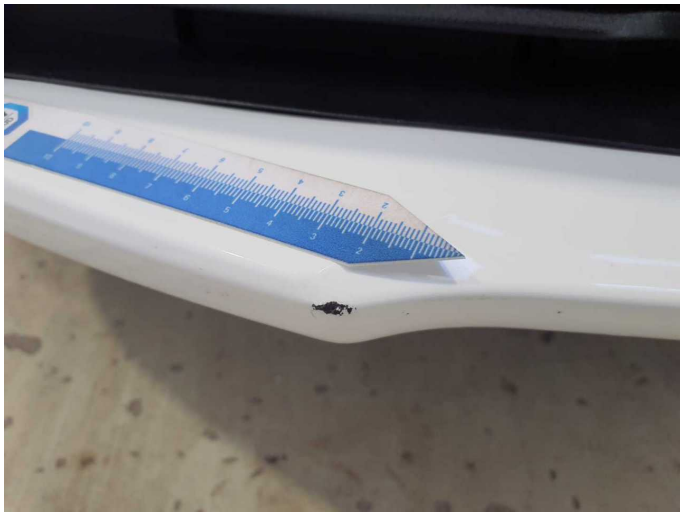
Damage 8: Door - rear left side: Door - Scratch(es) - Paint

Damage 9: Front bumper: Front bumper - Scratch(es) - Paint
