Expertise

Protocol number: 48612484
Order No. / Reference: 27174656
Inspection date: 10 Nov 2026

Manufacturer: Ford	Model: Transit Connect 230 L1 LKW Trend
VIN: WF06XXWPG6PK58827

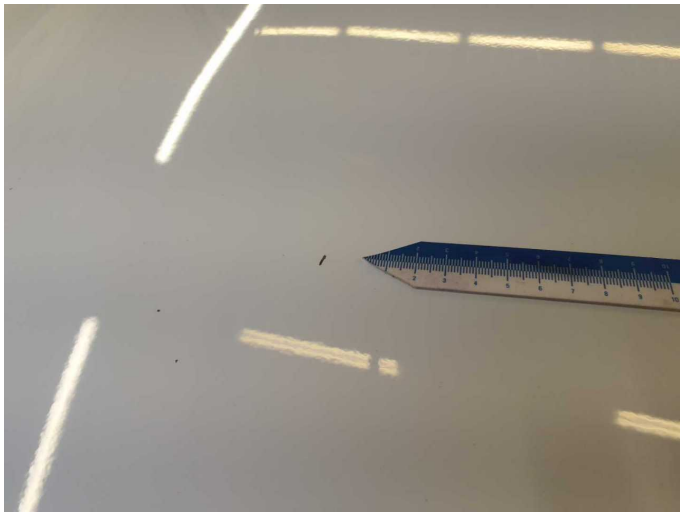
Damage 8: Bonnet: Bonnet - Dent / paintcoat damage - Paint
