Expertise

Protocol number: 48472400
Order No. / Reference: 27229359
Inspection date: 2 Nov 2026

Manufacturer: Skoda	Model: Octavia Combi 2.0 TSI DSG RS Plus
VIN: TMBJU0NX7PY007845

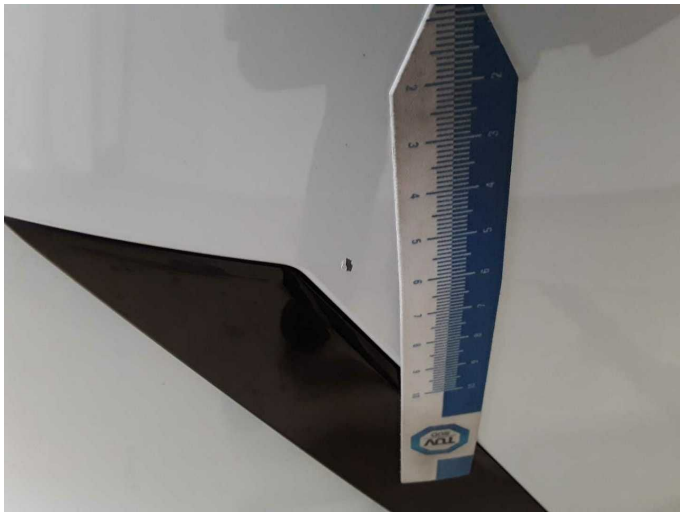
No.	Component group	Description
1	Instrument panel	Indicator light (Reifendruck) - on - Perform diagnosis
2	Roof	Roof - dent(s) - Smooth repair work
3	2nd wheel set	1 alloy rim - Scratch(es) - Loss in value
4	2nd wheel set	1 alloy rim - Scratch(es) - Loss in value
5	Rear bumper	Spoiler - Scratch(es) - Paint
6	Rear bumper	Rear bumper - Scratch(es) - Paint

Damage 6: Rear bumper: Rear bumper - Scratch(es) - Paint
