Expertise

Protocol number: 48111592
Order No. / Reference: 26951964
Inspection date: 14 Oct 2026

Manufacturer: Peugeot	Model: 308 SW BlueHDi 130 EAT8 Allure
VIN: VR3FCYHZTPY558654

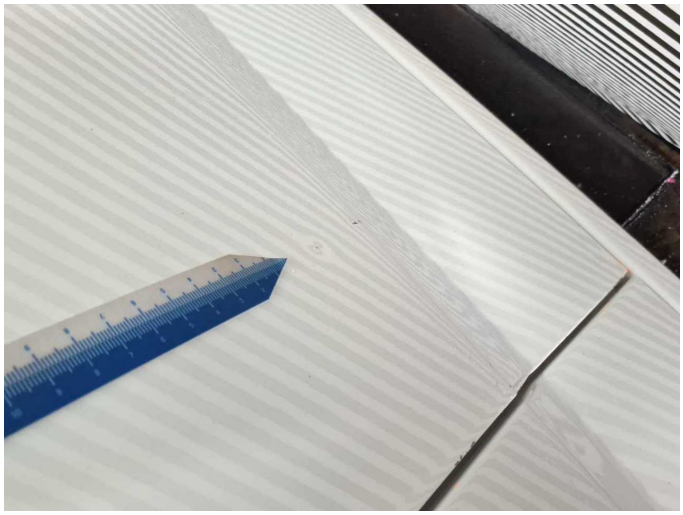
Damage 4: Door - front right side: Door - Dent / paintcoat damage - Smart repair

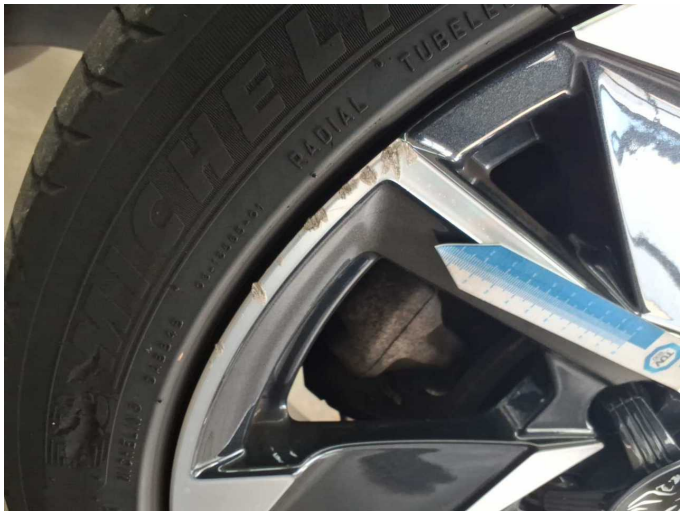
Damage 6: Wheel / tyres: Alloy rim - front left side (Materialabtrag) - Scratched - Replace

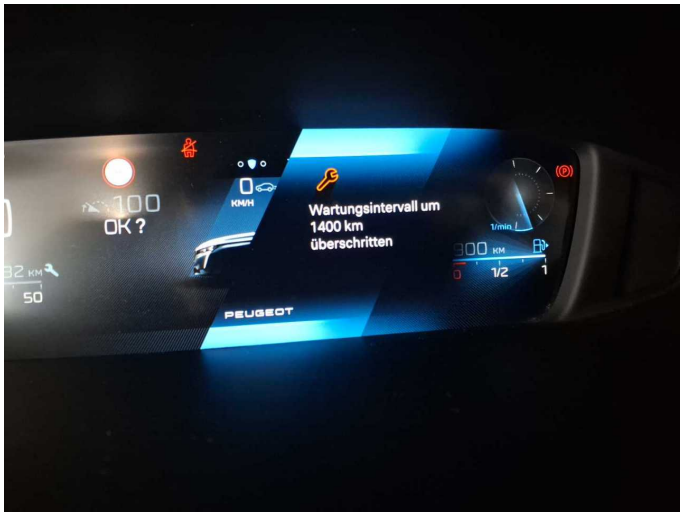
Damage 7: Misc.: Inspection / maintenance - Due - Replace

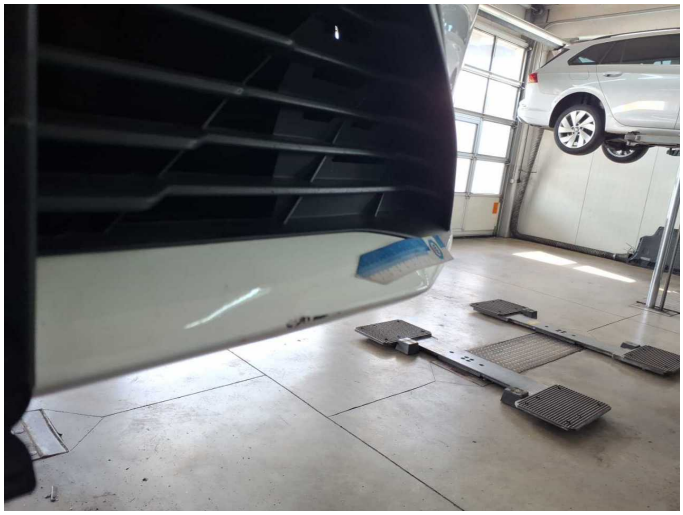
Damage 8: Front bumper: Front bumper (+ viele steinschläge) - Scratched - Repair and paint

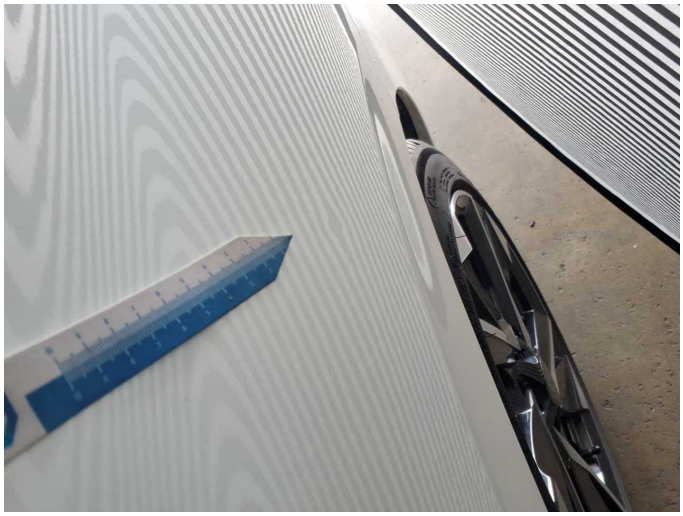
Wear and tear 4: Side panel - rear left side: Side panel - dent(s) - Smooth repair work
