Expertise

Protocol number: 48468702
Order No. / Reference: 27182230
Inspection date: 3 Nov 2026

Manufacturer: Ford	Model: Mondeo Turnier 2.0 EcoBlue Aut. Titanium
VIN: WF0FXXWPCFNS68734

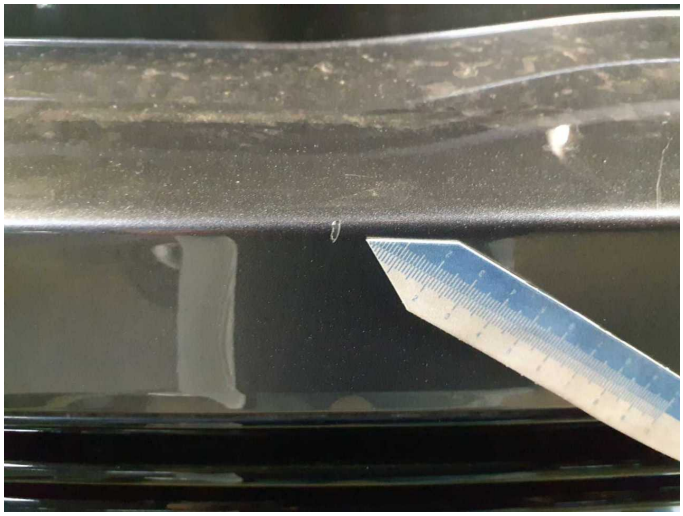
No.	Component group	Description
1	Mudguard - right side	Mudguard - right side - Stone chips - Smart repair
2	Rear bumper	Rear bumper - Scratch(es) - Smart repair
3	Side panel - rear left side	Side panel - Scratch(es) - Smart repair
4	Sill - left side	Sill - Dent / paintcoat damage - Smart repair
5	Door - front left side	Door - Scratched - Paint
6	Bonnet	Bonnet - Stone chips - Paint

Damage 2: Rear bumper: Rear bumper - Scratch(es) - Smart repair

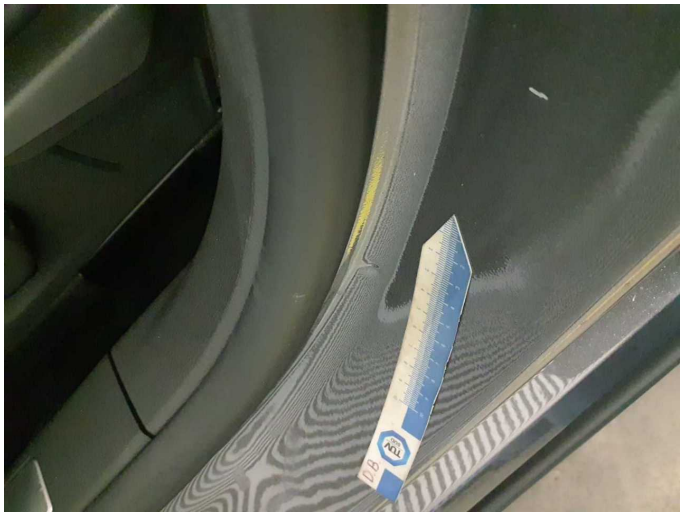
Damage 4: Sill - left side: Sill - Dent / paintcoat damage - Smart repair

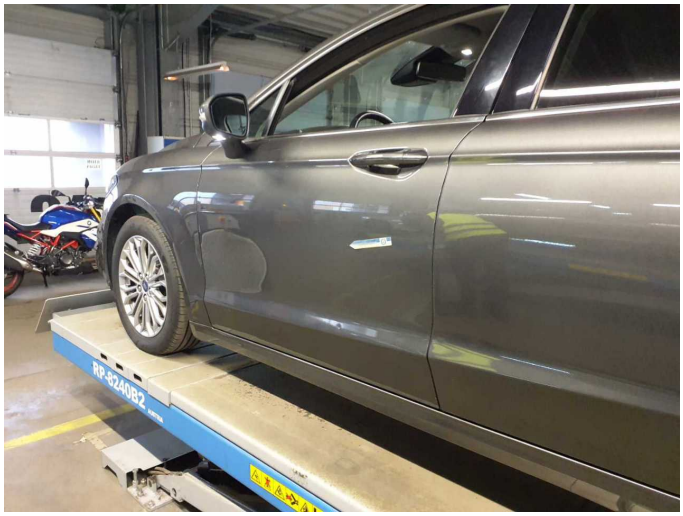
Damage 4: Sill - left side: Sill - Dent / paintcoat damage - Smart repair

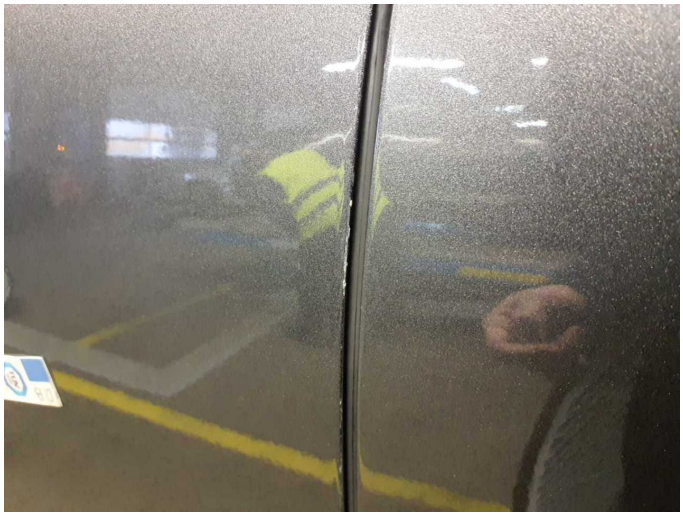
Damage 5: Door - front left side: Door - Scratched - Paint

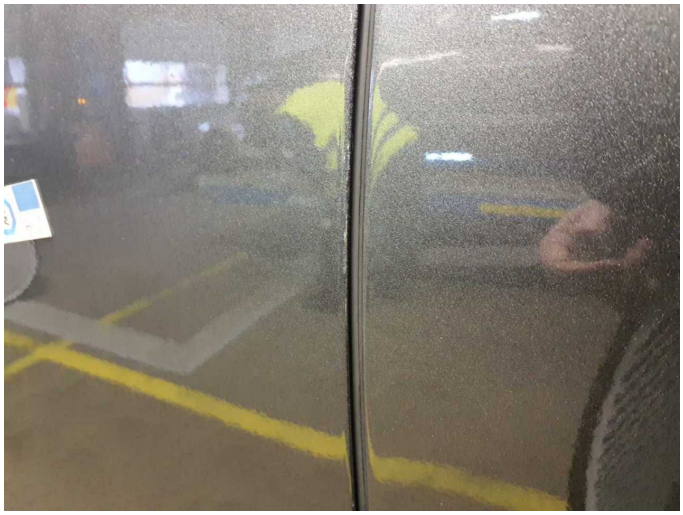
Damage 5: Door - front left side: Door - Scratched - Paint

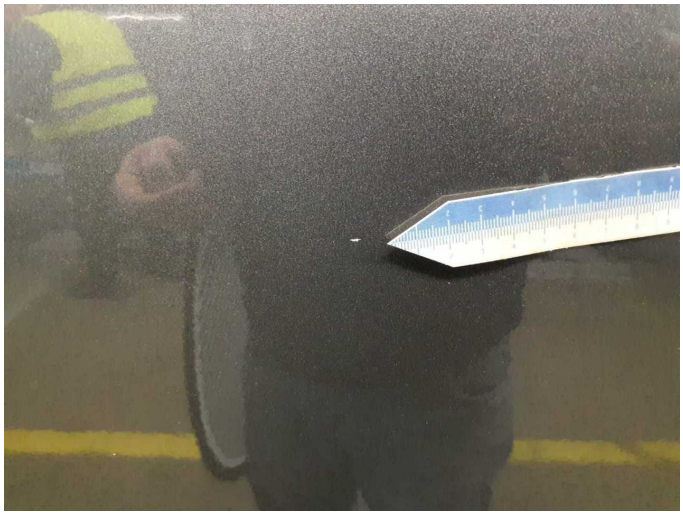
Damage 5: Door - front left side: Door - Scratched - Paint
