APPRAISAL REPORT

Driver name:	HM Tongeren
Make:	BMW
Model / version:	X3
Vin:	WBATS110209H72815
Plate:	2BAW832
Mileage:	69344
SOH:	
First registration:	14/09/2021
Color:	Black Sapphi

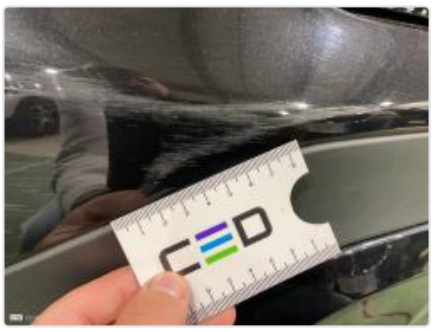
2 - Bumper F - Grooved

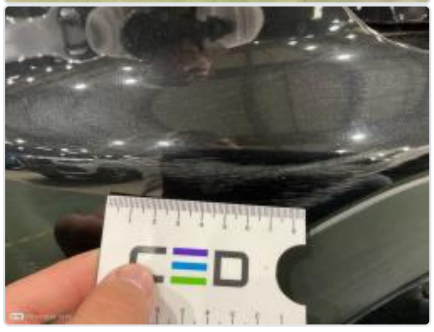
3 - Wing trim FL - Grooved

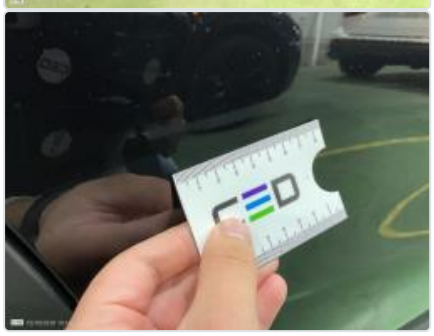
5 - Bumper R - Grooved

6 - Spoier bumper R - Grooved

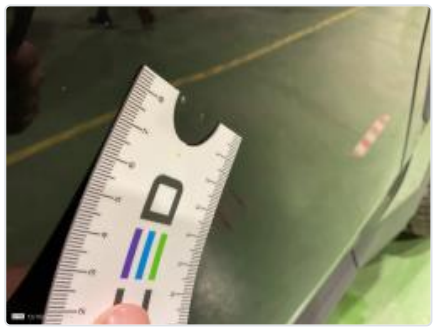
7 - Door RR - Dent(s) and scratch(es)

8 - Wing trim RR - Grooved

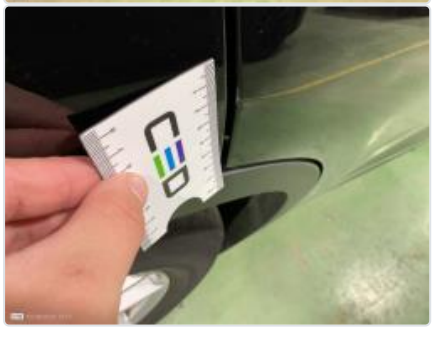
4 - Bodywork - Scratch(es) - Renta®
