Expertise

Protocol number: 48102687
Order No. / Reference: 27025046
Inspection date: 14 Oct 2026

Manufacturer: Ford	Model: S-Max 2.5 Duratec FHEV TREND
VIN: WF0JXXWPCHNJ56565

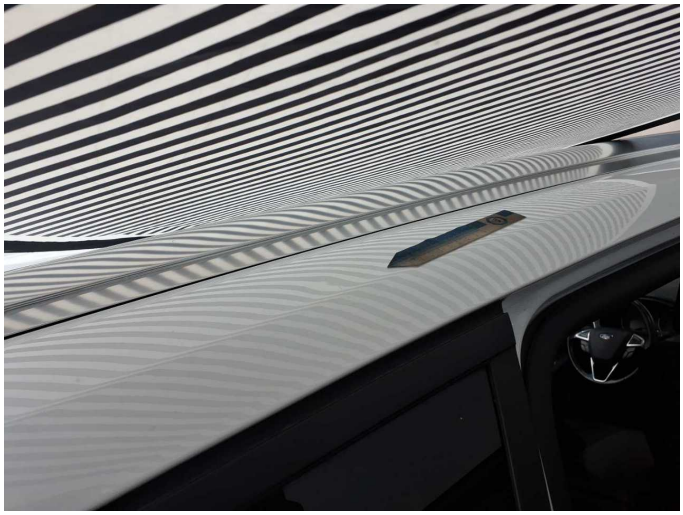
Damage 2: Roof: Roof rail - right side - dent(s) - Smart repair

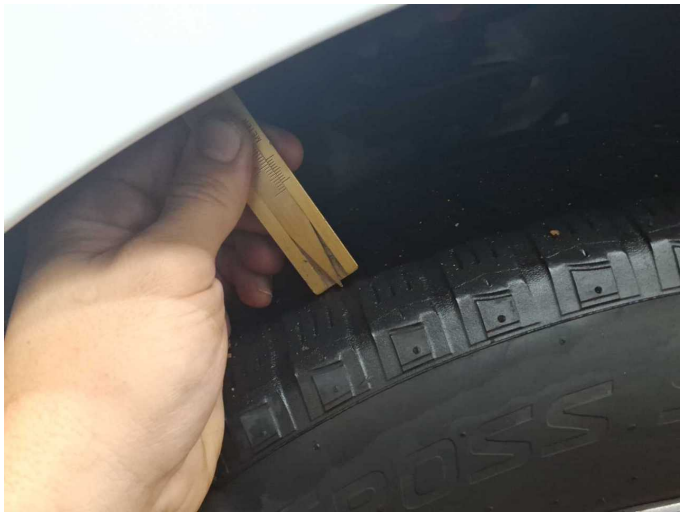
#	Tyre size	Type of tyre	Manufacturer	Tread depth
1)	235/55 R17 103V	Winter tyres on Light alloy	Sonstige	2mm / 2mm
2)	235/55 R17 103V	Winter tyres on Light alloy	Sonstige	5mm / 5mm

Damage 3: Wheel / tyres: Tyre - front - Does not meet the leasing specifications - Replace
