Expertise

Protocol number: 48112248
Order No. / Reference: 27078847
Inspection date: 14 Oct 2026

Manufacturer: Volkswagen	Model: Tiguan 2.0 TDI SCR DSG Elegance
VIN: WVGZZZ5N4RW000515

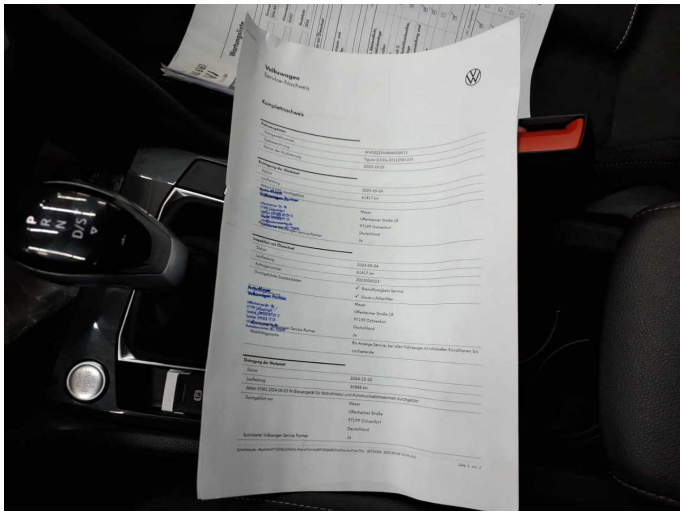
Figure 15: Documents

Documents submitted	At the time of the inspection, the vehicle registration certificate Part 2 (title) was available, but the vehicle registration certificate Part 1 (document) was not. (Copy)
VIN comparison	The vehicle identification number (VIN) was read from the vehicle and its conformity with the submitted documents was confirmed by the undersigned during the inspection.
Inspection	The inspection conditions were sufficient for the assessment of the vehicle. No lifting equipment or pit was available for inspecting the vehicle. Therefore, inspection of the vehicle's underside was only possible to a limited extent.
Test drive	No test drive/shunting maneuver was carried out during the inspection of the vehicle.
Engine function test	An engine test run was performed.

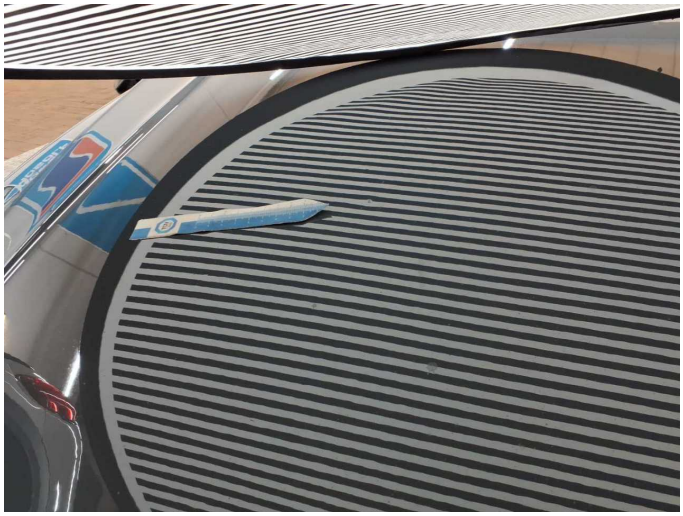
Wear and tear 6: Bonnet: Bonnet - Dent / paintcoat damage - No deduction
