Expertise

Protocol number: 48506171
Order No. / Reference: 27186743
Inspection date: 3 Nov 2026

Manufacturer: Volkswagen	Model: Golf Variant 2.0 TDI SCR DSG Style
VIN: WVWZZZCD2RW813043

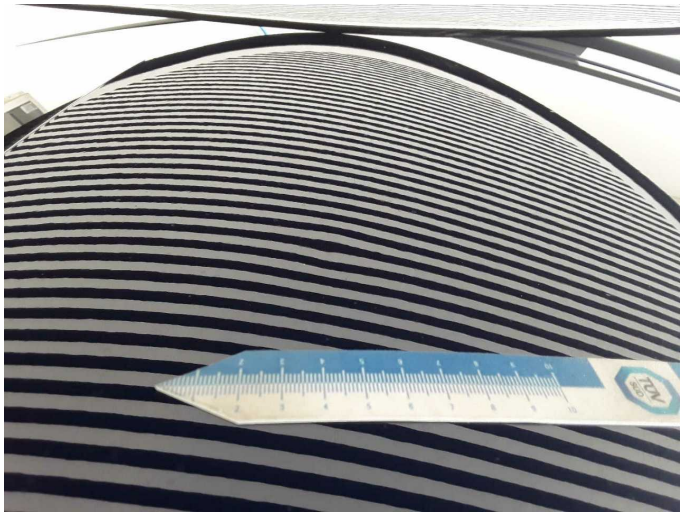
Damage 3: Roof: Roof - dent(s) - Smooth repair work

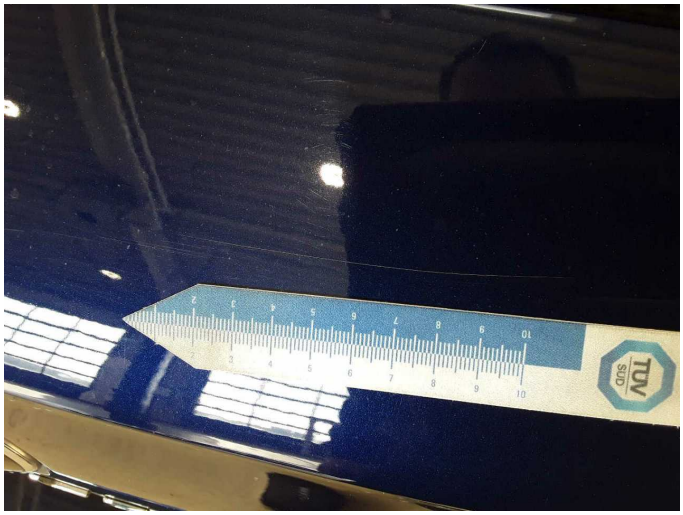
Damage 6: Boot lid / rear door: Boot lid - Scratch(es) - Paint

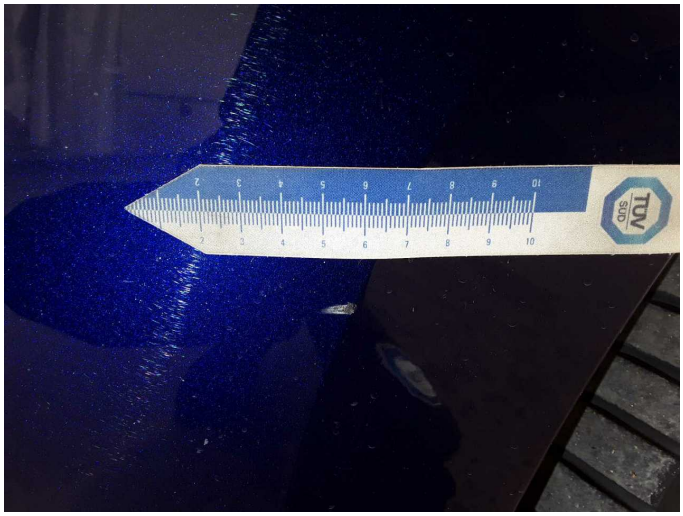
Damage 7: Front bumper: Front bumper - Scratch(es) - Paint

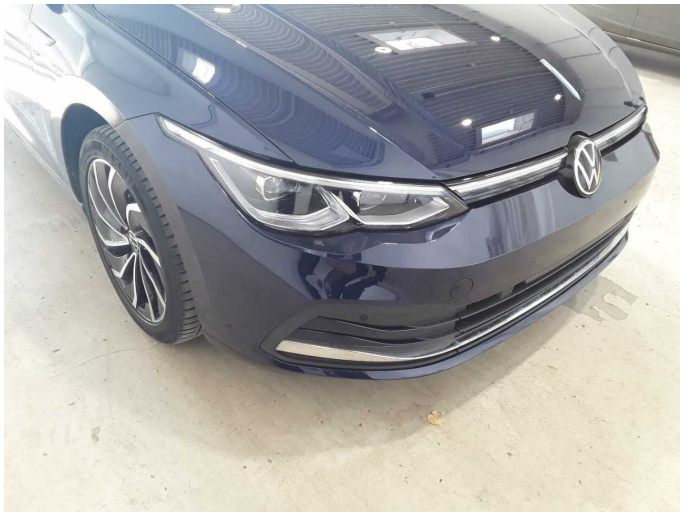
Damage 7: Front bumper: Front bumper - Scratch(es) - Paint

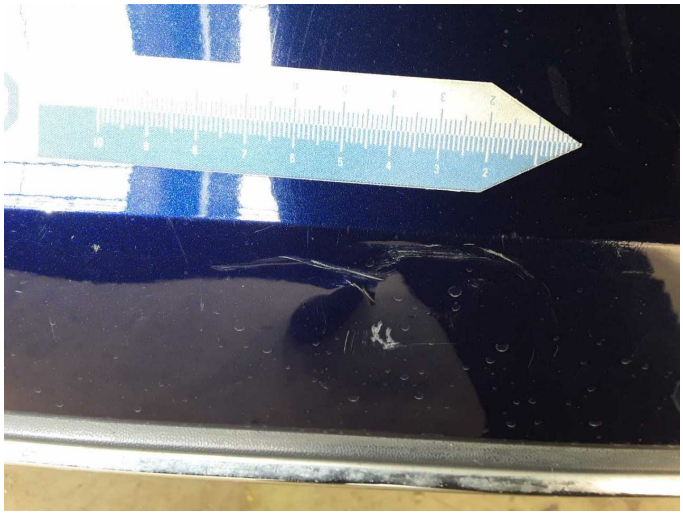
Damage 8: Rear bumper: Rear bumper - Scratched - Repair and paint

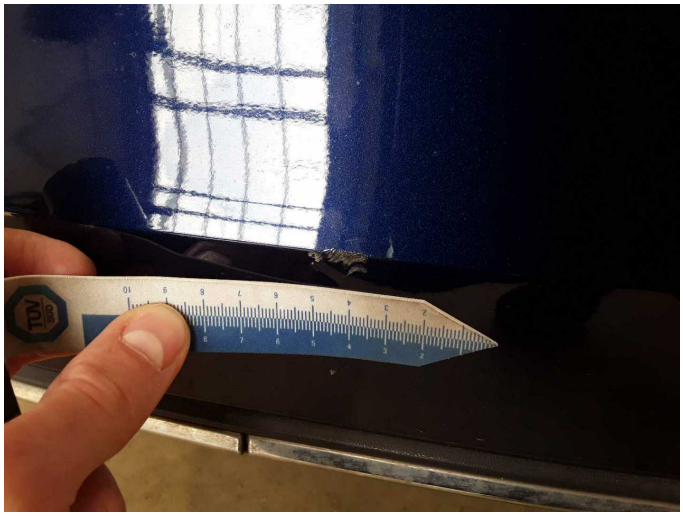
Damage 8: Rear bumper: Rear bumper - Scratched - Repair and paint

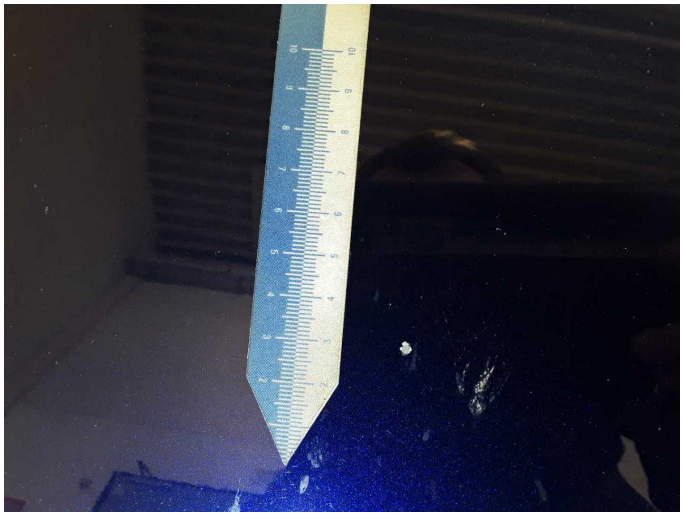
Wear and tear 3: Bonnet: Bonnet - Stone chips - No deduction
