TÜV SÜD Auto Partner GmbH
Wiesenring 2
04159 Leipzig

Expertise

Protocol number: 48086875
Order No. / Reference: 27065038
Inspection date: 13 Oct 2026

Manufacturer: Opel	Model: Astra 1.5 D Automatik Business Elegance
VIN: VXKFBYHZTP1000607

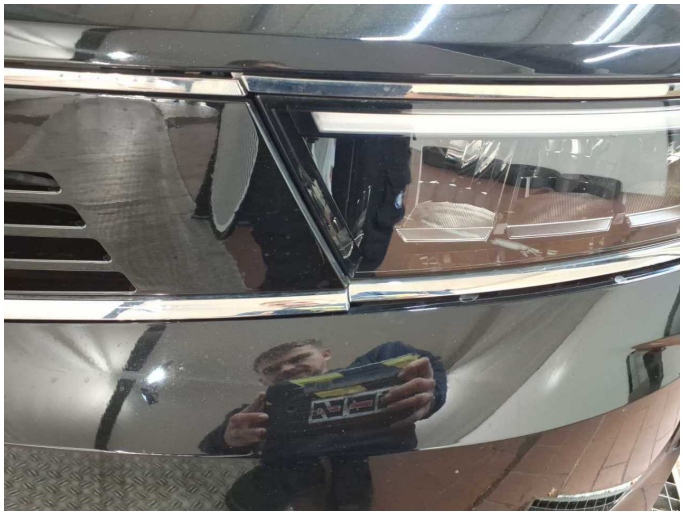
Damage 3: Front bumper: Front bumper - Loose - Repair

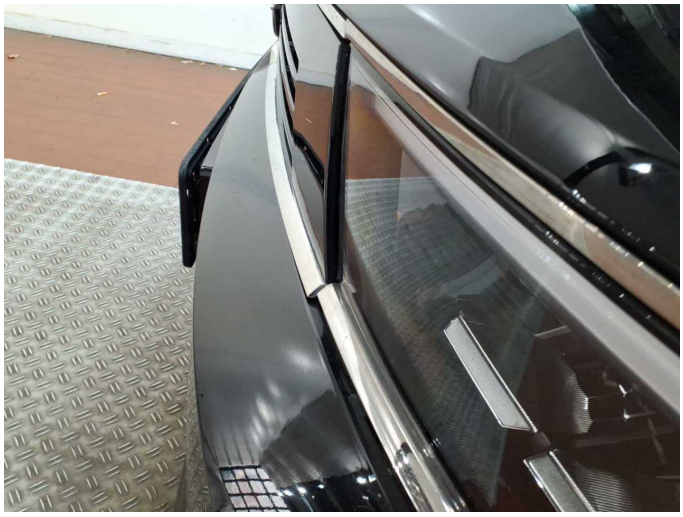
Damage 4: Headlight: Headlight - left side (Fehlstellung) - Repair

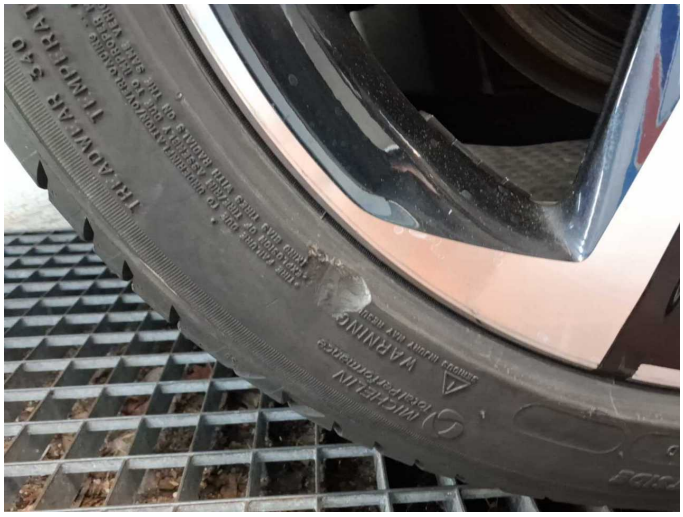
Damage 5: Wheel / tyres: Alloy rim - front right side - Scratch(es) - Loss in value

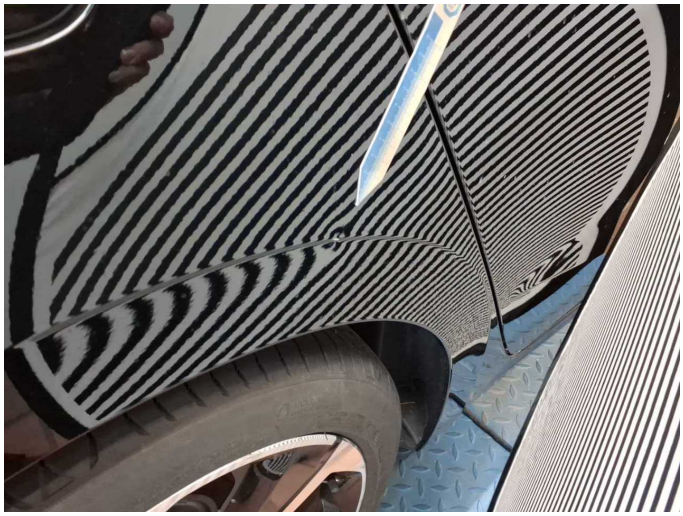
Damage 7: Side panel - rear right side: Side panel - Dent / paintcoat damage - Smart repair

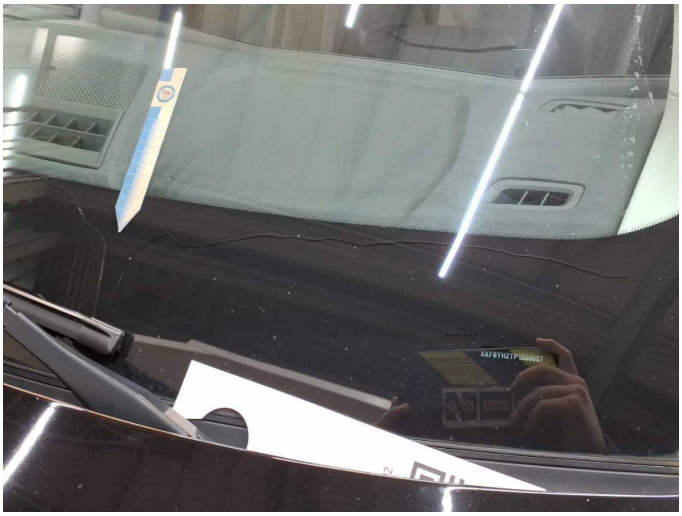
Damage 9: Vehicle glazing: Windscreen - Broken / torn - Replace
