Expertise

Protocol number: 48411035
Order No. / Reference: 27056638
Inspection date: 20 Oct 2026

Manufacturer: Volkswagen	Model: Tiguan Allspace 2.0 TDI SCR 4Motion DSG Elegance
VIN: WVGZZZ5NZNM103943

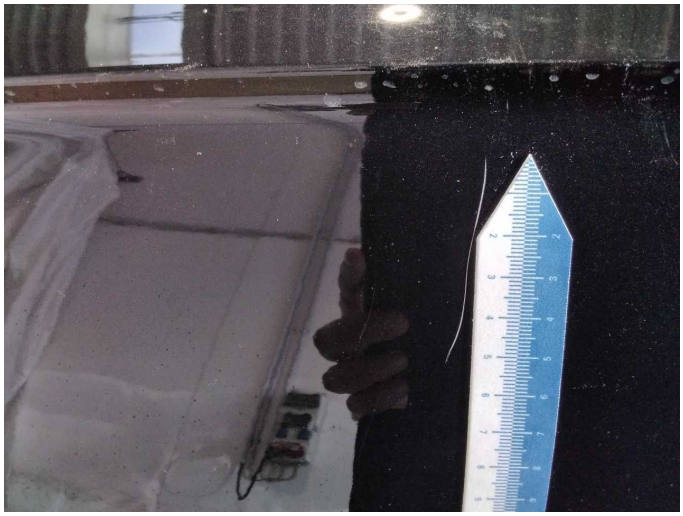
Damage 5: Mudguard - left side: Mudguard - left side - Scratch(es) - Paint

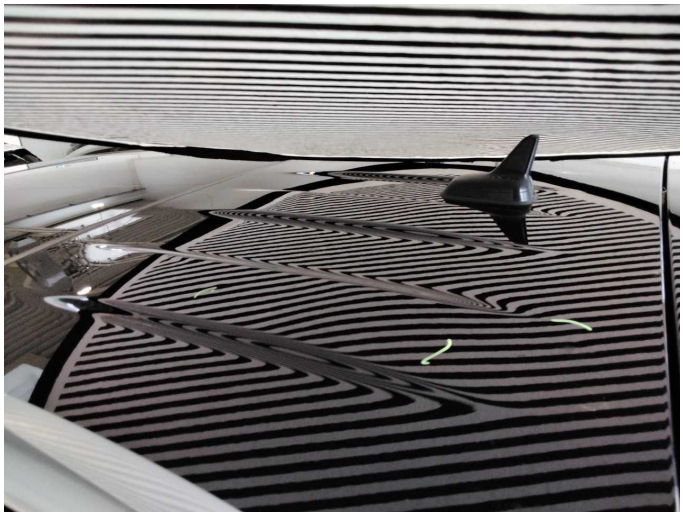
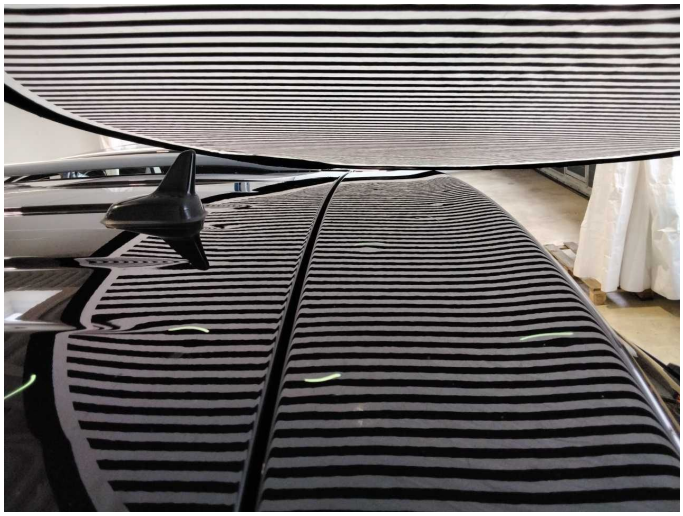
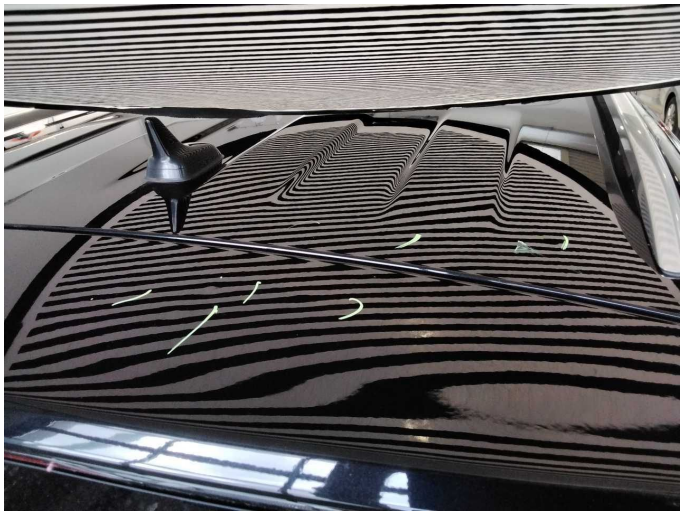
Damage 7: Roof: Roof - Deformed - repair according to calculation
