Ford

2.0TDCI 96KW TREND RWD 350E HD

VIN: WF0AXXTTRARY04334

Inspection loc PARC HÖDLMAYR TONGEREN	**Statement date** 26/10/2026	**Inspection approval date** 27/10/2026

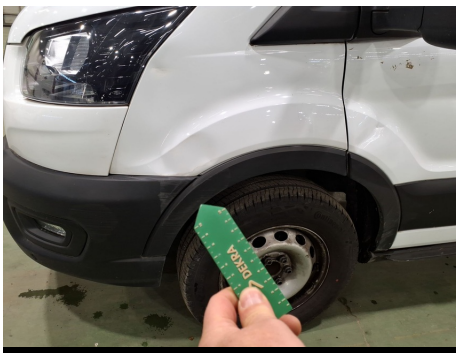
Wing / Front Left / Dent

003	Wing / Front Left	Dent	Replace Part number : 2203290

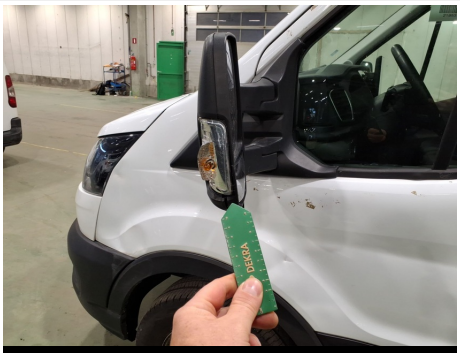
Door / Front Left / Dent

005	Door / Front Left	Dent	Repair

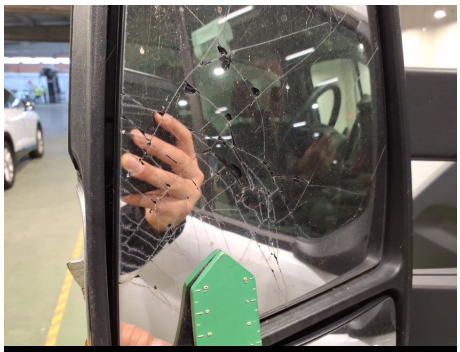
Rear-view mirror / Left / Broken

006	Rear-view mirror / Left	Broken	Replace Part number : 2863968
