PEUGEOT 5008

Vehicle information

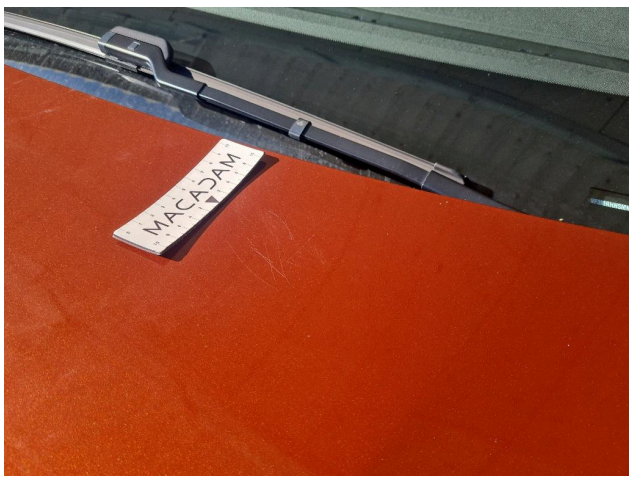
Roof & other

Damaged -

Acceptable.

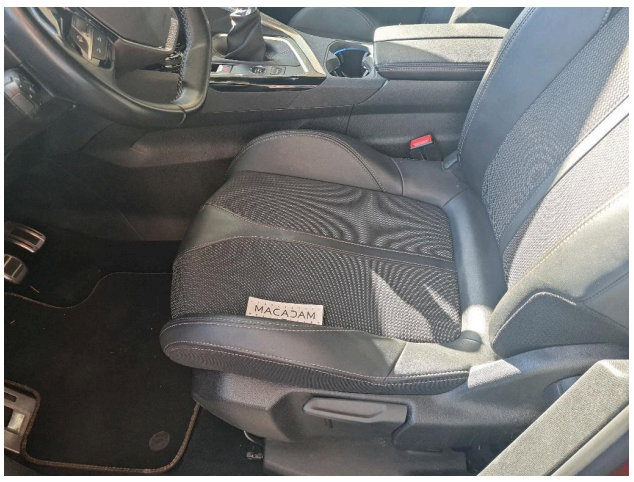
Damaged **Interior**

- Acceptable
