ARVAL
BNP PARIBAS GROUP

2CLW156

INSPECTION REPORT

End of contract

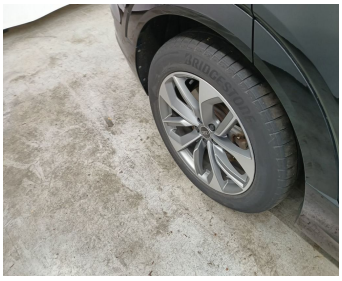
Wing Rear Right // Repair & Painting-scratch + dent

Windshield // Repair-stone chipping

Wheel Two Tone Rear Left // Repair-scratch

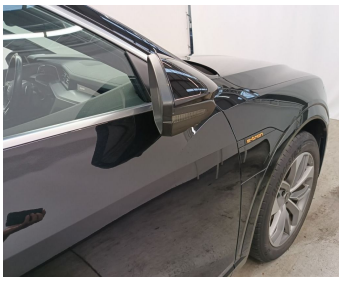
Wheel Two Tone Rear Right // Repair-scratch

Side View Mirror Right // Painting-scratch

Wing Front right / Trim / Replace-scratch

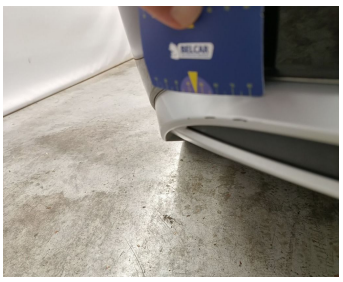
Wing Front right // Polish-scratch

Bumper Rear // Repair & Painting-scratch + dent

Bumper Rear / Spoiler / Replace-scratch + dent
