Expertise

Protocol number: 48427621
Order No. / Reference: 27090415
Inspection date: 27 Oct 2026

Manufacturer: Opel	Model: Combo Cargo XL 1.5 D EHZ Edition
VIN: W0VEFYHYCMJ854523

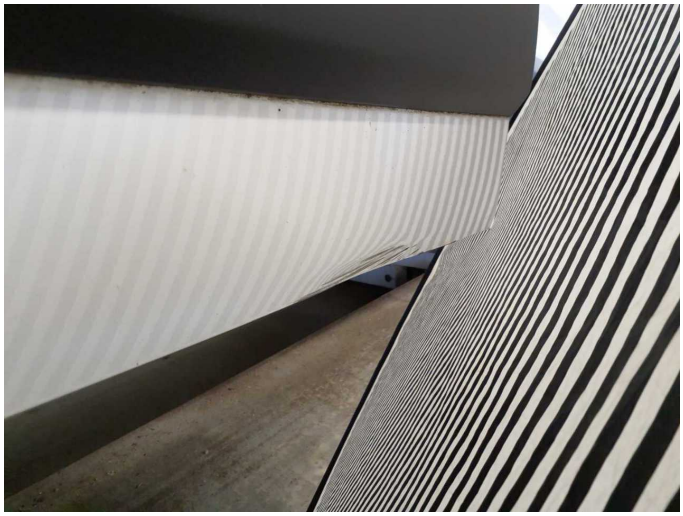
Accident 2: Side right

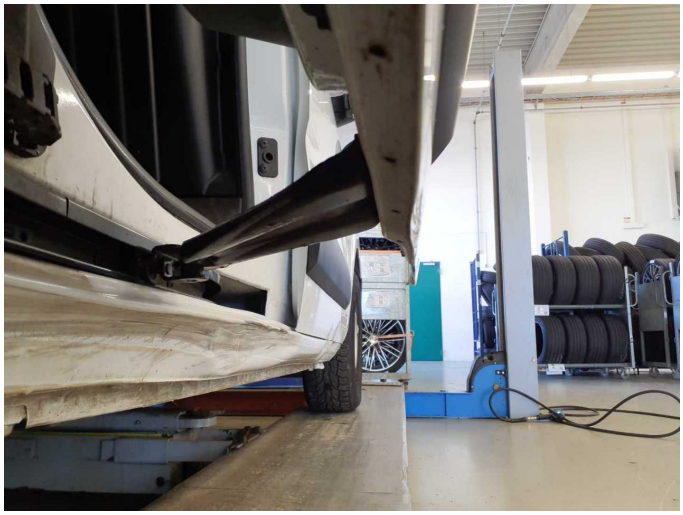
Accident 2: Side right
