Expertise

Protocol number: 48368747
Order No. / Reference: 27191015
Inspection date: 26 Oct 2026

Manufacturer: Mercedes-Benz	Model: GLC 300 de 4Matic 9G-TRONIC
VIN: W1N2539111G087254

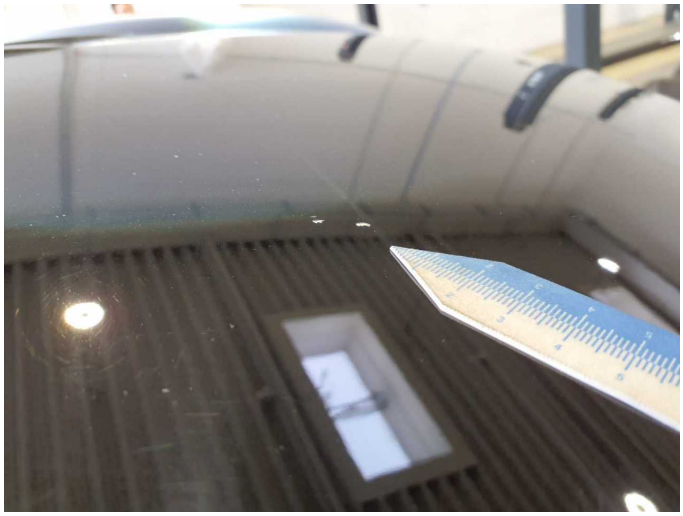
Damage 5: Roof: Roof - Stone chips - Loss in value

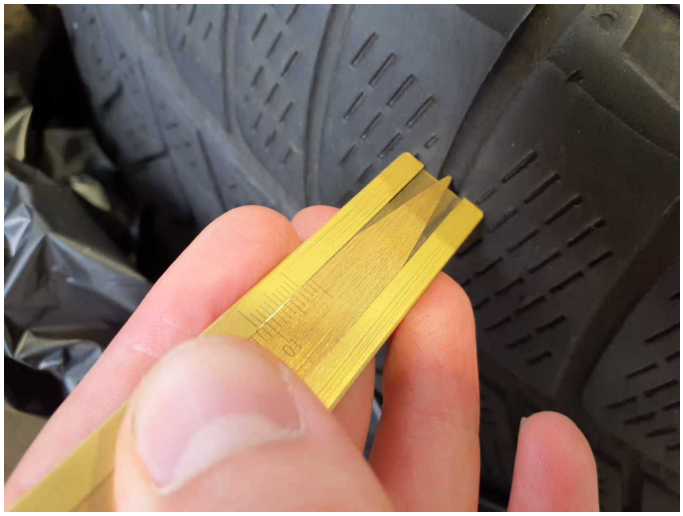
Damage 7: 2nd wheel set: 2 tyres - Worn - Replace

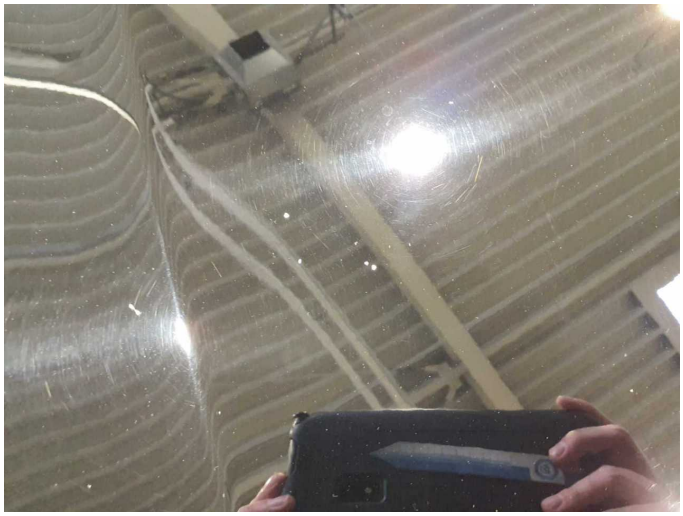
Damage 8: Wheel / tyres: Tyre - front - Worn - Replace

Damage 9: Bonnet: Bonnet - Stone chips - Paint

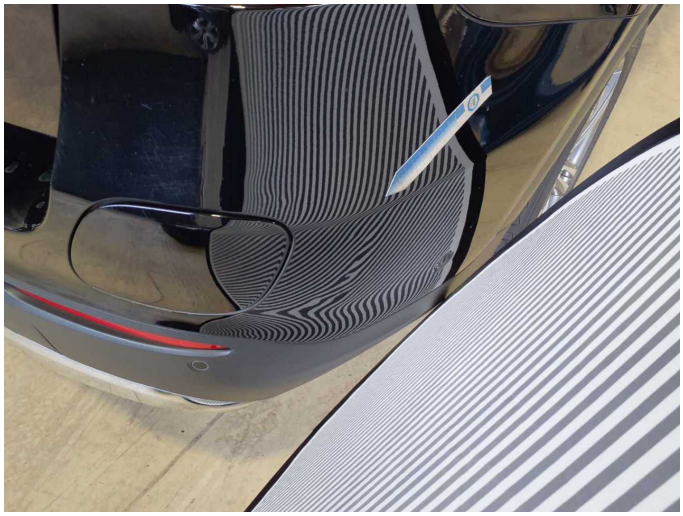
Damage 9: Bonnet: Bonnet - Stone chips - Paint

Damage 10: Rear bumper: Rear bumper - Dent / paintcoat damage - Repair and paint

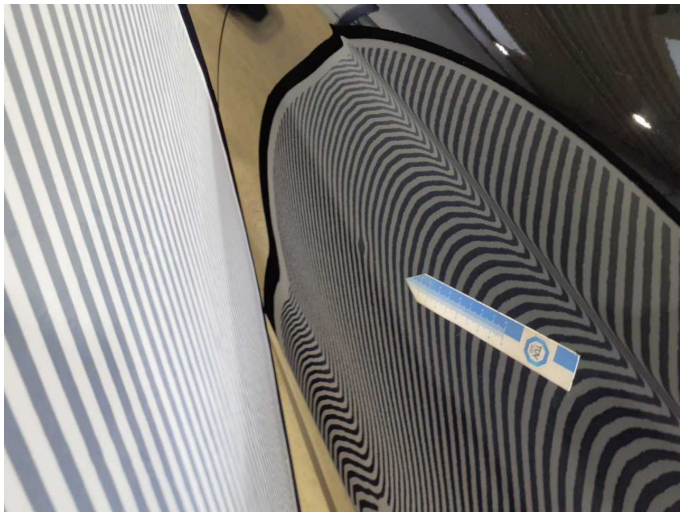
Damage 10: Rear bumper: Rear bumper - Dent / paintcoat damage - Repair and paint

Wear and tear 8: Door - front left side: Door - dent(s) - No deduction

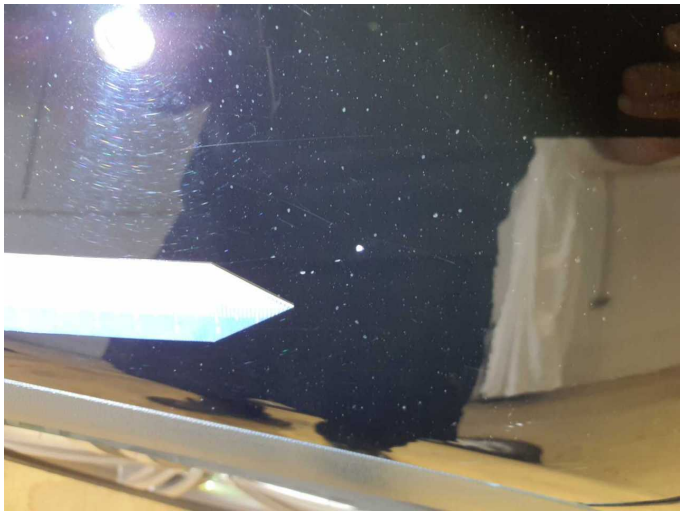
Wear and tear 10: Mudguard - right side: Mudguard - right side - Stone chips - Cover / polish

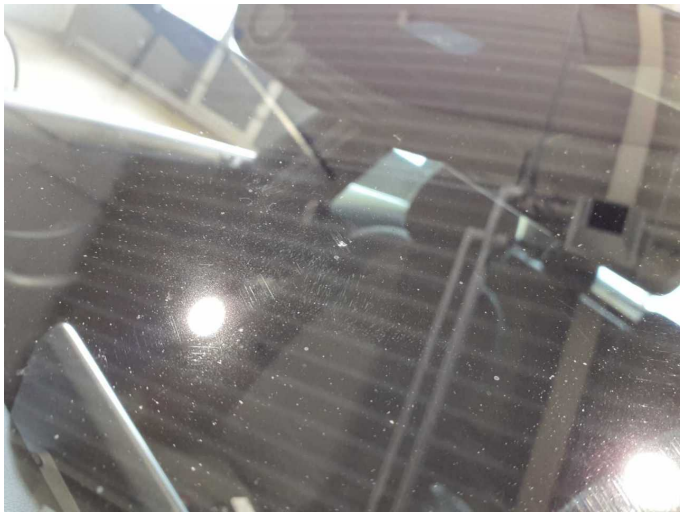
Wear and tear 11: Vehicle glazing: Windscreen - Stone chips - No deduction
