TÜV SÜD Auto Partner GmbH
Wiesenring 2
04159 Leipzig

Expertise

Protocol number: 48485954
Order No. / Reference: 27176895
Inspection date: 4 Nov 2026

Manufacturer: Audi	Model: A5 Sportback 40 TDI S tronic S line
VIN: WAUZZZF57PA040744

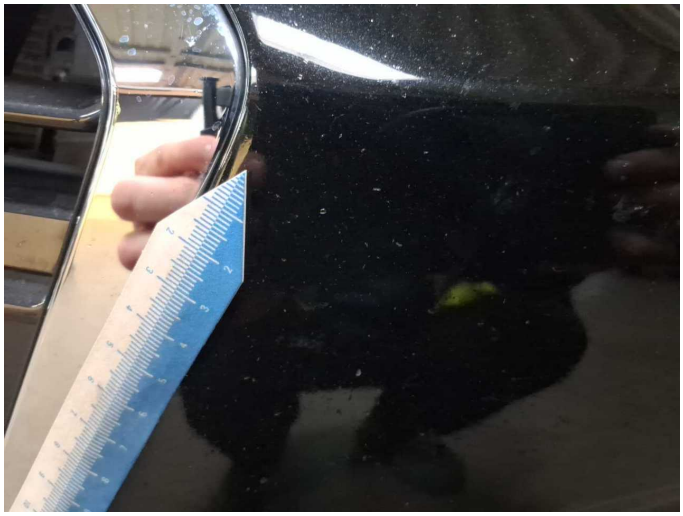
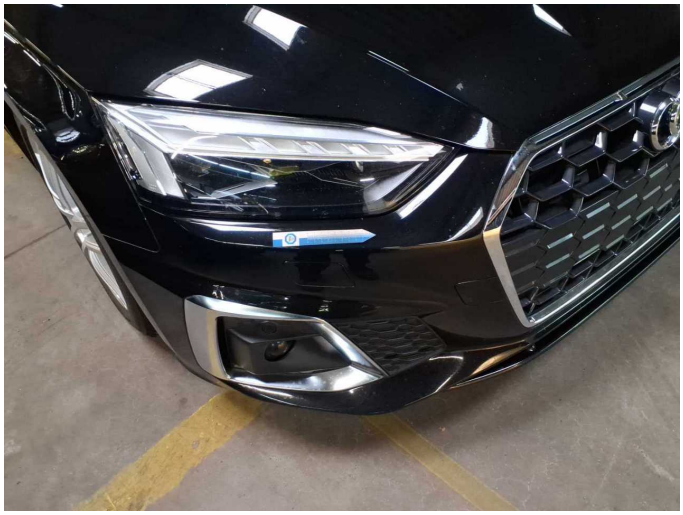
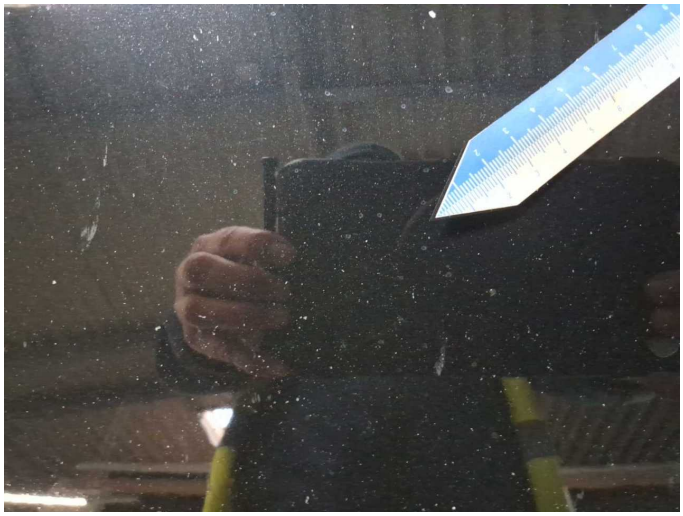
Damage 2: Front bumper: Front bumper (Viele Steinschläge) - Dent / paintcoat damage - Repair and paint

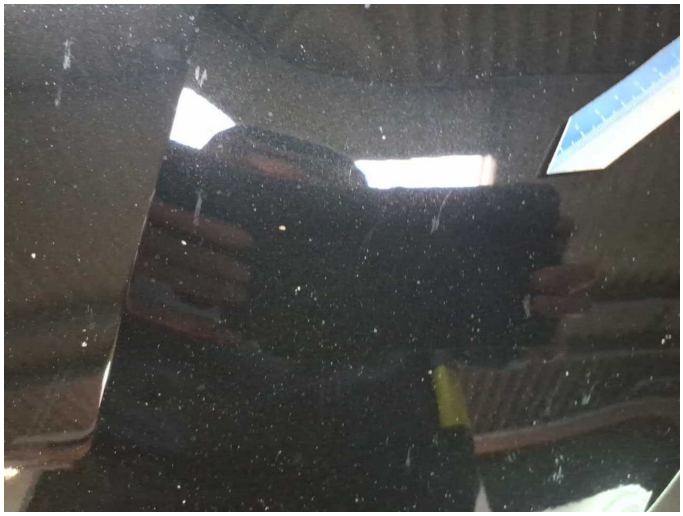
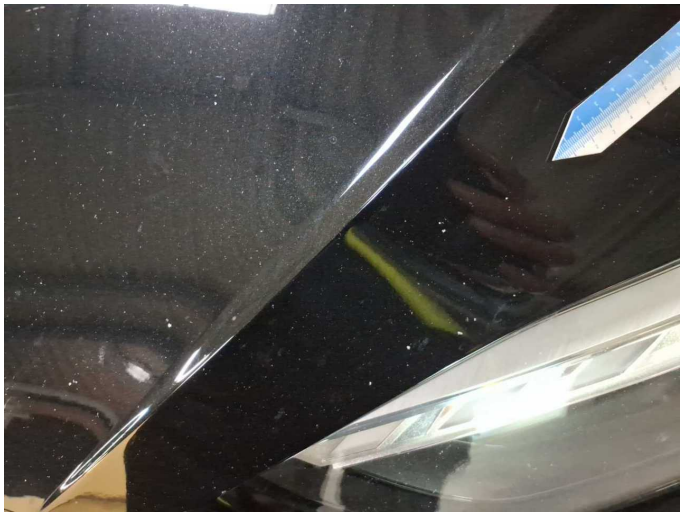
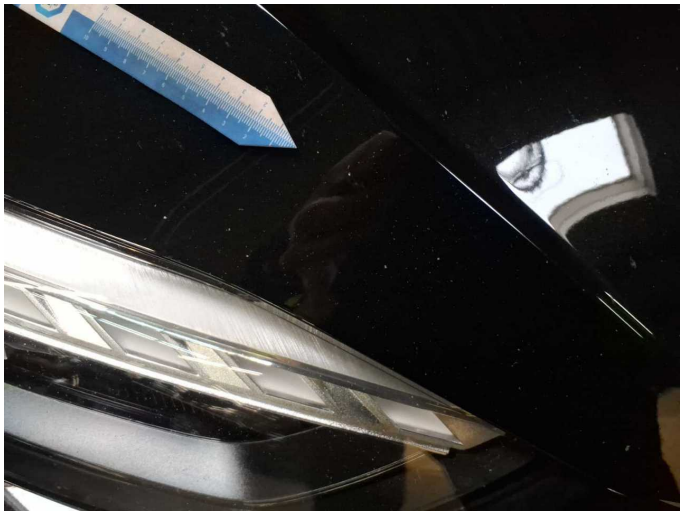
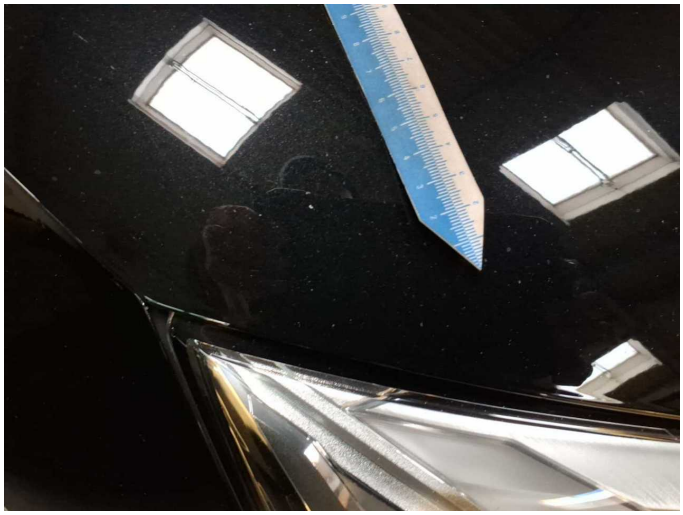
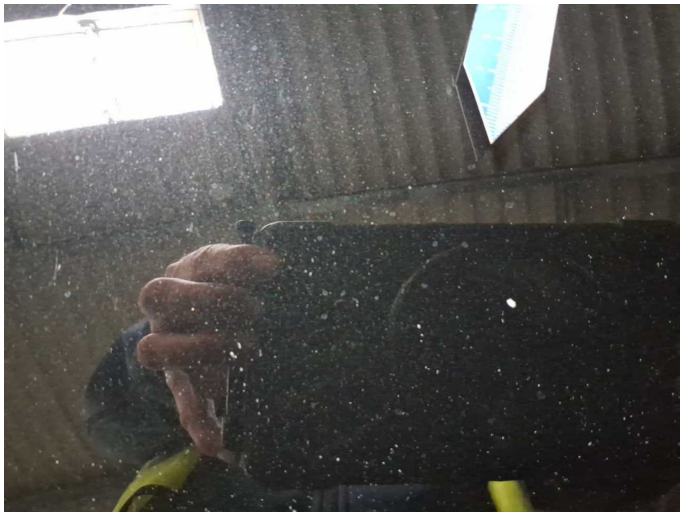
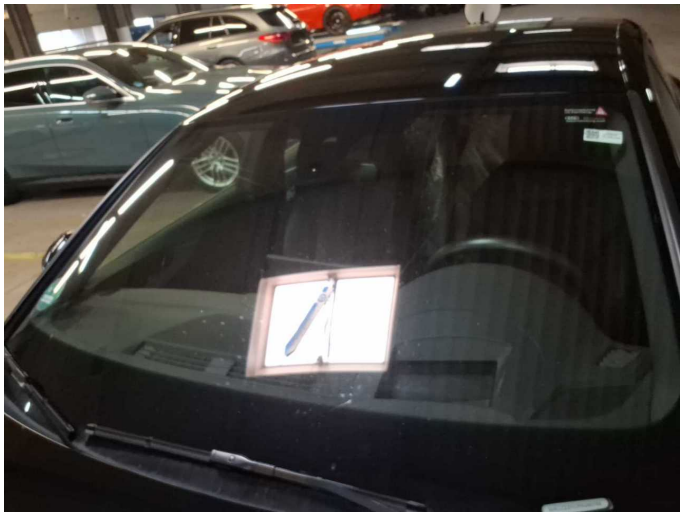
Damage 3: Bonnet: Bonnet (Mehrere) - Stone chips - Paint

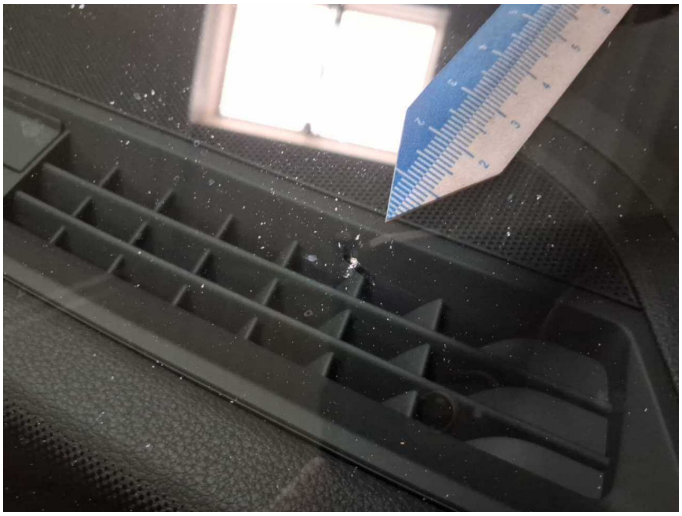
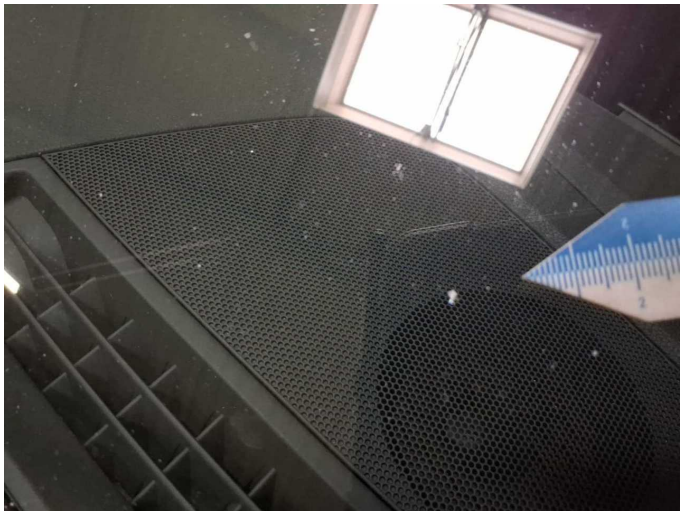
Damage 4: Vehicle glazing: Windscreen with lane departure assistant - Damaged - Replace
