Expertise

Protocol number: 48398974
Order No. / Reference: 27204066
Inspection date: 29 Oct 2026

Manufacturer: Ford	Model: Focus Turnier 1.0 EcoBoost Hybrid Aut. ST-LINE X
VIN: WF0PXXGCHPSC43715

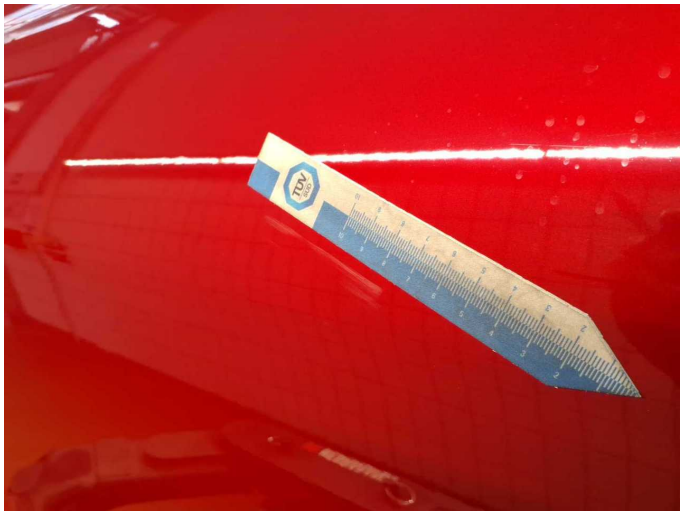
No.	Component group	Description
1	Front bumper	Front bumper - Scratched - Paint

Damage 1: Front bumper: Front bumper - Scratched - Paint
