Expertise

Protocol number: 48459409
Order No. / Reference: 27192785
Inspection date: 2 Nov 2026

Manufacturer: CUPRA	Model: Leon Sportstourer 1.4 e-Hybrid (150 kW System)
VIN: VSSZZZKL9PR054393

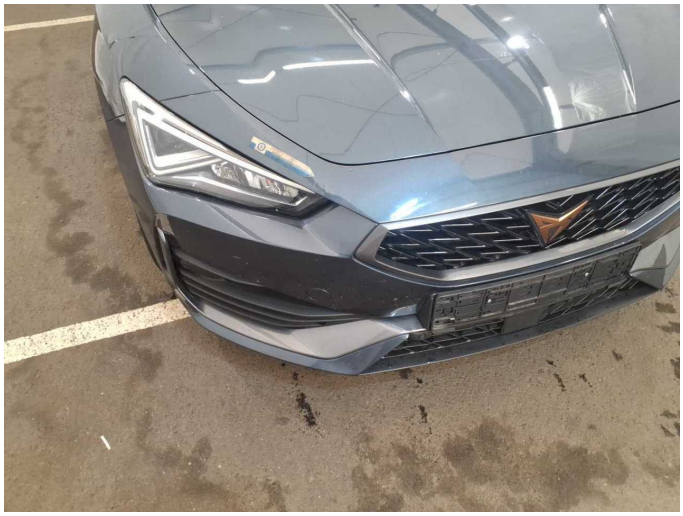
Damage 3: Front bumper: Front bumper - Scratch(es) - Paint

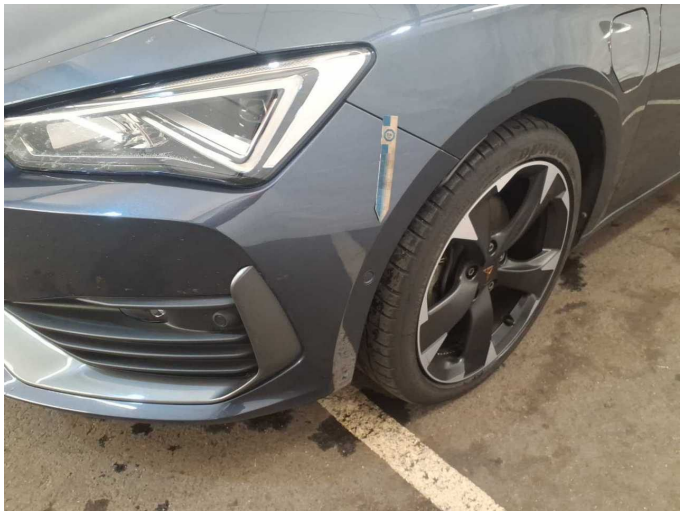
Damage 3: Front bumper: Front bumper - Scratch(es) - Paint
