TÜV SÜD Auto Partner GmbH
Wiesenring 2
04159 Leipzig

Expertise

Protocol number: 48203551
Order No. / Reference: 27075484
Inspection date: 9 Oct 2026

Manufacturer: Peugeot	Model: 5008 BlueHDi 130 EAT8 Active Pack
VIN: VF3MCYHZUNS062457

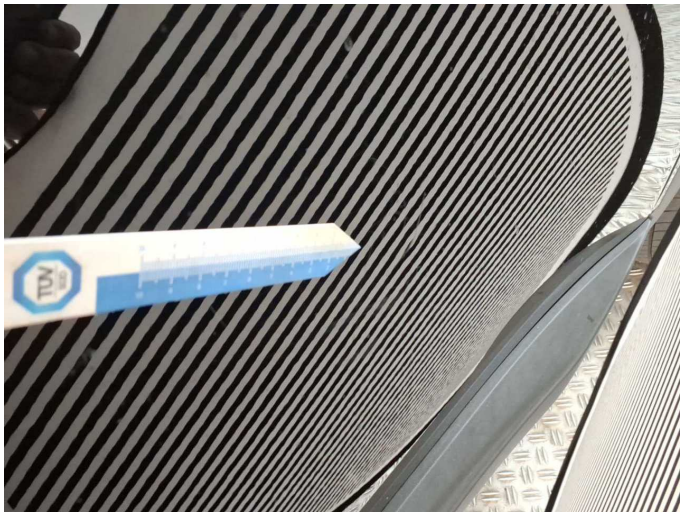
No.	Component group	Description
1	Door - front right side	Door - dent(s) - Smart repair
2	Rear bumper	Rear bumper - Deformed - Repair and paint
3	Door - rear left side	Door - Scratch(es) - Paint
4	Boot lid / rear door	Boot lid - Deformed - Repair and paint

Damage 1: Door - front right side: Door - dent(s) - Smart repair
