Expertise

Protocol number: 48362336
Order No. / Reference: 27205194
Inspection date: 28 Oct 2026

Manufacturer: Opel	Model: Astra Sports Tourer 1.5 D Automatik Business Elegance
VIN: VXKFCYHZTP1056130

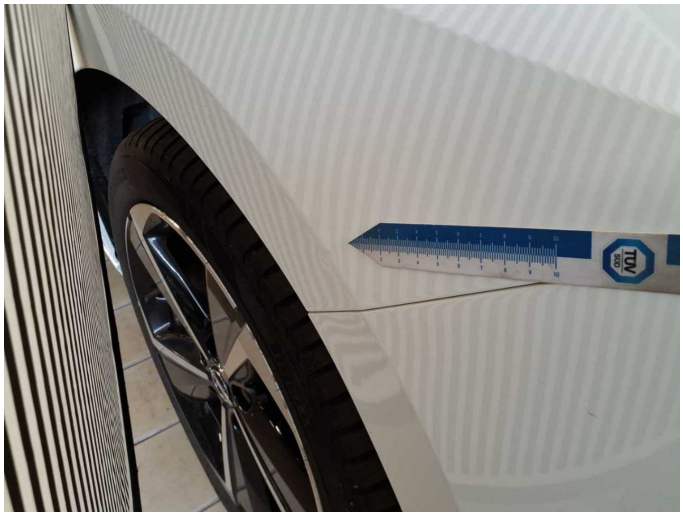
Damage 1: Mudguard - right side: Mudguard - right side - dent(s) - Smooth repair work
