Expertise

Protocol number: 48467942
Order No. / Reference: 27165474
Inspection date: 3 Nov 2026

Manufacturer: Mercedes-Benz	Model: E 220 d Cabrio 9G-TRONIC AMG Line
VIN: W1K1K1EB1PF209257

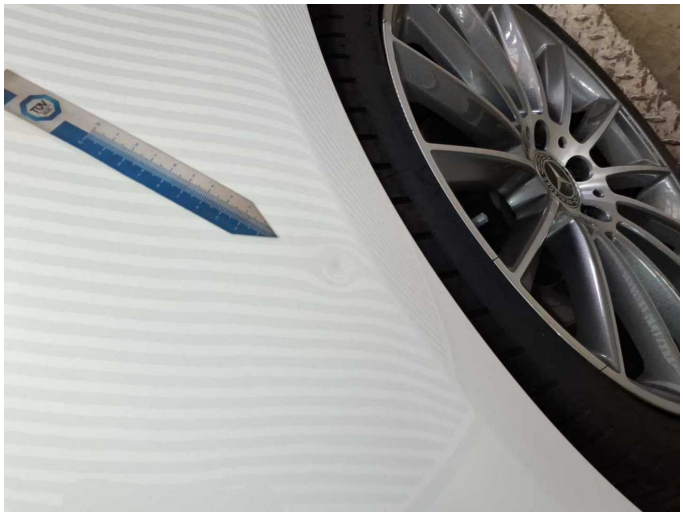
Damage 1: Side panel - rear left side: Side panel - dent(s) - Smooth repair work
