Expertise

Protocol number: 48476010
Order No. / Reference: 27228731
Inspection date: 2 Nov 2026

Manufacturer: Renault	Model: Master dCi 135 L2H2 VA Basis Kasten
VIN: VF1MA000967896490

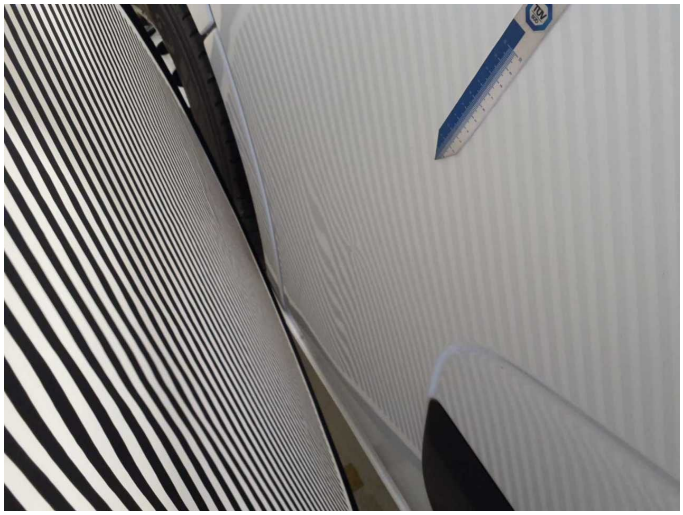
Damage 2: Door - front left side: Door - dent(s) - Smooth repair work

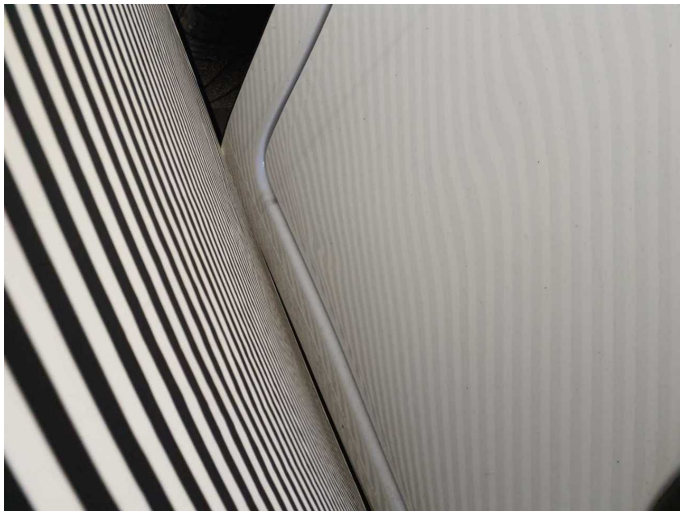
Damage 2: Door - front left side: Door - dent(s) - Smooth repair work
