Expertise

Protocol number: 47403291
Order No. / Reference: 26949406
Inspection date: 4 Sept 2026

Manufacturer: Mercedes-Benz	Model: GLE 300 d 4Matic 9G-TRONIC
VIN: W1N1671091A788958

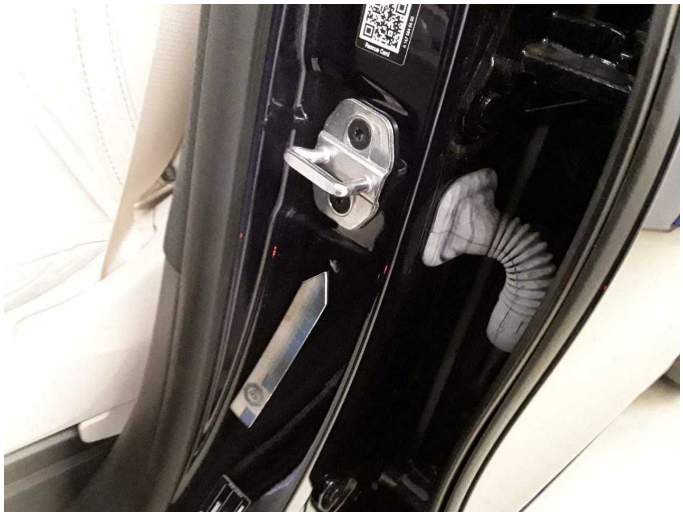
Damage 4: Sill - left side: Sill - Scratch(es) - Smart repair

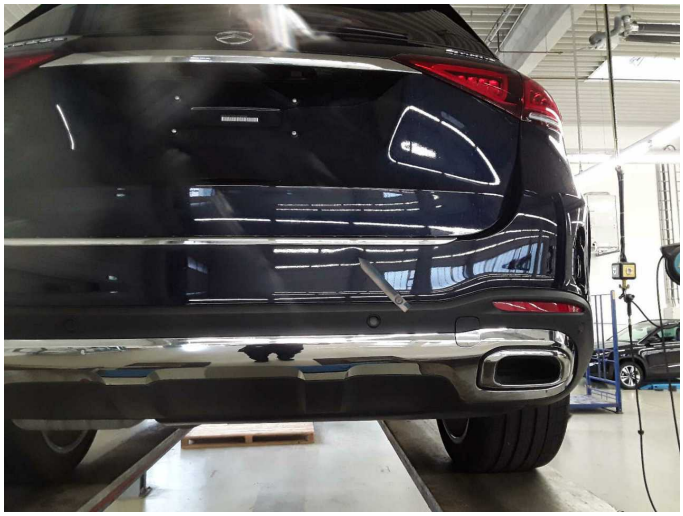
Damage 5: Rear bumper: Rear bumper - Dent / paintcoat damage - Smart repair
