Expertise

Protocol number: 48200751
Order No. / Reference: 26970458
Inspection date: 16 Oct 2026

Manufacturer: Peugeot	Model: 308 SW BlueHDi 130 EAT8 Allure Pack
VIN: VR3FCYHZTPY530489

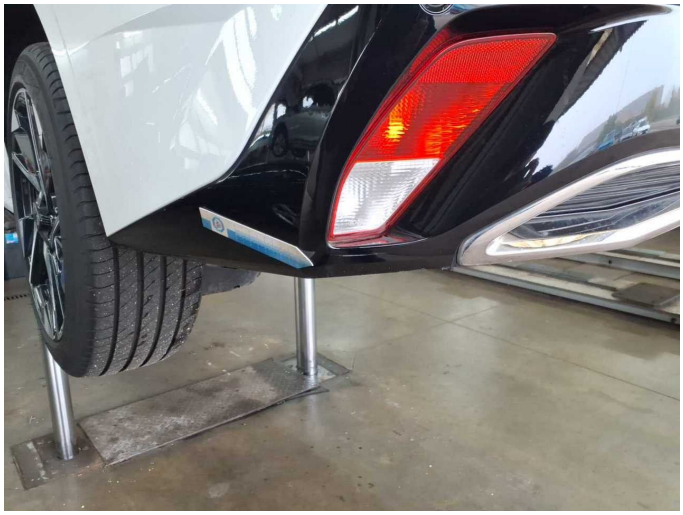
Damage 5: Rear bumper: Spoiler (im Verbund Stoßfänger erneuern) - Scratch(es) - Replace

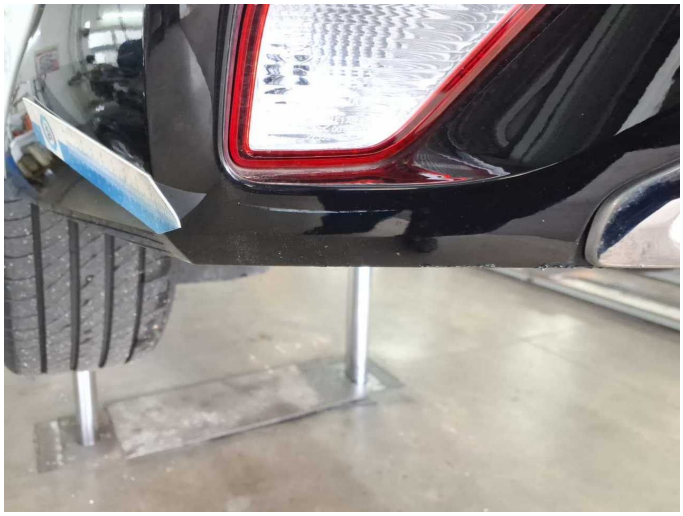
Damage 5: Rear bumper: Spoiler (im Verbund Stoßfänger erneuern) - Scratch(es) - Replace

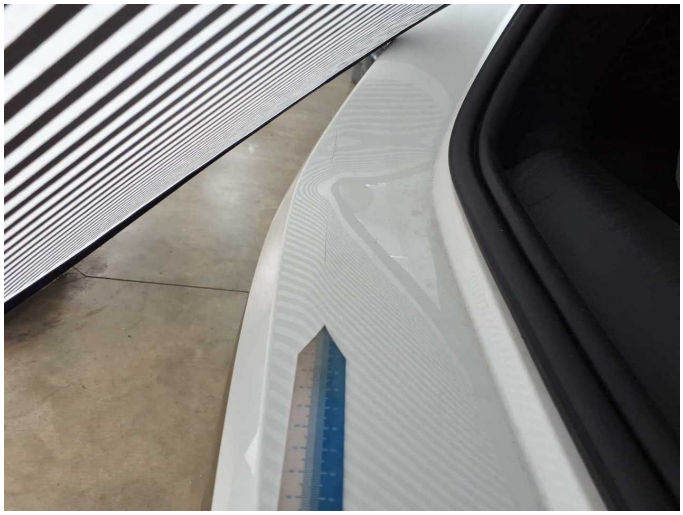
Stoßfänger macht einen Bauch, wo der Kratzer ist

Damage 6: Rear bumper: Rear bumper - Deformed - Replace

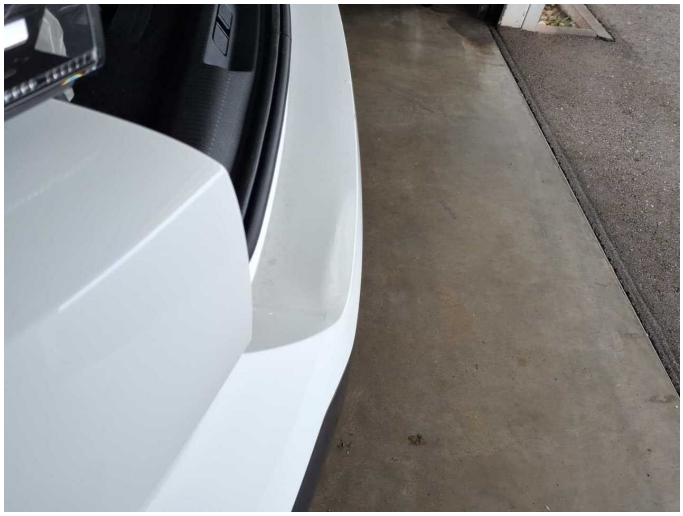
Damage 6: Rear bumper: Rear bumper - Deformed - Replace
