Expertise

Protocol number: 48163979
Order No. / Reference: 27162824
Inspection date: 15 Oct 2026

Manufacturer: Volkswagen	Model: Transporter T6.1 DSG Kurz
VIN: WV1ZZZ7HZMX011860

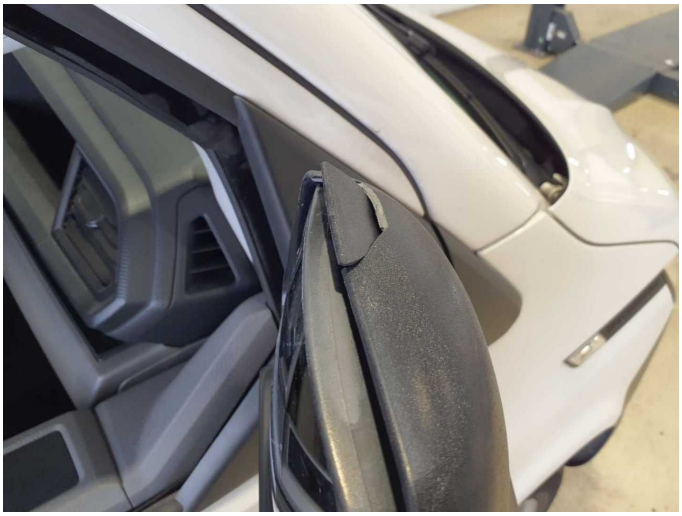
Damage 5: Wing mirror - right side: Cap - Broken / torn - Replace

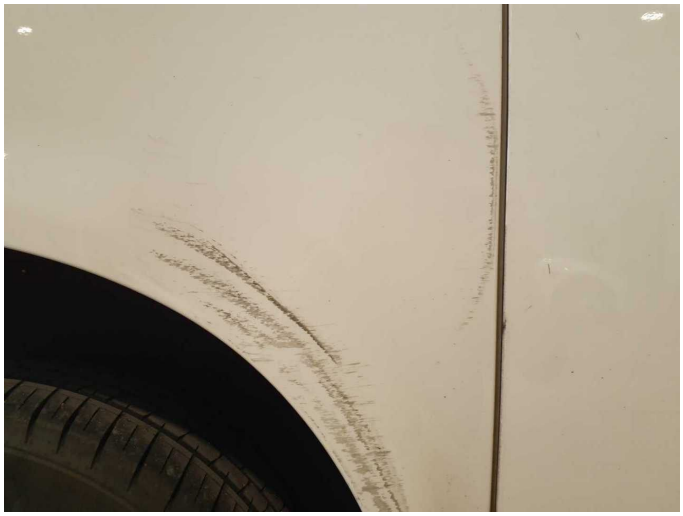
No.	Accident
1	Side right

Accident 1: Side right
