Expertise

Protocol number: 47978961
Order No. / Reference: 27039156
Inspection date: 7 Oct 2026

Manufacturer: Audi	Model: A4 Avant 35 TDI S tronic
VIN: WAUZZZF45PA069389

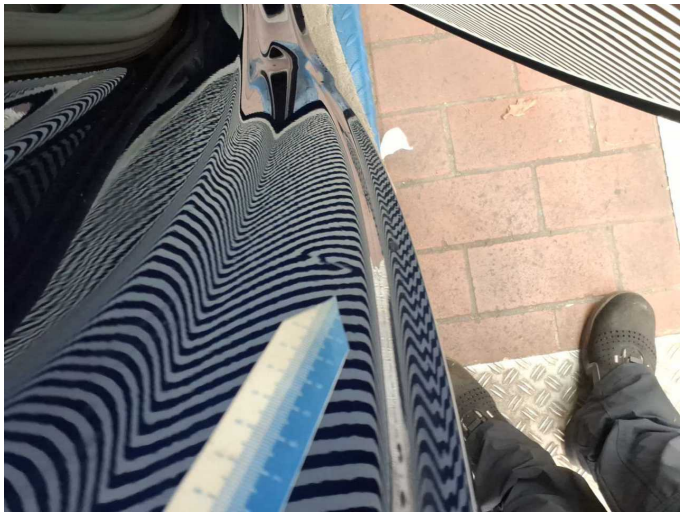
No.	Component group	Description
1	Side panel - rear right side	Sill - dent(s) - Smooth repair work
2	Side panel - rear left side	Sill - dent(s) - Smooth repair work
3	Door - rear left side	Door - Scratch(es) - Smart repair
4	Bonnet	Bonnet - Stone chips - Paint
5	Door - front left side	Door - Deformed - Repair and paint

Damage 1: Side panel - rear right side: Sill - dent(s) - Smooth repair work

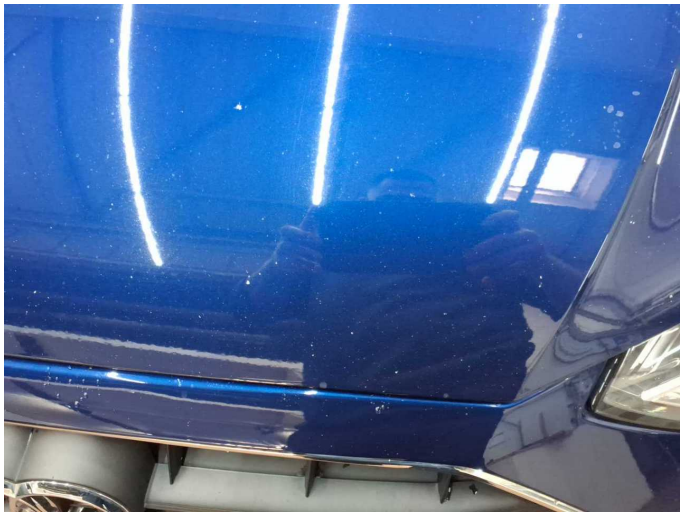
Damage 4: Bonnet: Bonnet - Stone chips - Paint

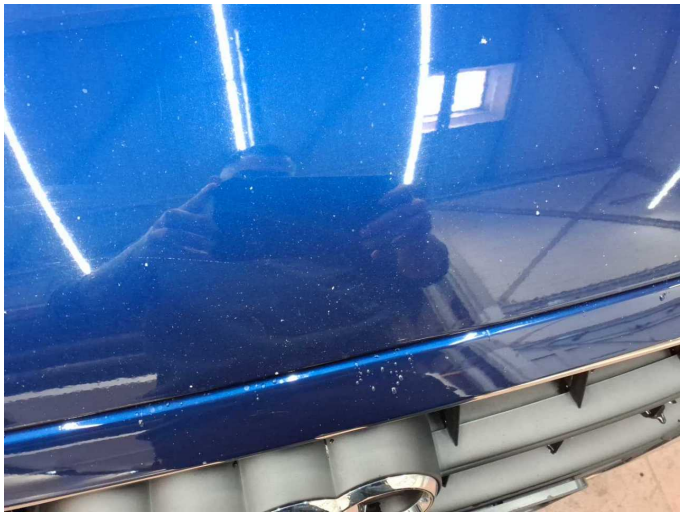
Damage 4: Bonnet: Bonnet - Stone chips - Paint

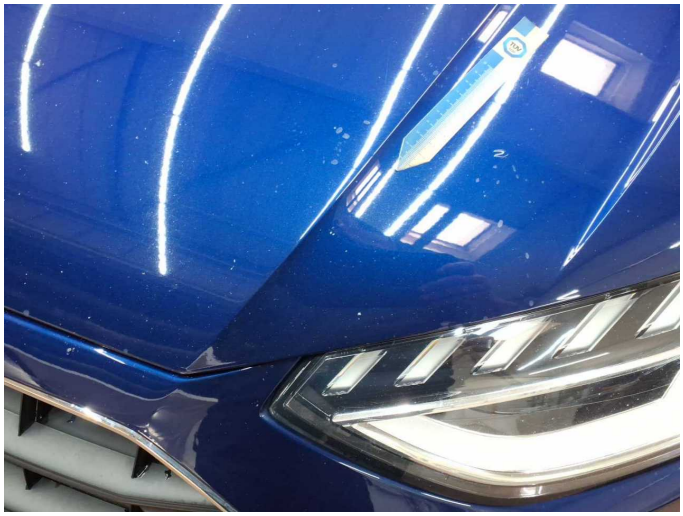
Damage 4: Bonnet: Bonnet - Stone chips - Paint

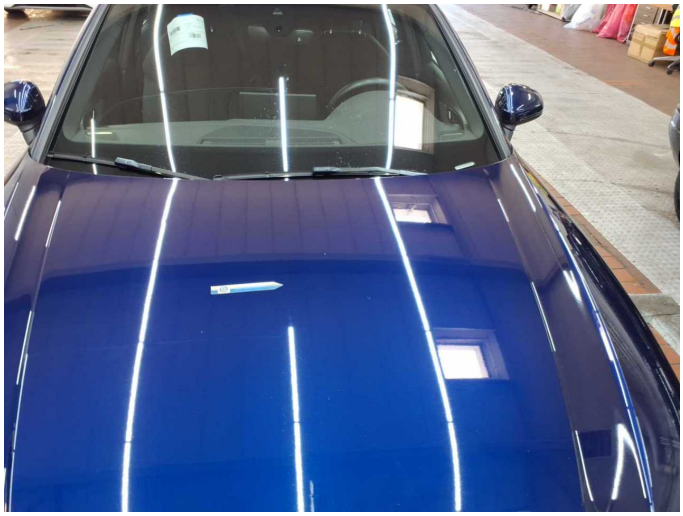
Damage 4: Bonnet: Bonnet - Stone chips - Paint

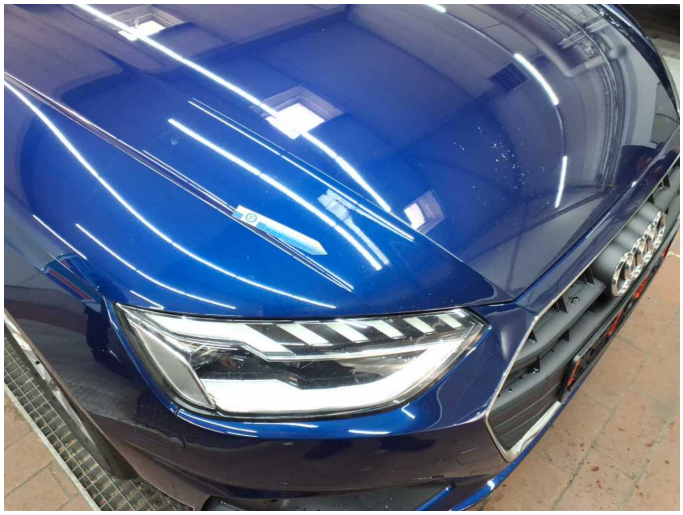
Damage 4: Bonnet: Bonnet - Stone chips - Paint

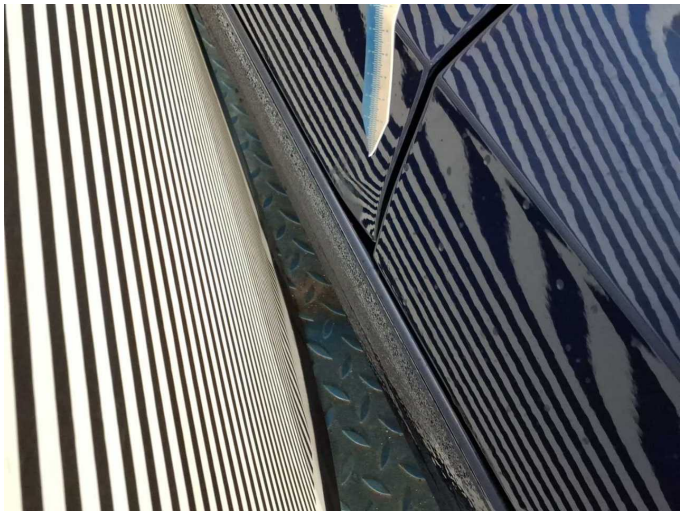
Damage 5: Door - front left side: Door - Deformed - Repair and paint
