BMW X2

Vehicle information

Summary of damages

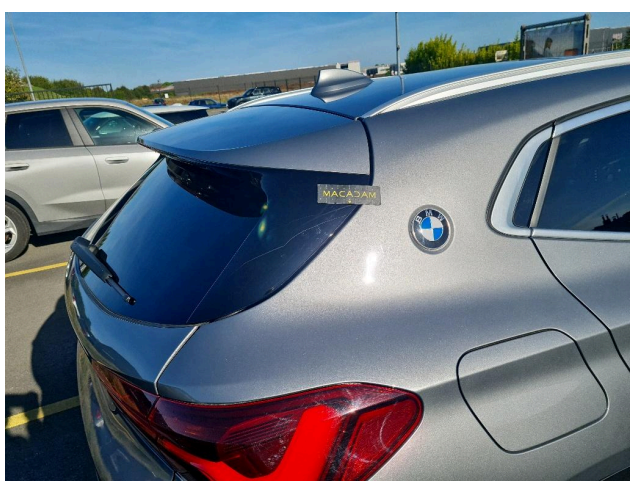
Damaged -

Acceptable.
