# Expertise

Protocol number: 48473757
Order No. / Reference: 27216594
Inspection date: 2 Nov 2026

| Manufacturer: Mercedes-Benz | Model: EQE 500 4Matic AMG Line |
| VIN: W1KEG2CBXRF057249 | |

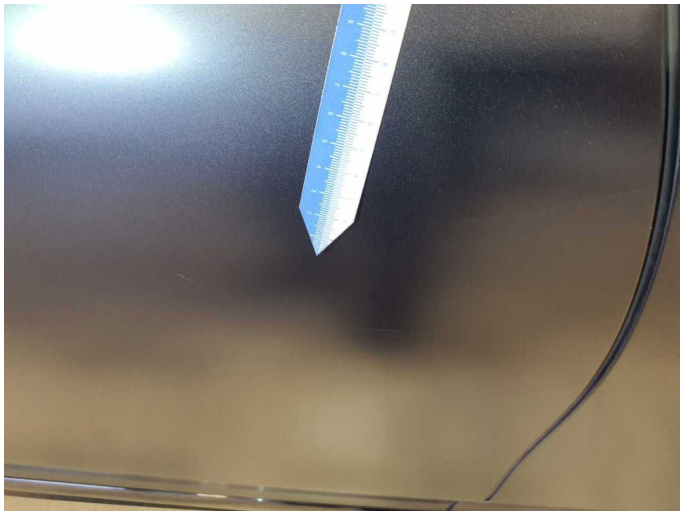
| No. | Component group | Description |
|---|---|---|
| 1 | Door - rear right side | Door - Scratch(es) - Loss in value |

**Damage 1:** Door - rear right side: Door - Scratch(es) - Loss in value

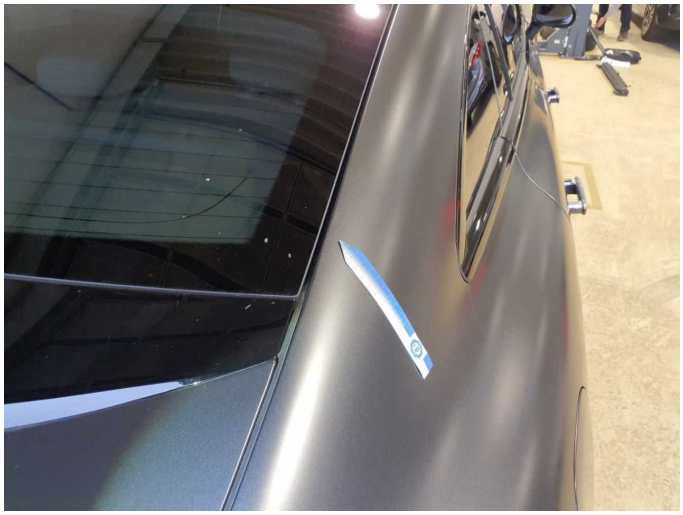
| No. | Component group | Description |
|---|---|---|
| 2 | Side panel - rear right side | Side panel - Scratch(es) - Loss in value |

**Damage 2:** Side panel - rear right side: Side panel - Scratch(es) - Loss in value

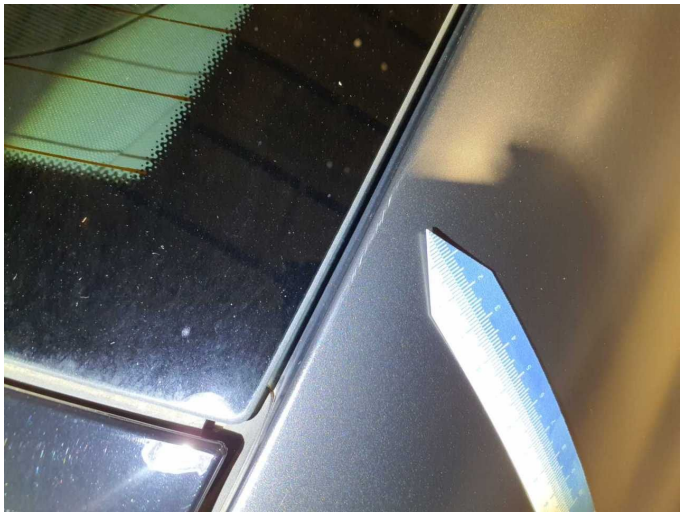
**Damage 2:** Side panel - rear right side: Side panel - Scratch(es) - Loss in value

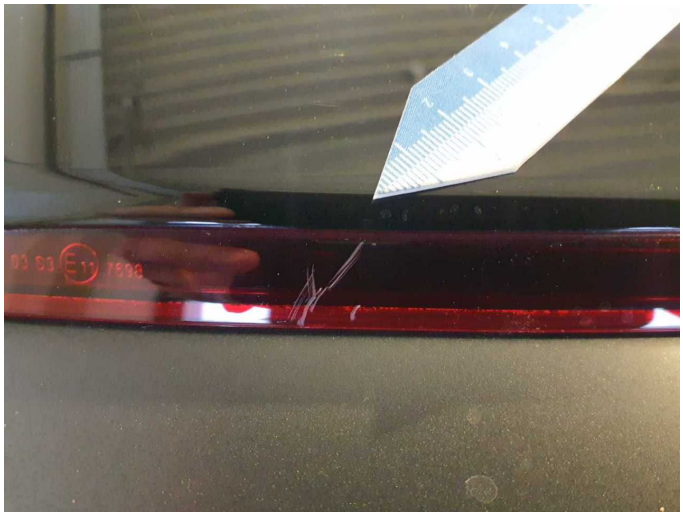
| No. | Component group | Description |
|---|---|---|
| 3 | Tail light | Auxiliary brake light - Scratch(es) - Replace |

**Damage 3:** Tail light: Auxiliary brake light - Scratch(es) - Replace

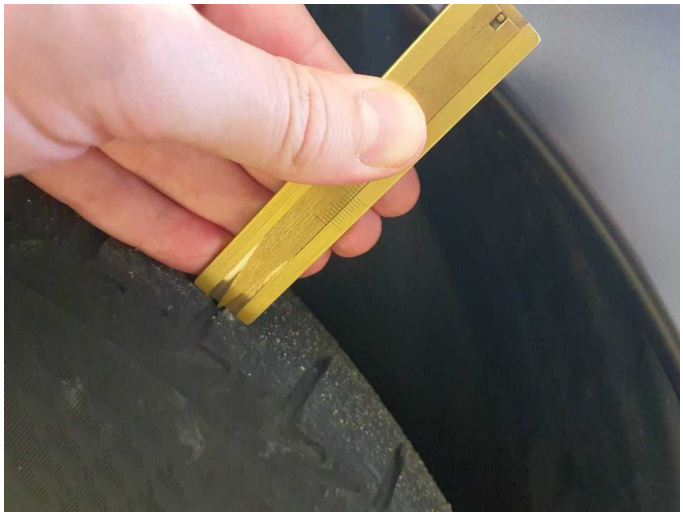
| No. | Component group | Description |
|---|---|---|
| 4 | Wheel / tyres | Tyre - front - Worn - Replace |

**Damage 4:** Wheel / tyres: Tyre - front - Worn - Replace

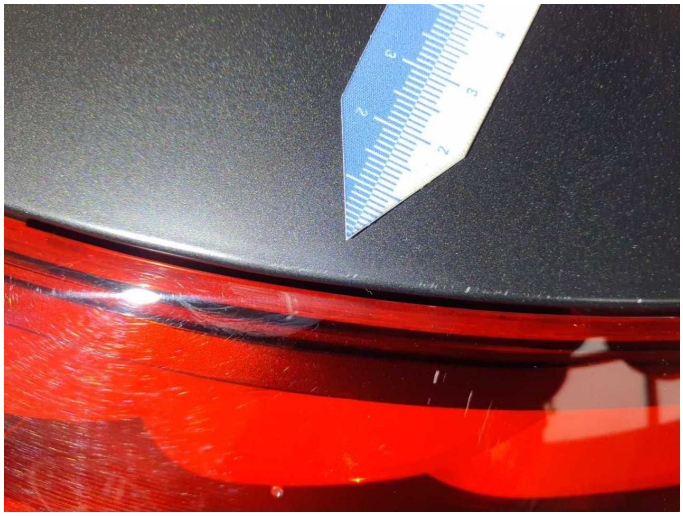
| No. | Component group | Description |
|---|---|---|
| 6 | Side panel - rear left side | Side panel - Scratch(es) - Paint |

**Damage 6:** Side panel - rear left side: Side panel - Scratch(es) - Paint

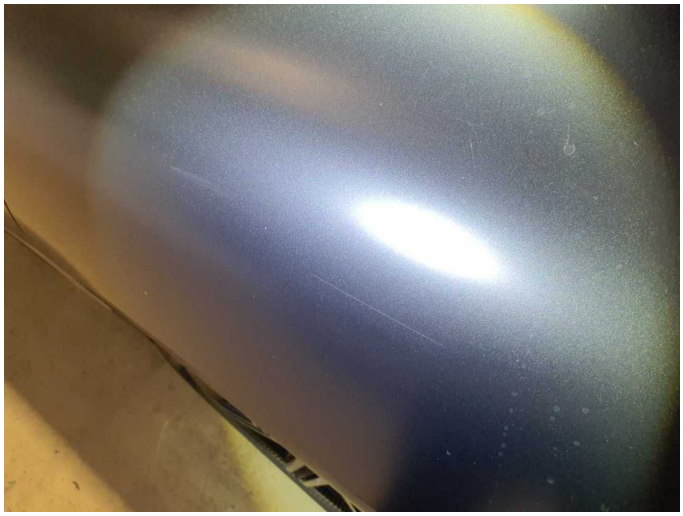
**Damage 6:** Side panel - rear left side: Side panel - Scratch(es) - Paint

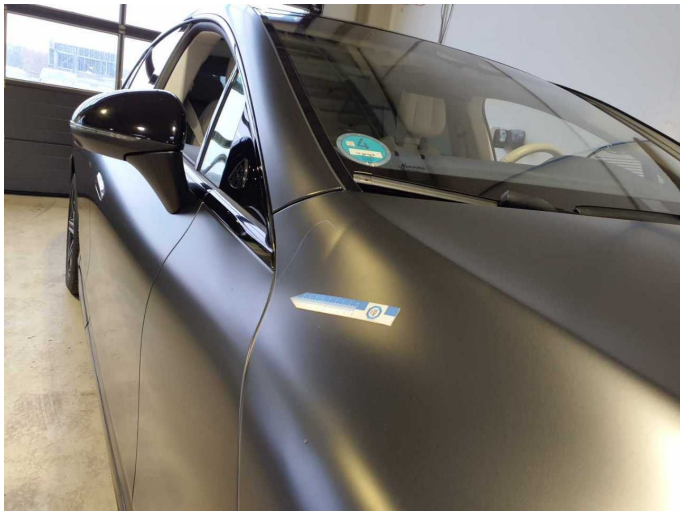
| No. | Accident |
|---|---|
| 1 | Front, Side right |

**Accident 1:** Front, Side right

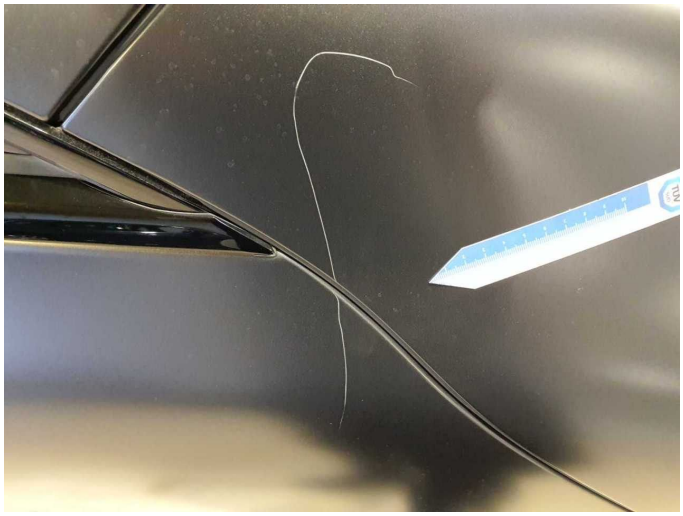
**Accident 1:** Front, Side right

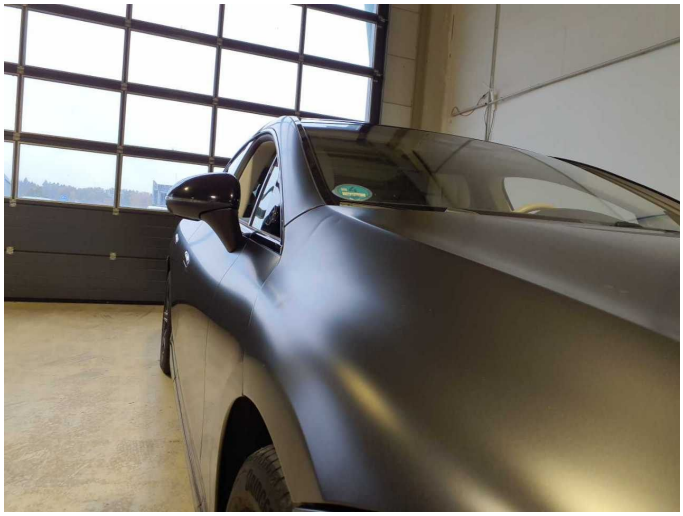
**Accident 1:** Front, Side right
