Expertise

Protocol number: 48573431
Order No. / Reference: 27259080
Inspection date: 9 Nov 2026

Manufacturer: Opel	Model: Astra Sports Tourer 1.5 D Business Edition
VIN: VXKFCYHZLP1052750

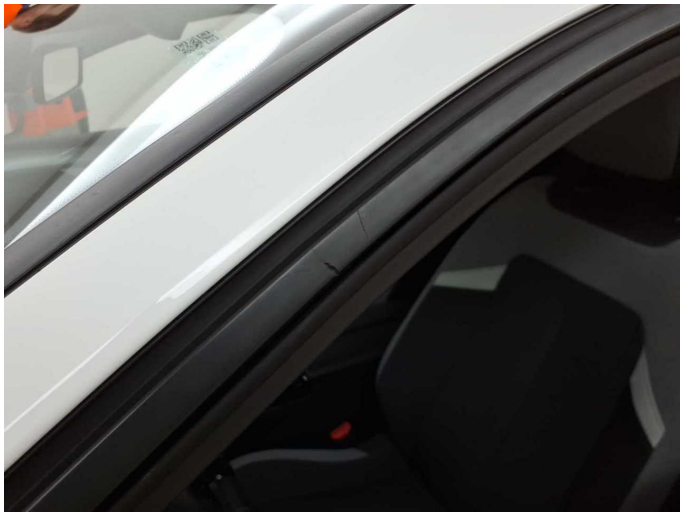
Damage 4: Door - front left side: Window guide - Scratch(es) - Loss in value

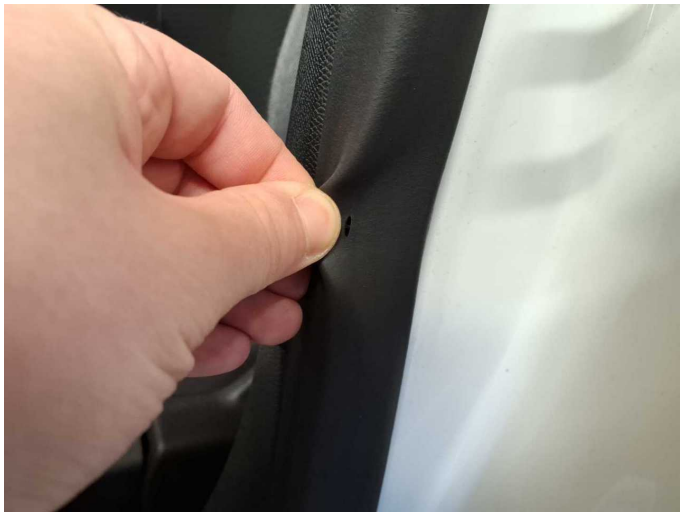
Damage 8: Door - front left side: Door seal - Broken / torn - Replace

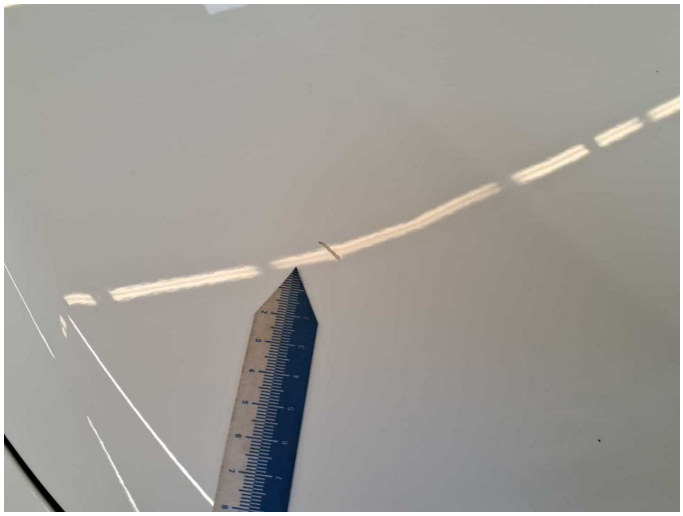
Damage 12: Bonnet: Bonnet - Scratch(es) - Paint

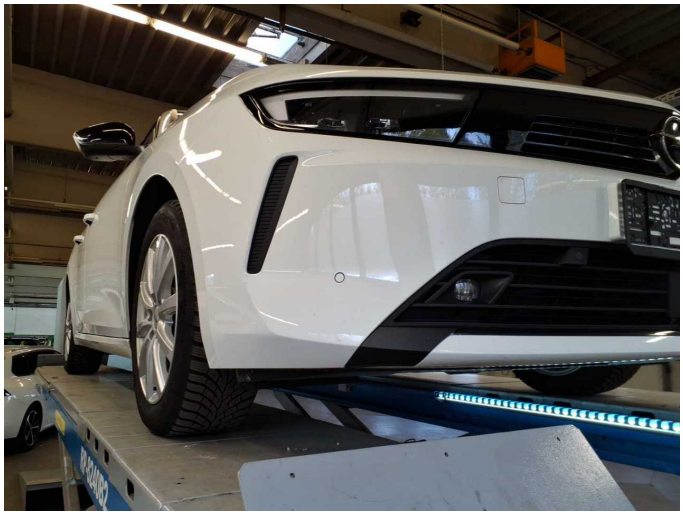
Damage 13: Front bumper: Front bumper - Stone chips - Paint
