Expertise

Protocol number: 48228774
Order No. / Reference: 27118562
Inspection date: 20 Oct 2026

Manufacturer: Audi	Model: A5 Sportback 40 TFSI quattro S tronic advanced
VIN: WAUZZZF56PA003104

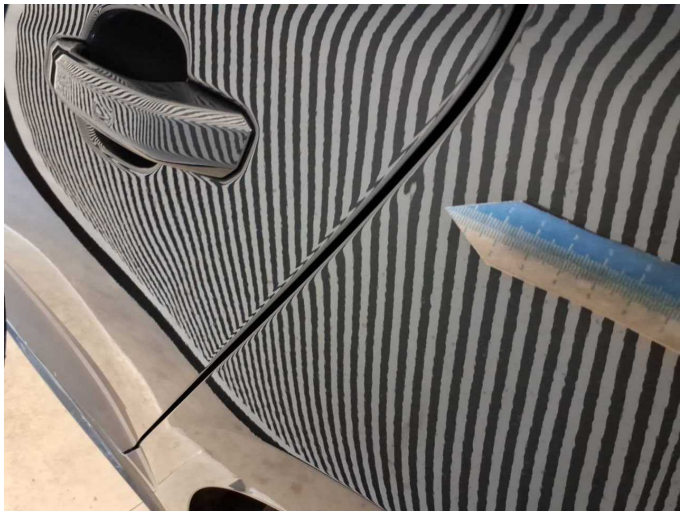
No.	Component group	Description
1	Side panel - rear left side	Side panel - dent(s) - Smooth repair work
2	Rear bumper	Rear bumper - Scratch(es) - Smart repair
3	Side panel - rear right side	Side panel - Scratch(es) - Smart repair
4	Door - rear left side	Door - Scratch(es) - Paint
5	Bonnet	Bonnet - Stone chips - Paint
6	Front bumper	Front bumper (+ Steinschläge) - Scratched - Paint

Damage 1: Side panel - rear left side: Side panel - dent(s) - Smooth repair work

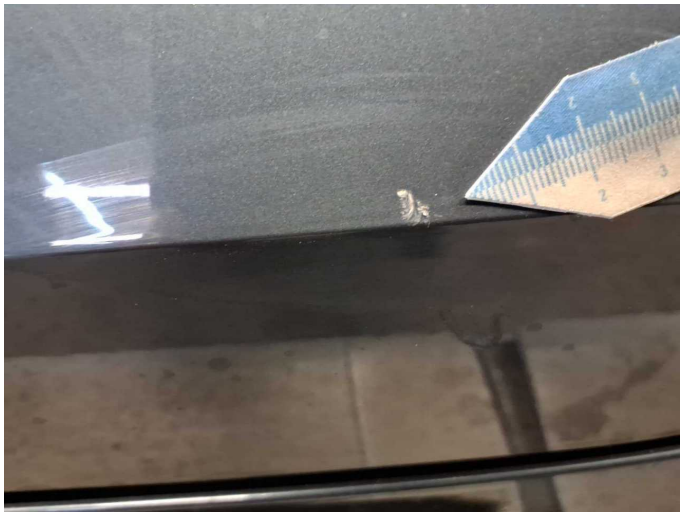
Damage 4: Door - rear left side: Door - Scratch(es) - Paint

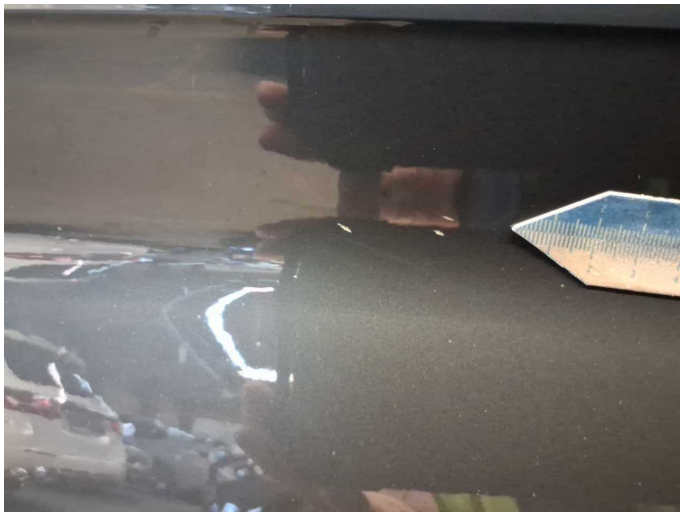
Damage 4: Door - rear left side: Door - Scratch(es) - Paint

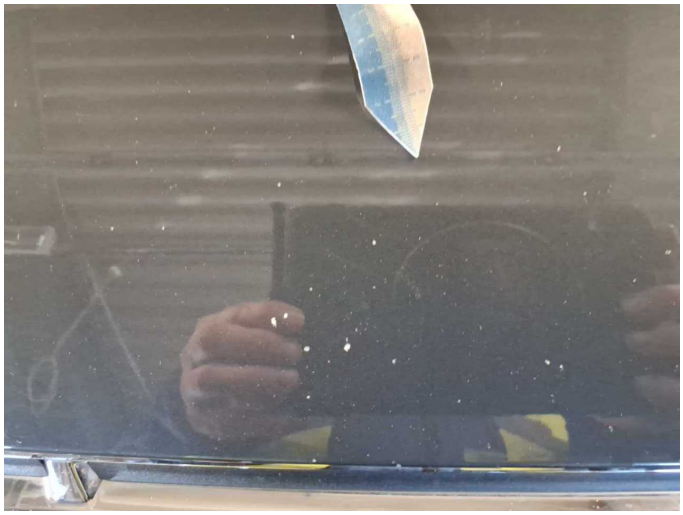
Damage 5: Bonnet: Bonnet - Stone chips - Paint

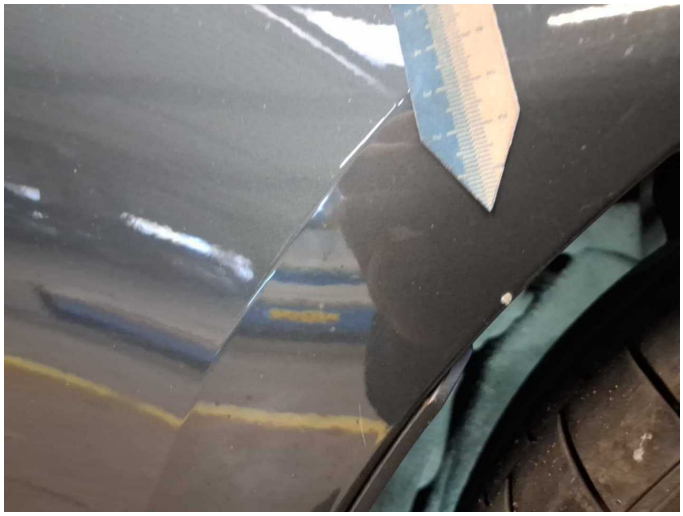
Damage 6: Front bumper: Front bumper (+ Steinschläge) - Scratched - Paint
