TÜV SÜD Auto Partner GmbH
Wiesenring 2
04159 Leipzig

Expertise

Protocol number: 48226247
Order No. / Reference: 27037152
Inspection date: 19 Oct 2026

Manufacturer: Audi	Model: A4 Avant 35 TDI S tronic
VIN: WAUZZZF48PA074411

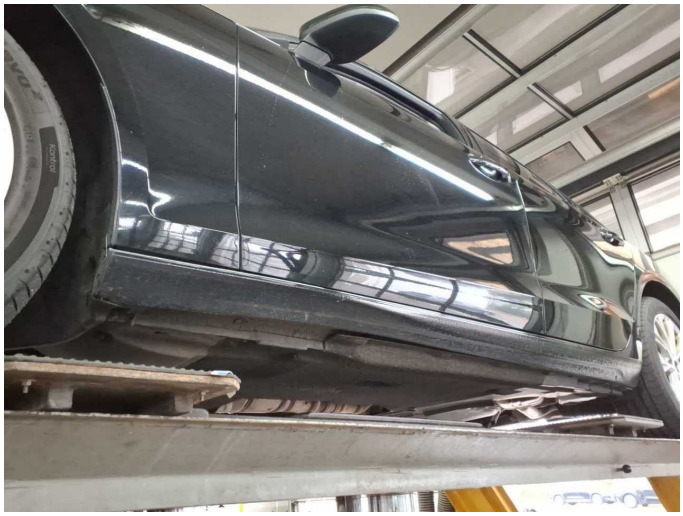
Damage 6: Body: Underbody panelling - Holes - Replace

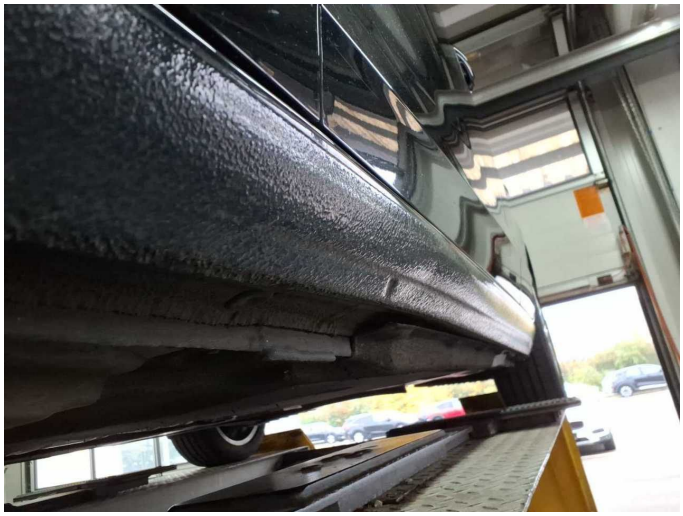
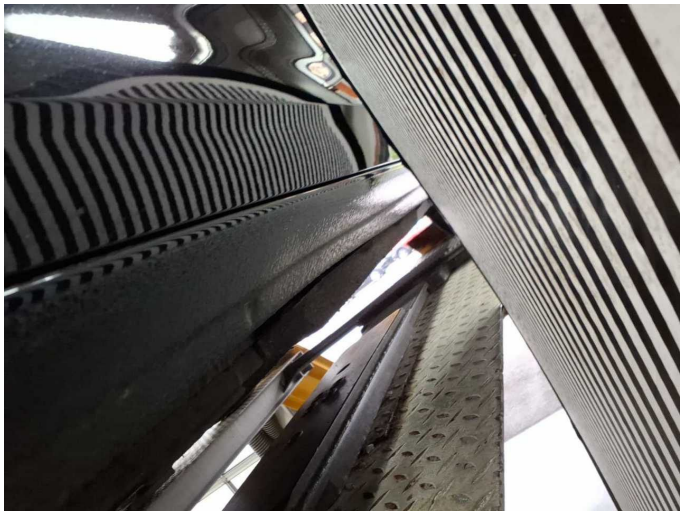
Damage 7: Sill - left side: Sill - Deformed - Repair and paint

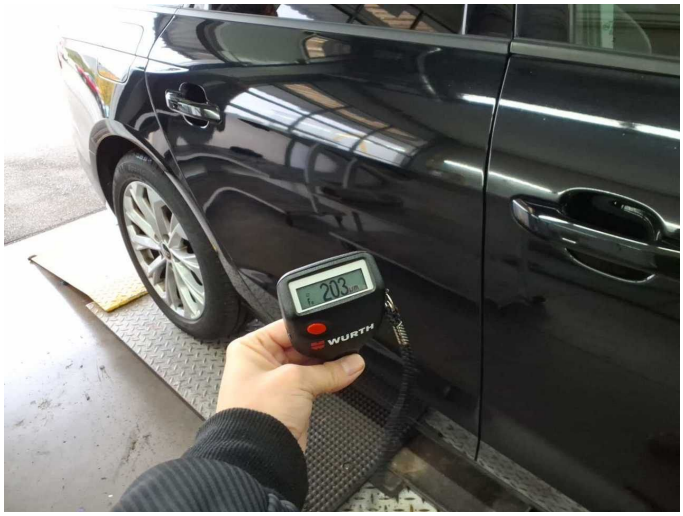
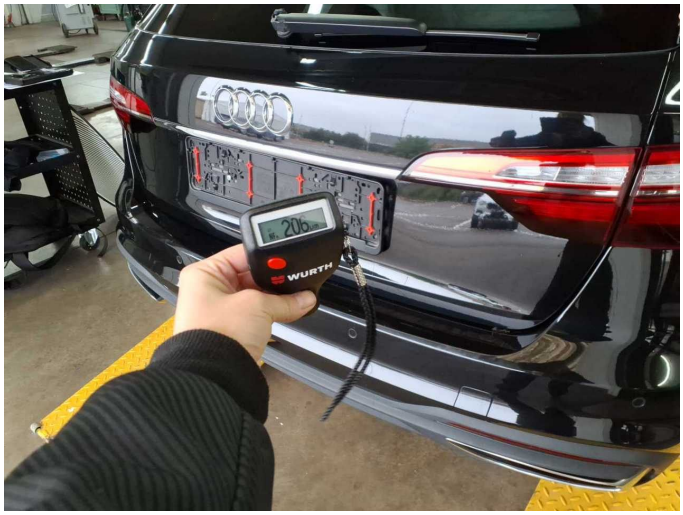
No.	Repainting
1	Boot lid / rear door, Mudguard - right side, Side panel - rear left side, Door - rear right side, Professionally carried out, Invoice of repair done Non-existent
2	Side panel - rear right side, Unprofessionally carried out, Invoice of repair done Non-existent

Roof	117 µm	Roof rail - left side	119 µm
Roof rail - right side	135 µm	Boot lid / rear door	206 µm
Mudguard - left side	110 µm	Mudguard - right side	157 µm
Bonnet	121 µm	Side panel - rear left side	161 µm
Side panel - rear right side	214 µm	Door - rear left side	114 µm
Door - rear right side	203 µm	Door - front left side	122 µm
Door - front right side	123 µm

Repainting 1: Boot lid / rear door, Mudguard - right side, Side panel - rear left side, Door - rear right side
