Expertise

Protocol number: 48562377
Order No. / Reference: 27234316
Inspection date: 6 Nov 2026

Manufacturer: Volkswagen	Model: Caddy 2.0 TDI BMT (7-Si.) Caddy Maxi
VIN: WV2ZZZSKZNX051602

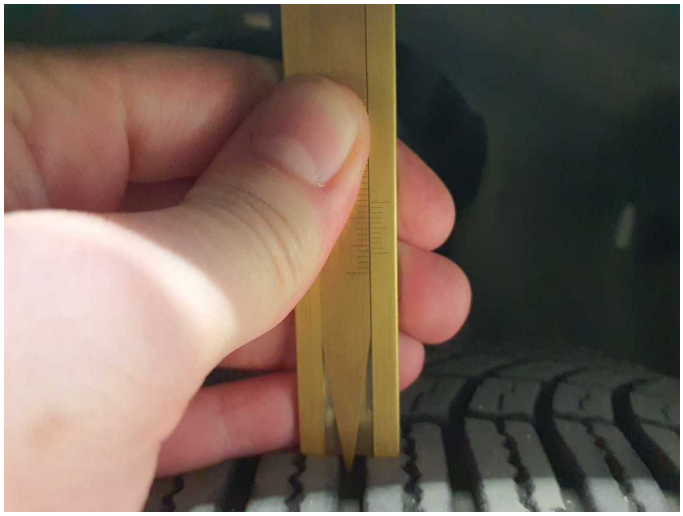
Damage 7: Wheel / tyres: Tyres - complete set - Worn - Replace

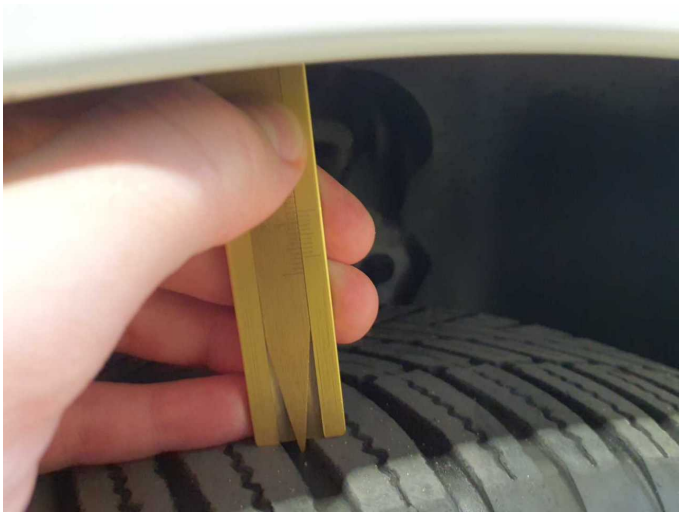
Damage 7: Wheel / tyres: Tyres - complete set - Worn - Replace
