# Expertise

Protocol number: 48104912
Order No. / Reference: 27074613
Inspection date: 14 Oct 2026

| Manufacturer: Volkswagen | Model: Passat Variant 2.0 TDI SCR DSG Business |

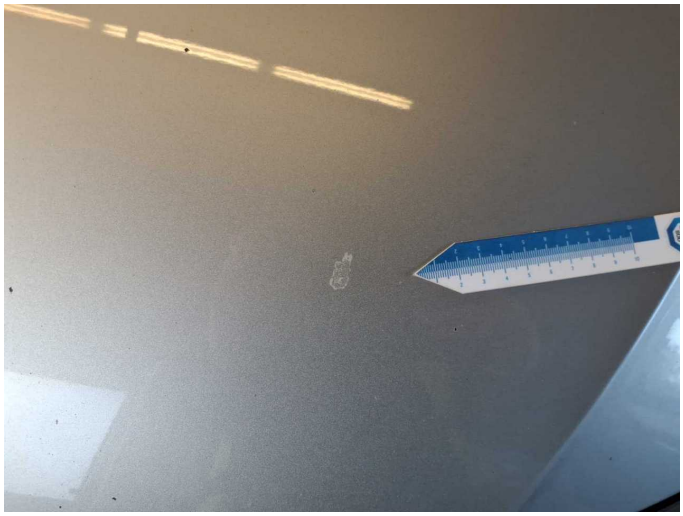
| No. | Component group | Description |
|---|---|---|
| 6 | Side panel - rear right side | Side panel - Dent / paintcoat damage - Repair and paint |

**Damage 6:** Side panel - rear right side: Side panel - Dent / paintcoat damage - Repair and paint
