Expertise

Protocol number: 48363965
Order No. / Reference: 27178807
Inspection date: 28 Oct 2026

Manufacturer: Ford	Model: Focus Turnier 1.0 EcoBoost Hybrid Aut. ST-LINE X
VIN: WF0PXXGCHPSC38696

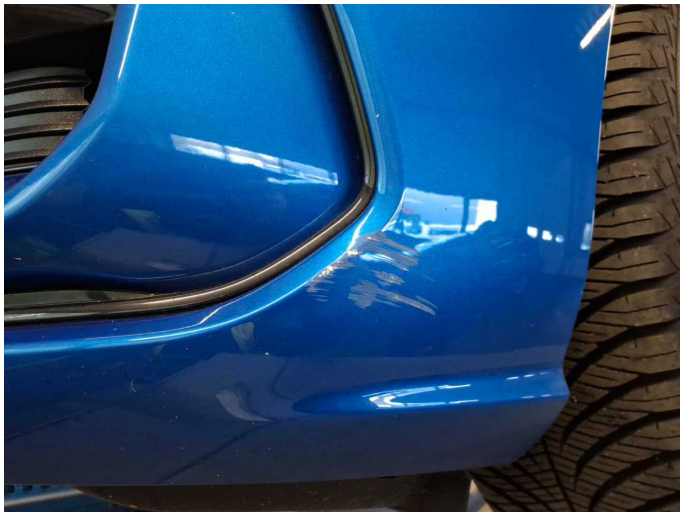
No.	Component group	Description
1	Bonnet	Insulation lining - Damage caused by marten / rodent - Replace
2	Front bumper	Front bumper - Scratch(es) - Paint

Damage 2: Front bumper: Front bumper - Scratch(es) - Paint
