Expertise

Protocol number: 48199626
Order No. / Reference: 27108450
Inspection date: 19 Oct 2026

Manufacturer: Ford	Model: Transit Custom 300 L1H1 LKW VA Basis
VIN: WF0ZXXTTGZNY45477

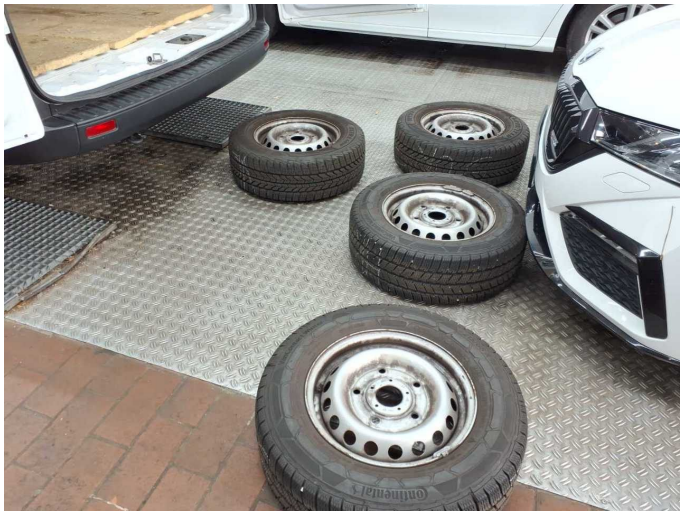
Figure 16: Additional tyres

#	Tyre size	Type of tyre	Manufacturer	Tread depth
1)	215/65 R15 102T	Winter tyres on Steel	Continental	7mm / 7mm
2)	215/65 R15 102T	Winter tyres on Steel	Continental	7mm / 7mm
