Expertise

Protocol number: 48416032
Order No. / Reference: 27198827
Inspection date: 28 Oct 2026

Manufacturer: Ford	Model: Focus Turnier 1.0 EcoBoost Hybrid Aut. TITANIUM
VIN: WF0PXXGCHPPY08882

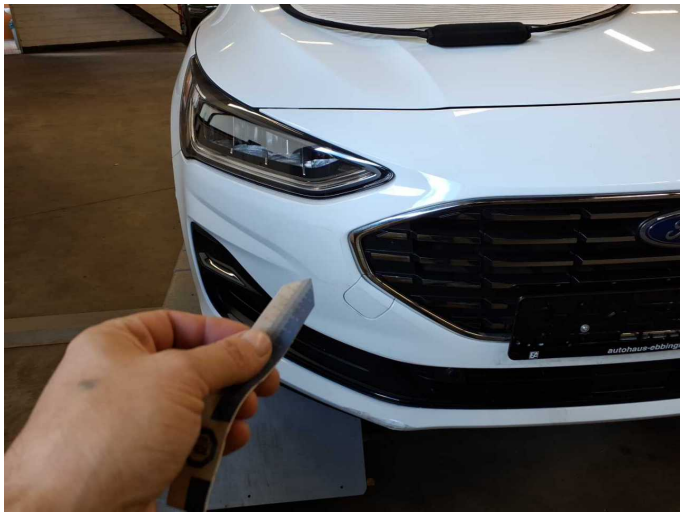
Damage 9: Front bumper: Air-inlet grille (Chromrahmen) - Scratched - Replace

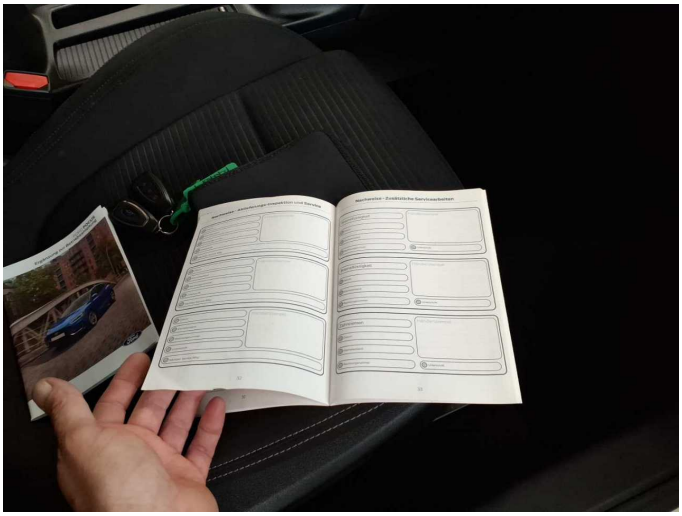
Damage 10: Misc.: Inspection / maintenance (Serviceheft leer) - Due - Perform
