Expertise

Protocol number: 47006530
Order No. / Reference: 26817911
Inspection date: 11 Aug 2026

Manufacturer: Peugeot	Model: 308 SW Hybrid 180 e-EAT8 Allure
VIN: VR3F4DGXTPY503752

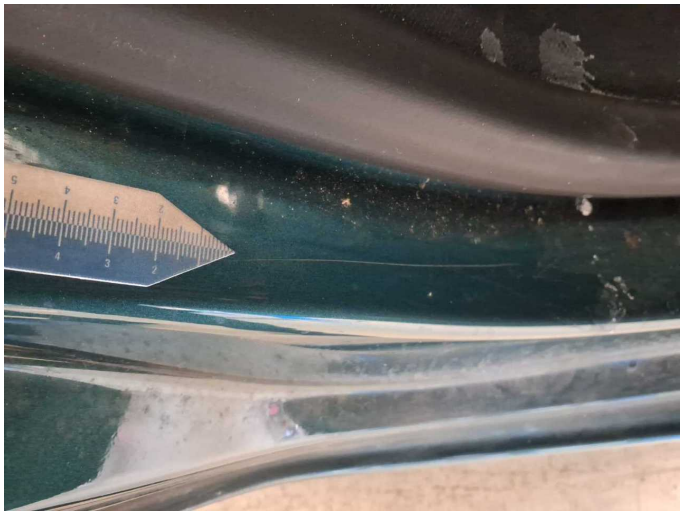
Damage 2: Side panel - rear right side: Sill - Scratch(es) - Smart repair

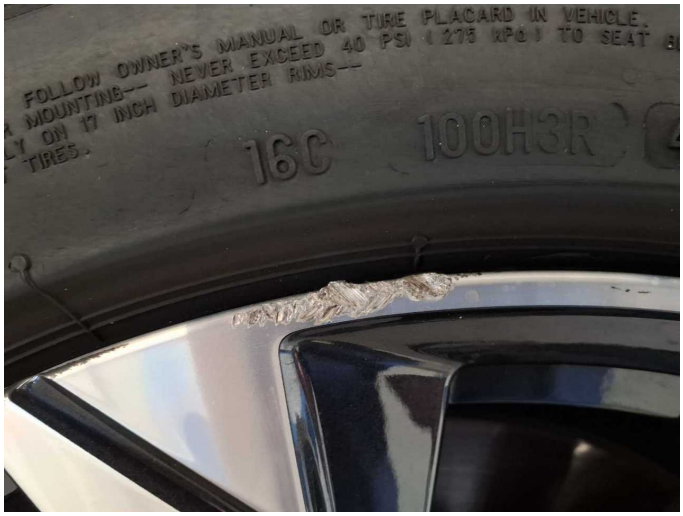
Damage 3: Wheel / tyres: Alloy rim - front right side (Materialabtrag) - Scratched - Replace

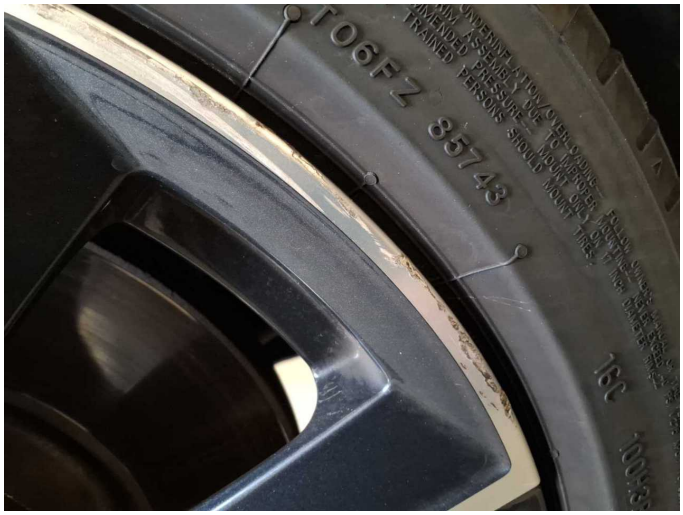
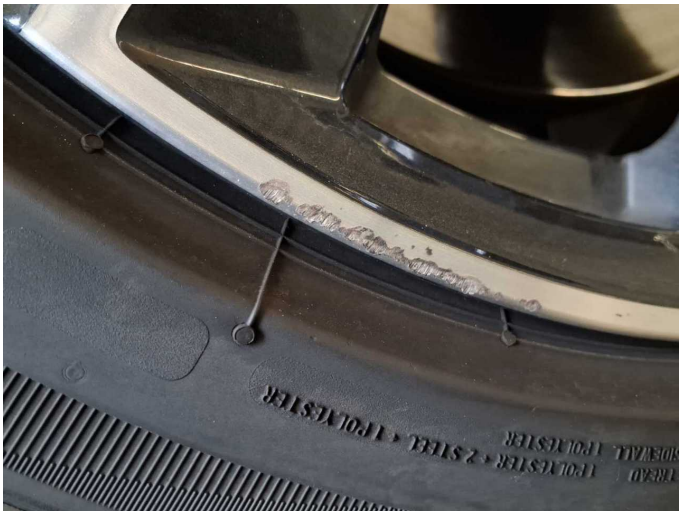
Damage 4: Wheel / tyres: Alloy rim - front left side (Materialabtrag) - Scratched - Replace

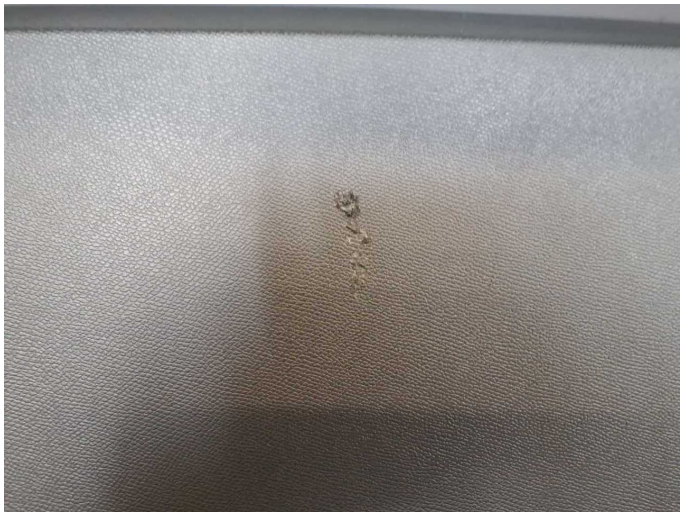
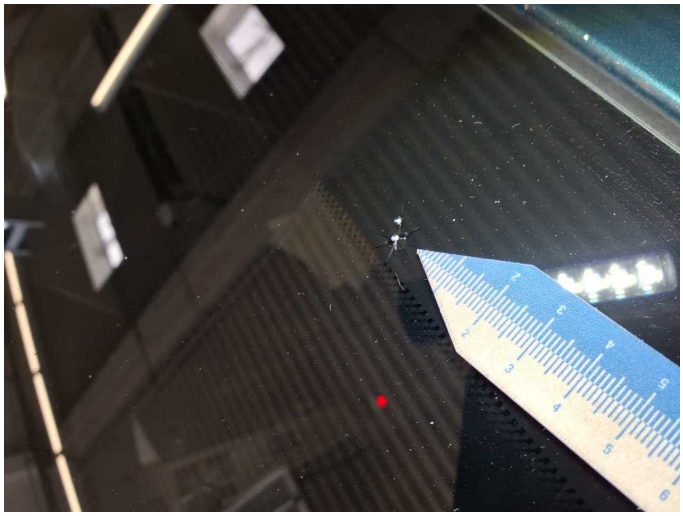
Damage 5: Trim / covers: Trim / covers (Laderaum / + verschmutzt) - Scratched - Loss in value

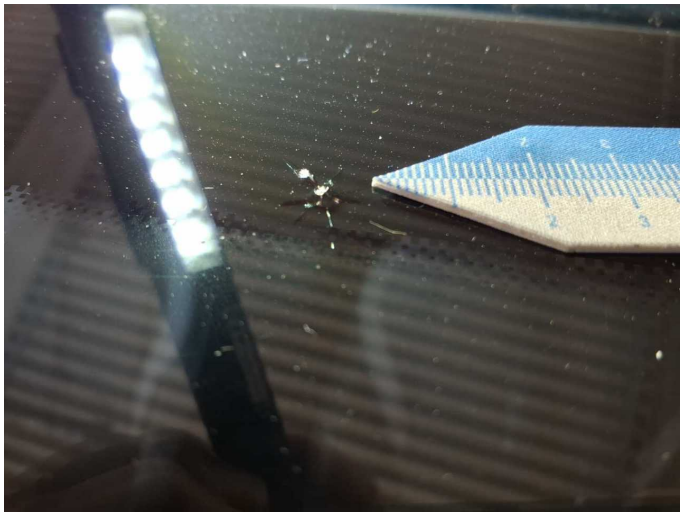
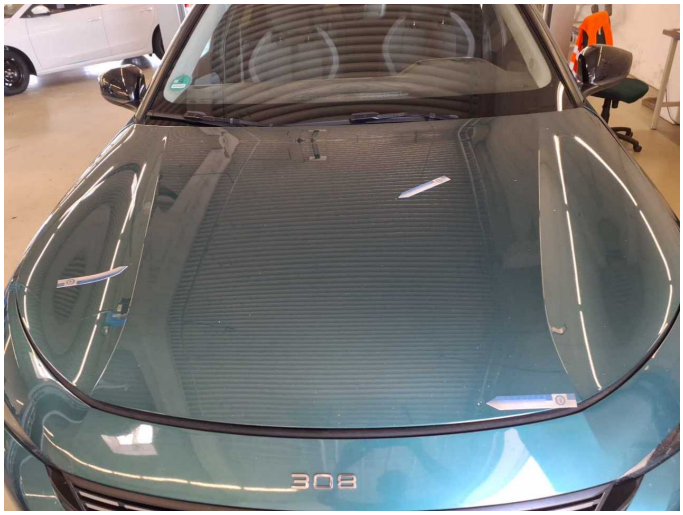
Damage 6: Vehicle glazing: Windscreen with lane departure assistant - Stone chips - Replace

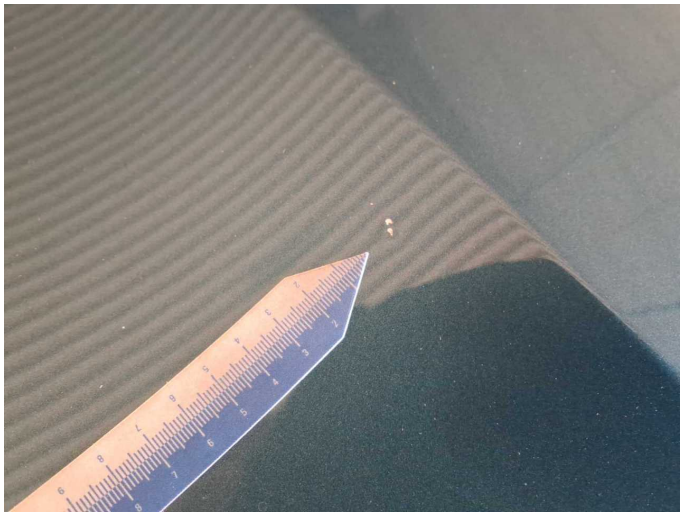
Damage 7: Bonnet: Bonnet (Steinschläge) - Dent / paintcoat damage - Repair and paint
