Expertise

Protocol number: 48237536
Order No. / Reference: 27156262
Inspection date: 17 Oct 2026

Manufacturer: Skoda	Model: Octavia Combi 2.0 TDI DSG 4x4 RS
VIN: TMBLK8NX0PY037962

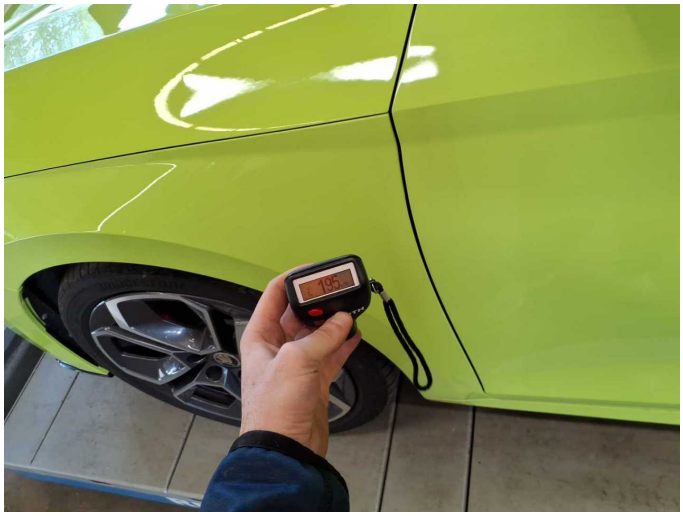
Repainting 1: Boot lid / rear door

No.	Repainting
1	Boot lid / rear door, Professionally carried out, Invoice of repair done Non-existent
2	Mudguard - left side, Professionally carried out, Invoice of repair done Non-existent
3	Bonnet, Professionally carried out, Invoice of repair done Non-existent
4	Side panel - rear left side, Professionally carried out, Invoice of repair done Non-existent

Boot lid / rear door	232 µm	Mudguard - left side	195 µm
Bonnet	265 µm	Side panel - rear left side	202 µm
