Expertise

Protocol number: 48567819
Order No. / Reference: 27196601
Inspection date: 9 Nov 2026

Manufacturer: Seat	Model: Born 150kW/58kWh
VIN: VSSZZZK1ZNP017594

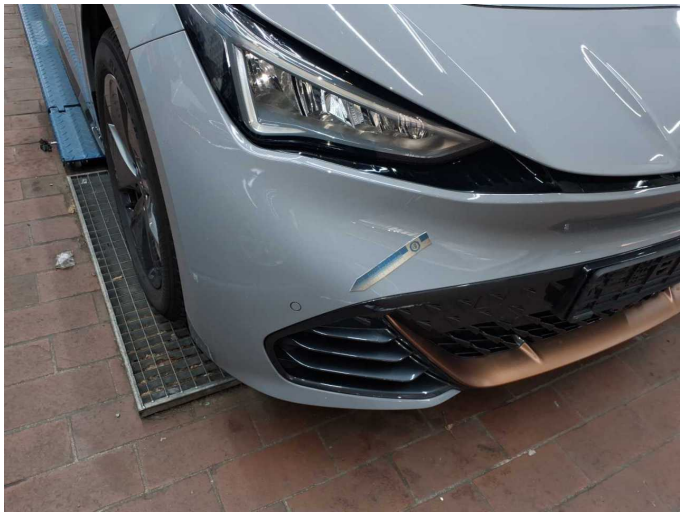
Damage 1: Equipment: Tirefit filler - Expired - Replace

Damage 2: Front bumper: Front bumper - Scratch(es) - Smart repair

Damage 3: Front bumper: Front strip - Scratched - Smart repair

Damage 4: Sill - right side: Sill - dent(s) - Smart repair

Damage 5: Rear bumper: Rear bumper - Scratch(es) - Smart repair

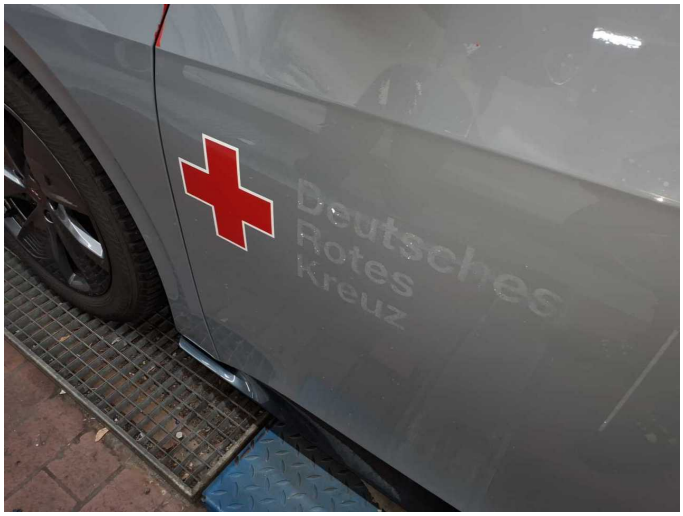
Damage 6: Body: Body (Kleberückstände / Mehrkosten können entstehen) - Glued / labelled - De-glue / neutralise
