Expertise

Protocol number: 48417013
Order No. / Reference: 27208605
Inspection date: 29 Oct 2026

Manufacturer: Volkswagen	Model: Passat Variant 1.4 TSI Plug-In-Hybrid DSG GTE
VIN: WVWZZZ3CZPE045007

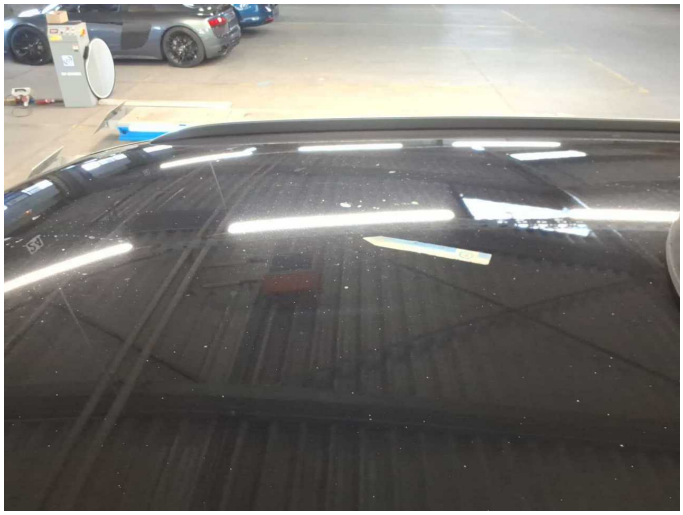
Damage 2: Roof: Roof - dent(s) - Smooth repair work

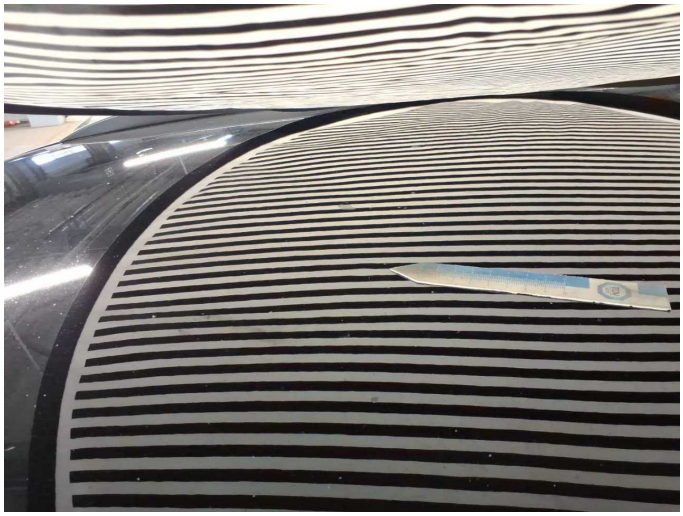
Damage 2: Roof: Roof - dent(s) - Smooth repair work

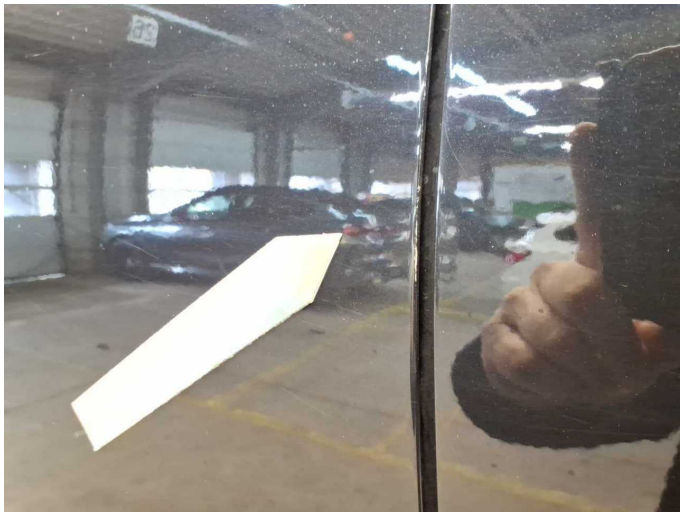
Damage 3: Door - front left side: Door edge - Scratched - Smart repair

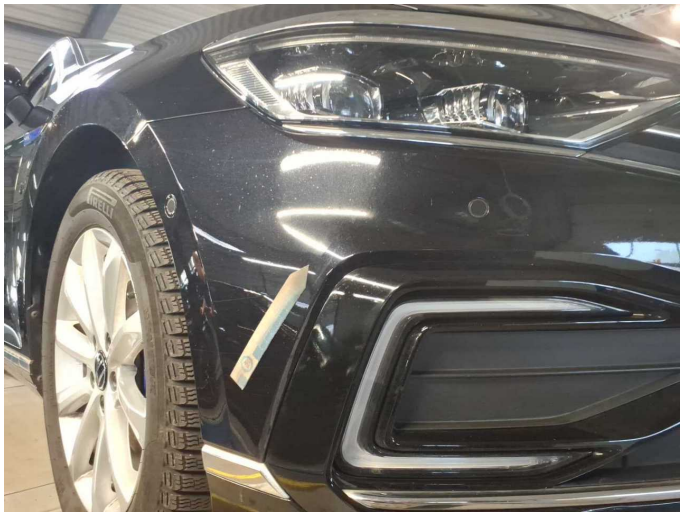
Damage 7: Front bumper: Front bumper (& Verkratzt/Verschürft) - Unprofessionally repaired - Repair and paint

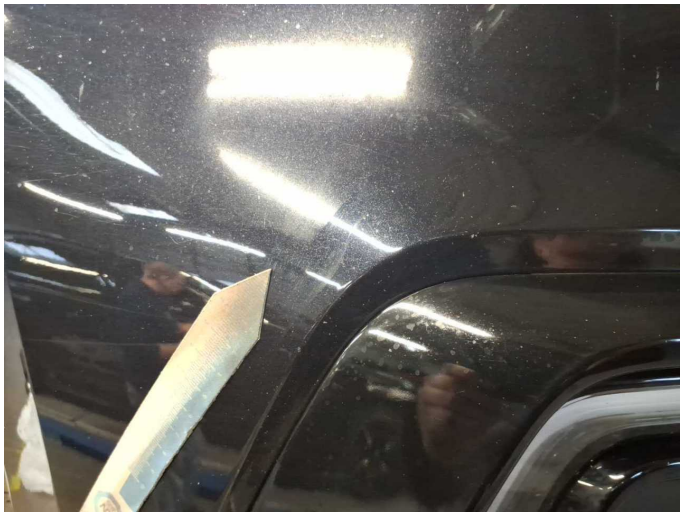
No.	Repainting
1	Bumper front, Unprofessionally carried out, Invoice of repair done Non-existent

Damage 7: Front bumper: Front bumper (& Verkratzt/Verschürft) - Unprofessionally repaired - Repair and paint

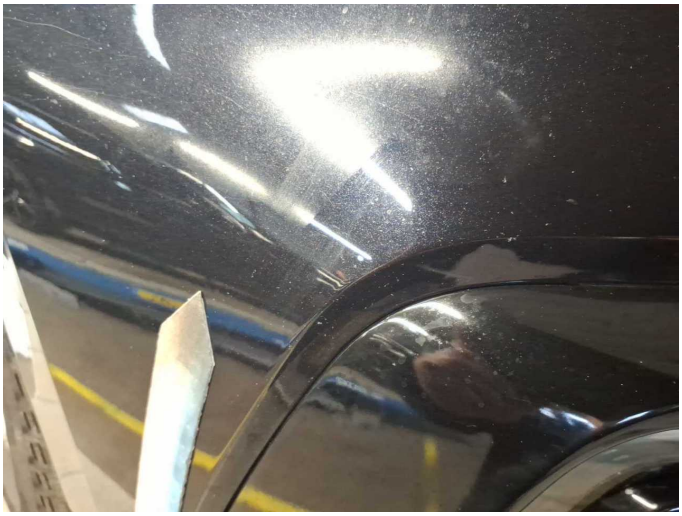
Repainting 1: Bumper front
