Expertise

Protocol number: 48550085
Order No. / Reference: 27204563
Inspection date: 2 Nov 2026

Manufacturer: Ford	Model: Transit 350 L4H3 Lkw HA Trend
VIN: WF0EXXTTRENJ39278

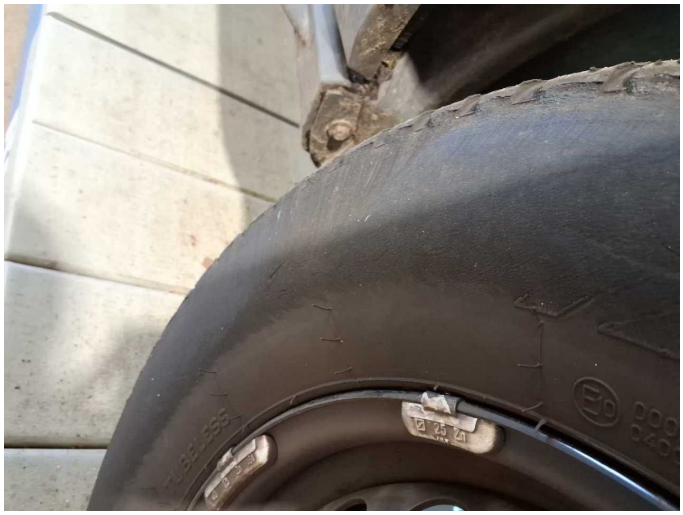
Damage 7: Wheel / tyres: Tyre - front right side (Flanke glatt) - Damaged - Replace

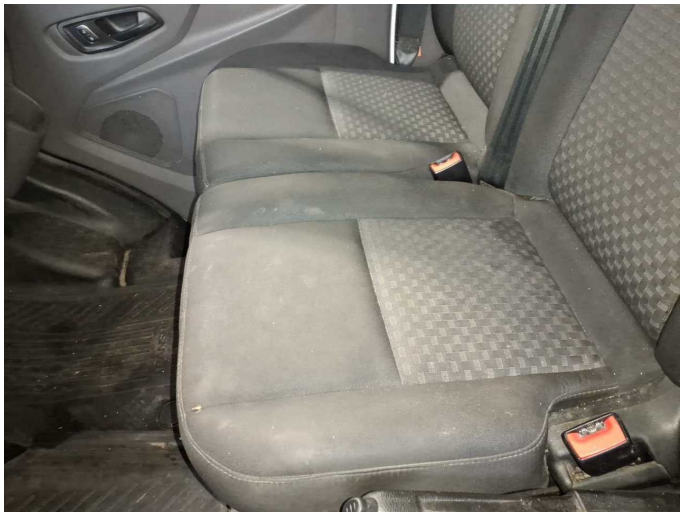
Damage 9: Interior: Interior (Sitze speckig) - Soiled - Clean

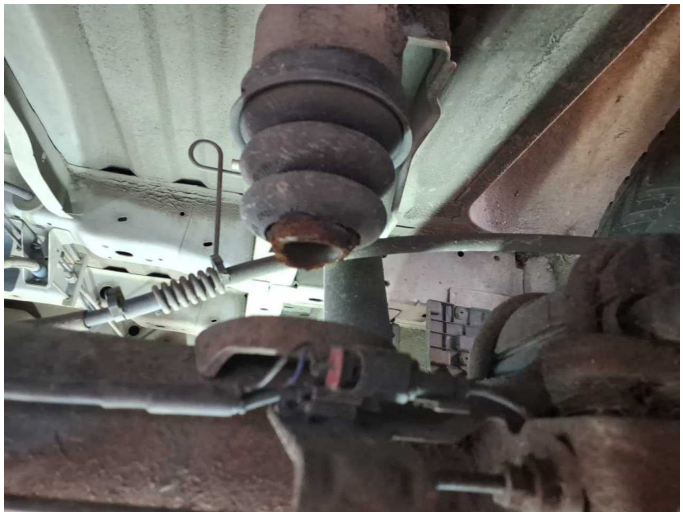
Damage 10: Rear axle: Rear axle (Anschlagpuffer) - Porous / cracked - Replace

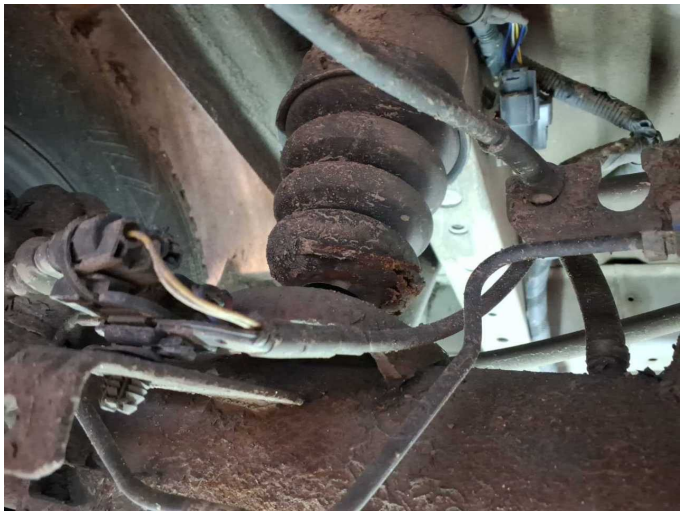
Damage 10: Rear axle: Rear axle (Anschlagpuffer) - Porous / cracked - Replace

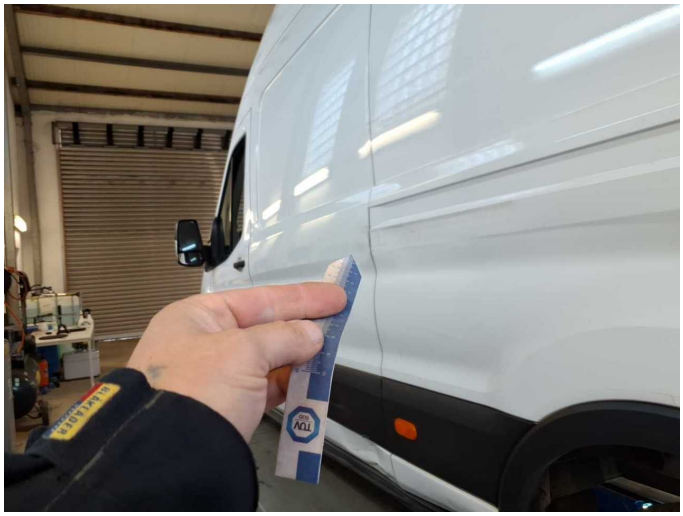
Accident 1: Side - left

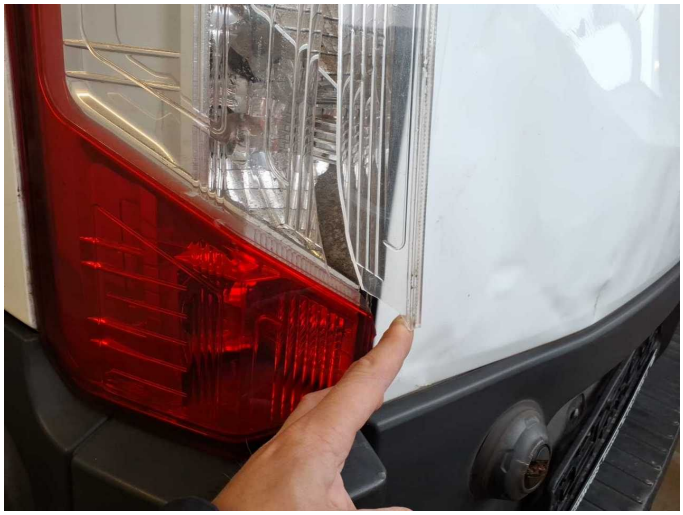
Accident 1: Side - left

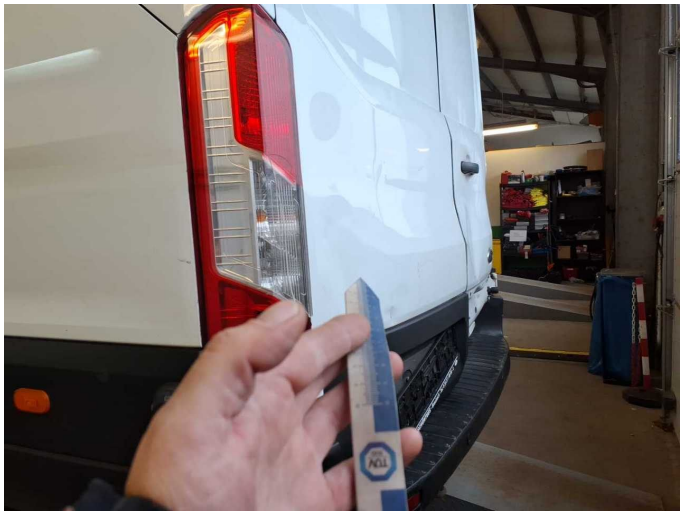
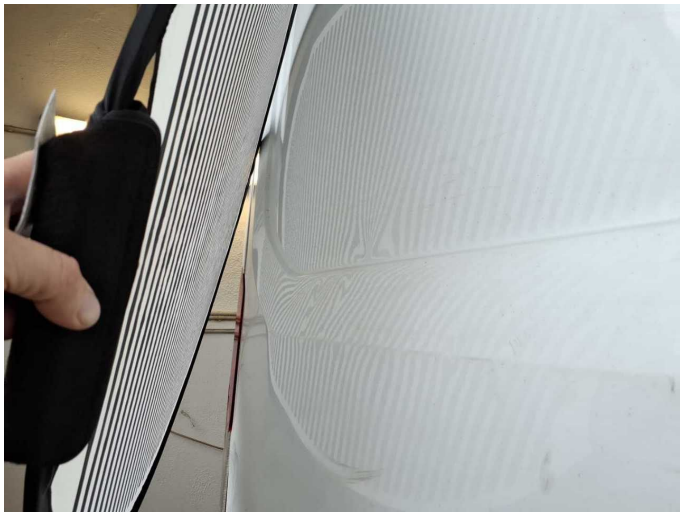
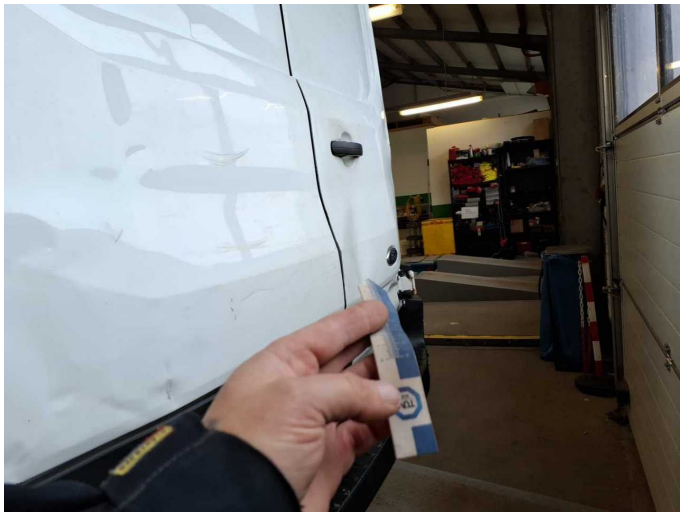
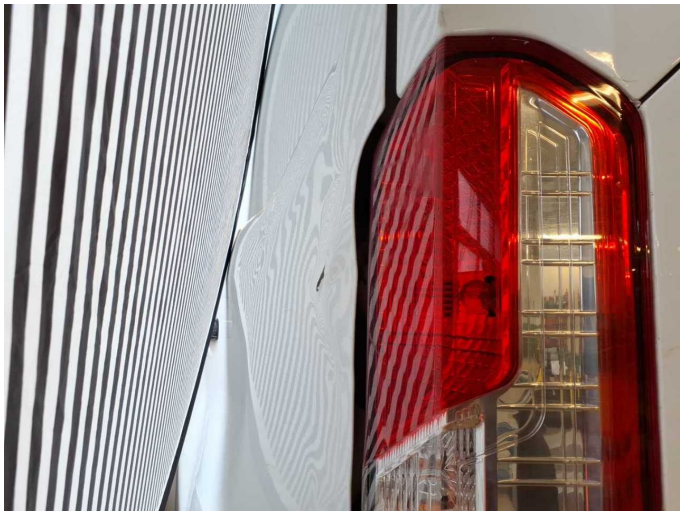
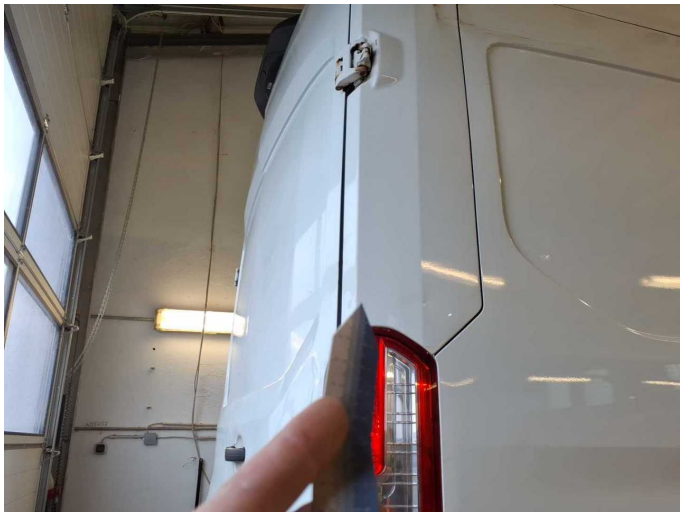
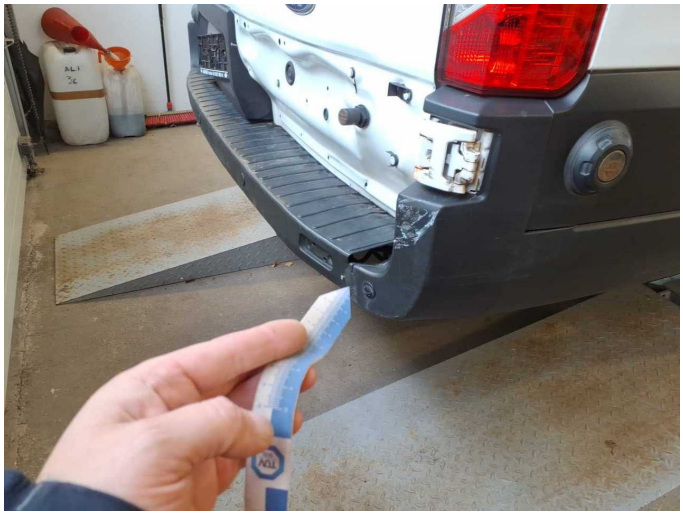
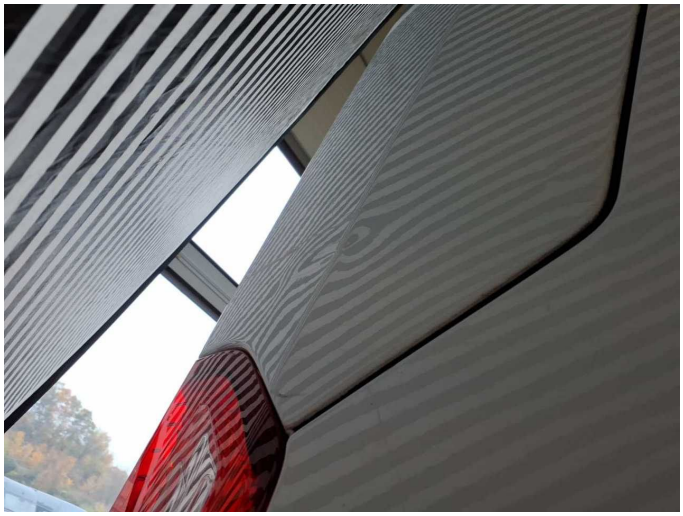
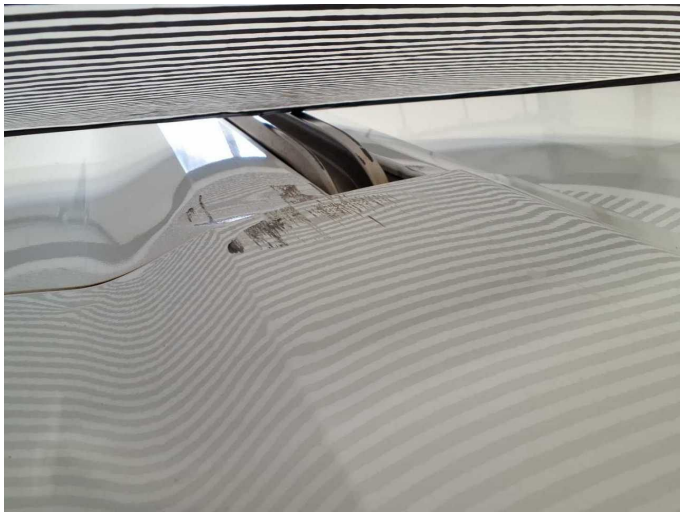
Accident 2: Roof, Rear, Side right
