Expertise

Protocol number: 48573352
Order No. / Reference: 27253531
Inspection date: 9 Nov 2026

Manufacturer: Ford	Model: Transit Connect 220 L1 S&S Trend
VIN: WF0RXXWPGRLL48130

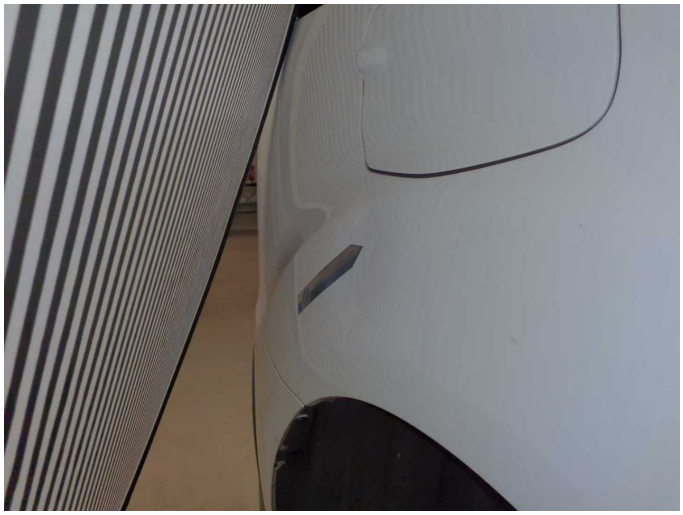
Damage 4: Front bumper: Front bumper - Scratch(es) - Smart repair

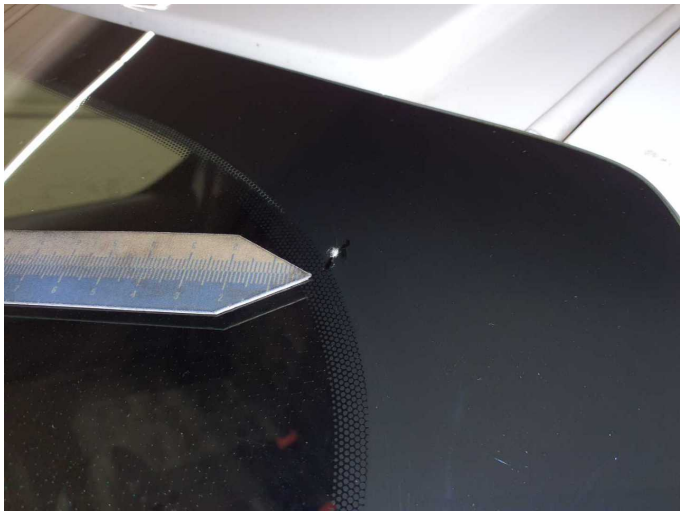
Damage 7: Vehicle glazing: Windscreen - Stone chips - Replace
