TÜV SÜD Auto Partner GmbH
Wiesenring 2
04159 Leipzig

Expertise

Protocol number: 48495427
Order No. / Reference: 27210293
Inspection date: 4 Nov 2026

Manufacturer: Opel	Model: Grandland 1.5 D Automatik Elegance
VIN: W0VZCYHZ2P6020831

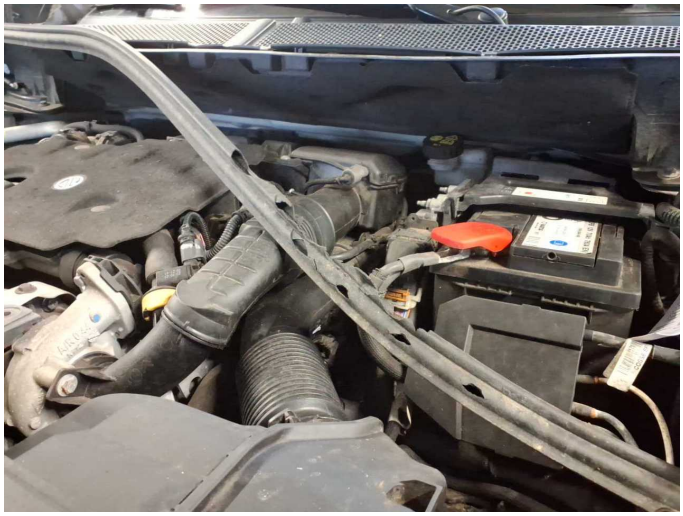
Damage 5: Misc.: Misc. (Wasserablauf Dichtung) - Damage caused by marten / rodent - Replace

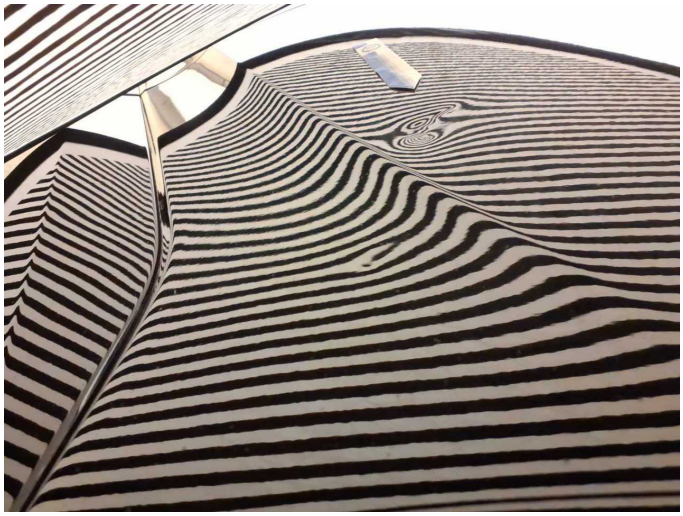
Damage 9: Door - rear left side: Door - Deformed - Repair and paint
