Expertise

Protocol number: 48487861
Order No. / Reference: 27204583
Inspection date: 4 Nov 2026

Manufacturer: Opel	Model: Crossland 1.5 Diesel Elegance
VIN: W0V7H9EN0P4240268

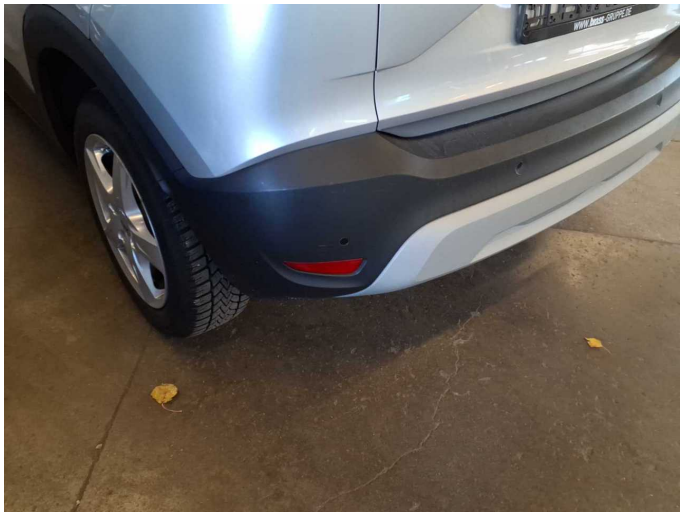
No.	Component group	Description
1	Misc.	Inspection / maintenance - No evidence - No deduction
2	Braking system	Brake fluid - No evidence - No deduction
3	Side panel - rear right side	Sill - dent(s) - Smooth repair work
4	Rear bumper	Rear bumper (unpainted) - Scratch(es) - Loss in value

Damage 3: Side panel - rear right side: Sill - dent(s) - Smooth repair work
