# Expertise

Protocol number: 48437868
Order No. / Reference: 27076616
Inspection date: 2 Nov 2026

| Manufacturer: Volkswagen | Model: Tiguan Allspace 2.0 TDI SCR DSG Life |
| VIN: WVGZZZ5N3PM021574 | |

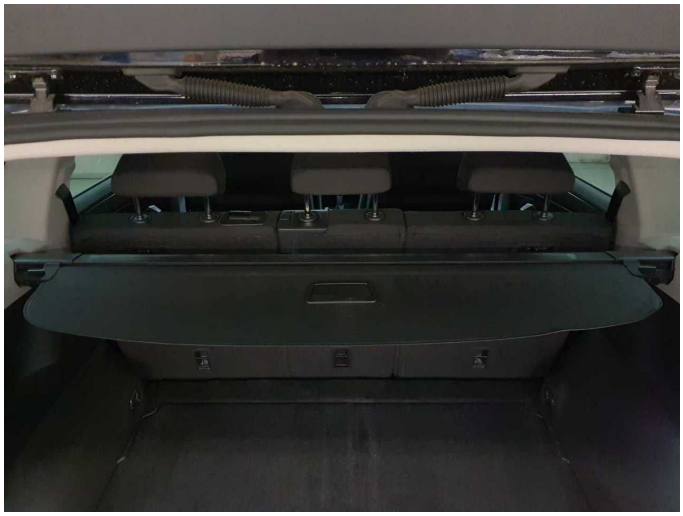
| No. | Component group | Description |
|---|---|---|
| 5 | Interior | Interior - Scratch(es) - Loss in value |

**Damage 5:** Interior: Interior - Scratch(es) - Loss in value

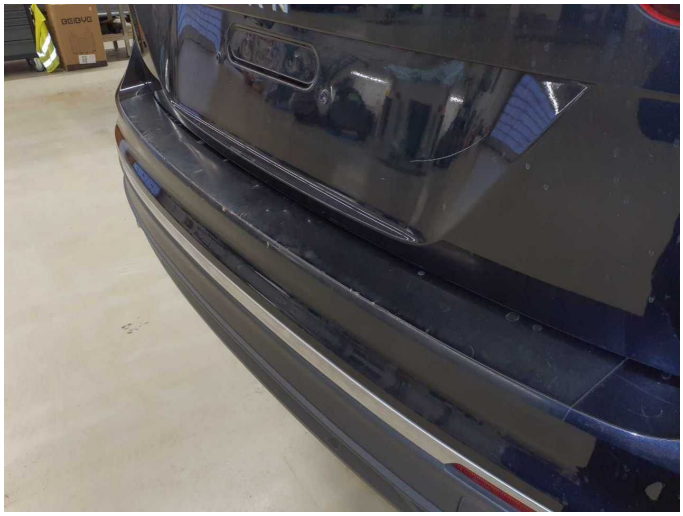
| No. | Component group | Description |
|---|---|---|
| 1 | Rear bumper | Rear bumper - Scratch(es) - No deduction |

**Wear and tear 1:** Rear bumper: Rear bumper - Scratch(es) - No deduction
