Expertise

Protocol number: 48221259
Order No. / Reference: 27041396
Inspection date: 12 Oct 2026

Manufacturer: Volkswagen	Model: Multivan T7 Kurz Life
VIN: WV2ZZZST1PH011921

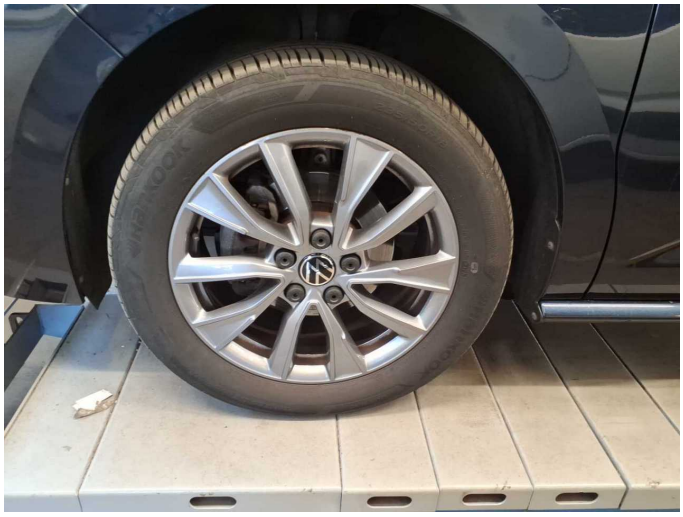
Figure 12: Mounted tyres

#	Tyre size	Type of tyre	Manufacturer	Tread depth
1)	235/50 R18 101H	Summer tyres on Light alloy	Hankook	6mm / 6mm
2)	235/50 R18 101H	Summer tyres on Light alloy	Hankook	5mm / 5mm

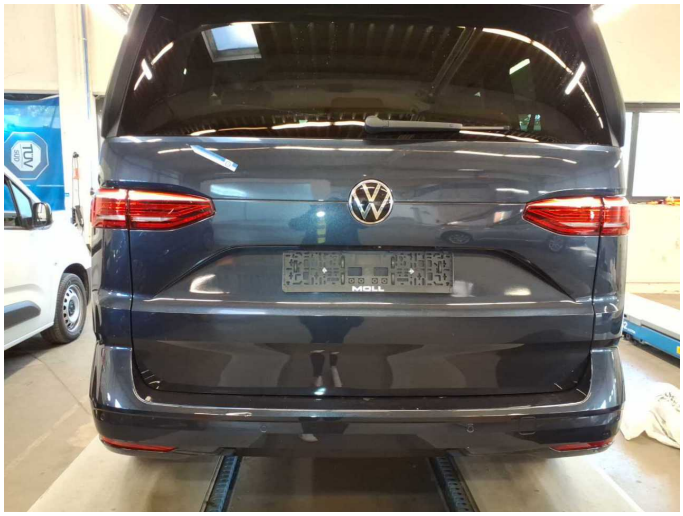
No.	Component group	Description
1	Rear bumper	Rear bumper - Scratch(es) - Smart repair
2	Boot lid / rear door	Boot lid - Scratch(es) - Smart repair

Damage 1: Rear bumper: Rear bumper - Scratch(es) - Smart repair
