DS

1.5 BLUEHDI 130 BASTILLE + AUTO

VIN: VR1JCYHZUMY534635

Inspection loc	Statement date	Inspection approval date
PARC HÖDLMAYR TONGEREN	24/06/2026	25/06/2026

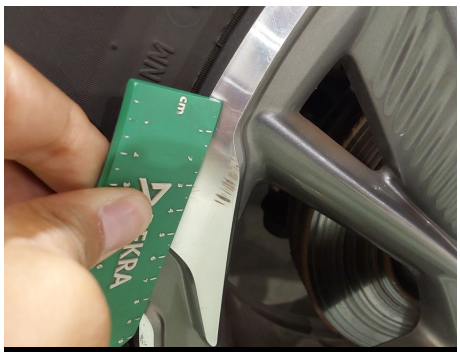
002	Rim / Back Left Material : Aluminium alloy / Rim/Tyre diameter : 19 " / Surface : Brushed Aluminium	Rust	Warranty

Rim / Back Left / Rust
