TÜV SÜD Auto Partner GmbH
Wiesenring 2
04159 Leipzig

Expertise

Protocol number: 48195457
Order No. / Reference: 27160973
Inspection date: 20 Oct 2026

Manufacturer: Ford	Model: Kuga 2.5 Duratec PHEV COOL&CONNECT
VIN: WF0FXXWPMHPY31090

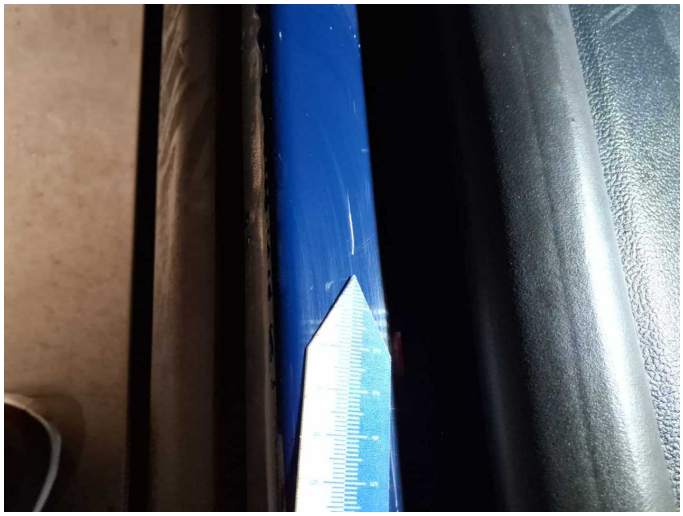
Damage 2: Wing mirror - right side: Cap - Scratch(es) - Smart repair

Damage 3: Side panel - rear left side: Sill - Scratch(es) - Smart repair

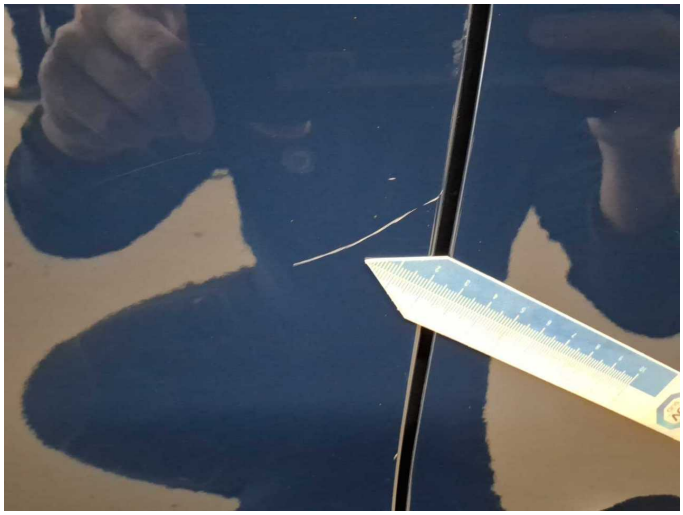
Damage 6: Door - rear right side: Door - Scratch(es) - Paint

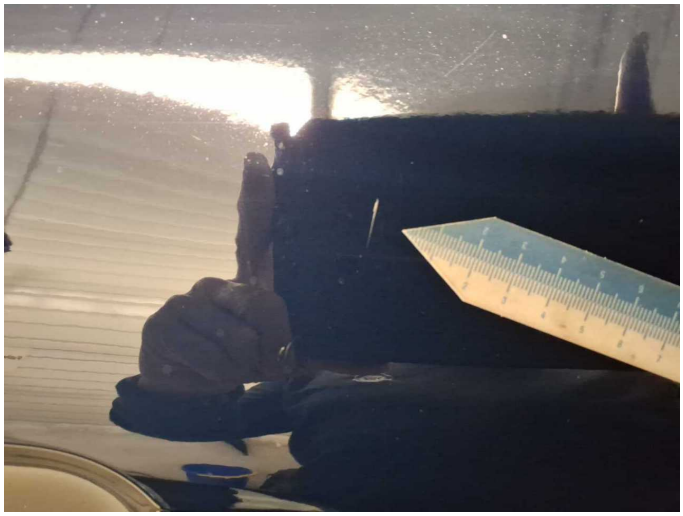
Damage 6: Door - rear right side: Door - Scratch(es) - Paint

Damage 7: Door - rear left side: Door - Scratch(es) - Paint

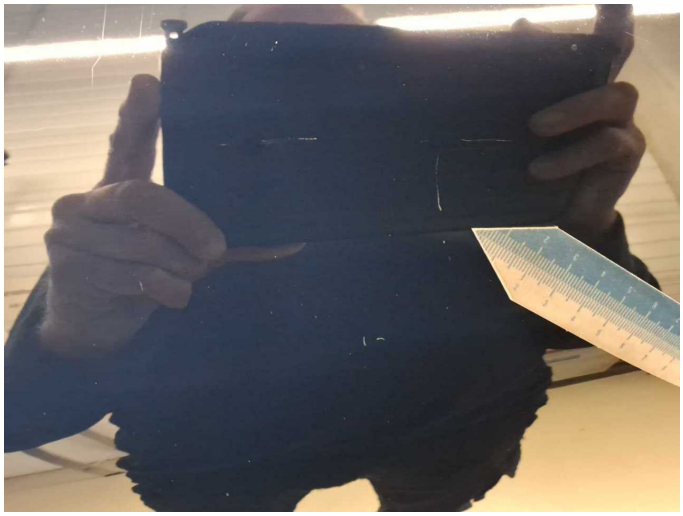
Damage 7: Door - rear left side: Door - Scratch(es) - Paint

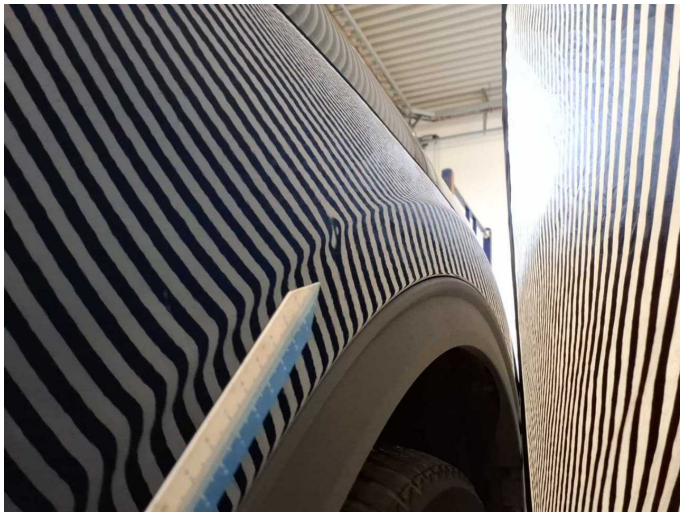
Damage 9: Mudguard - right side: Mudguard - right side - Dent / paintcoat damage - Repair and paint
