Expertise

Protocol number: 48563161
Order No. / Reference: 27204855
Inspection date: 4 Nov 2026

Manufacturer: Kia	Model: EV6 58-kWh
VIN: KNAC481AFP5120570

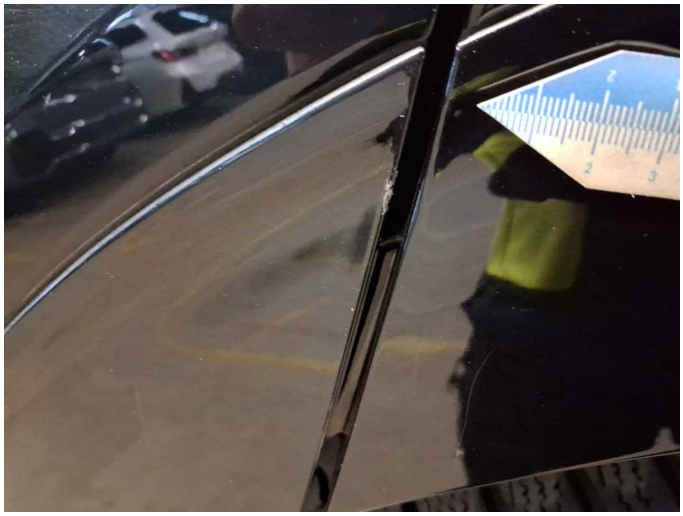
No.	Component group	Description
1	Door - rear left side	Door edge - Scratch(es) - Smart repair
2	Door - front left side	Door edge - Scratch(es) - Smart repair
3	Side panel - rear left side	Sill - Scratch(es) - Smart repair
4	Front bumper	Front bumper (Plus Steinschläge) - Scratched - Paint
5	Bonnet	Bonnet - Stone chips - Paint

Damage 1: Door - rear left side: Door edge - Scratch(es) - Smart repair

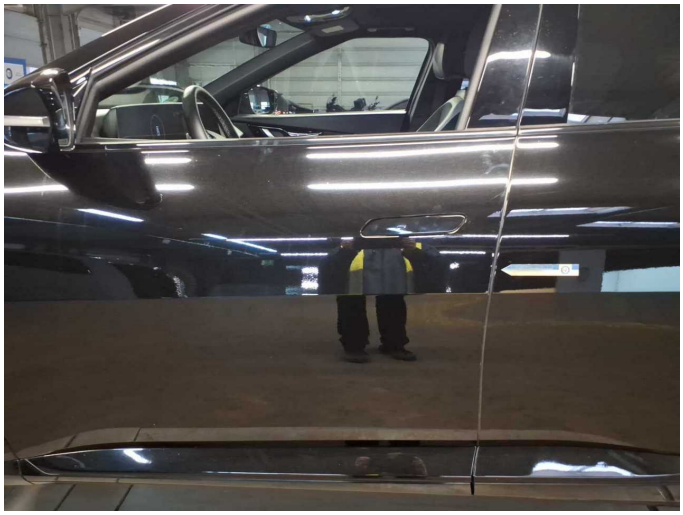
Damage 1: Door - rear left side: Door edge - Scratch(es) - Smart repair

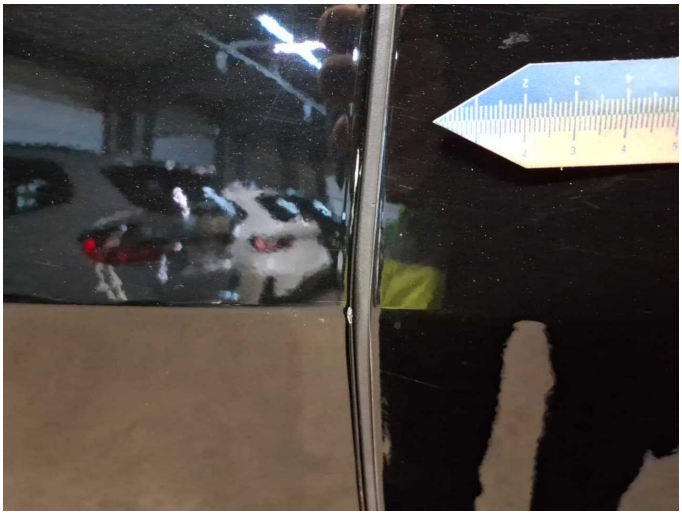
Damage 2: Door - front left side: Door edge - Scratch(es) - Smart repair

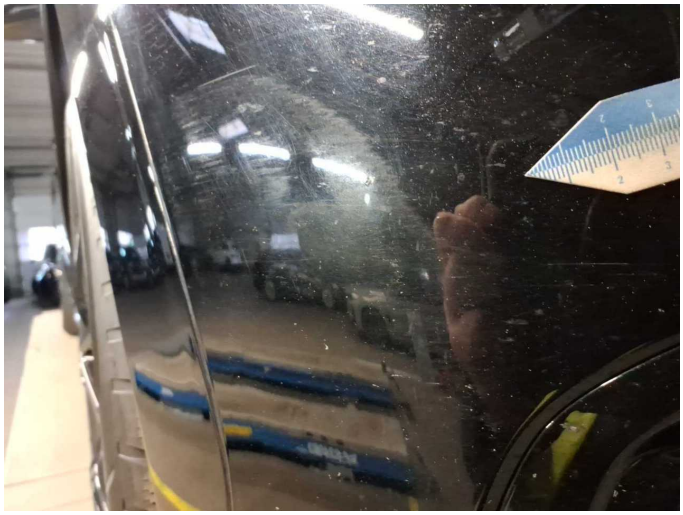
Damage 3: Side panel - rear left side: Sill - Scratch(es) - Smart repair

Damage 4: Front bumper: Front bumper (Plus Steinschläge) - Scratched - Paint

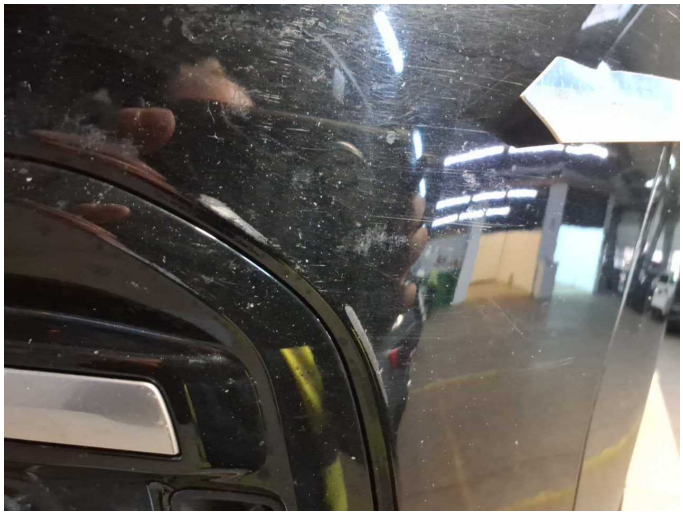
Damage 4: Front bumper: Front bumper (Plus Steinschläge) - Scratched - Paint

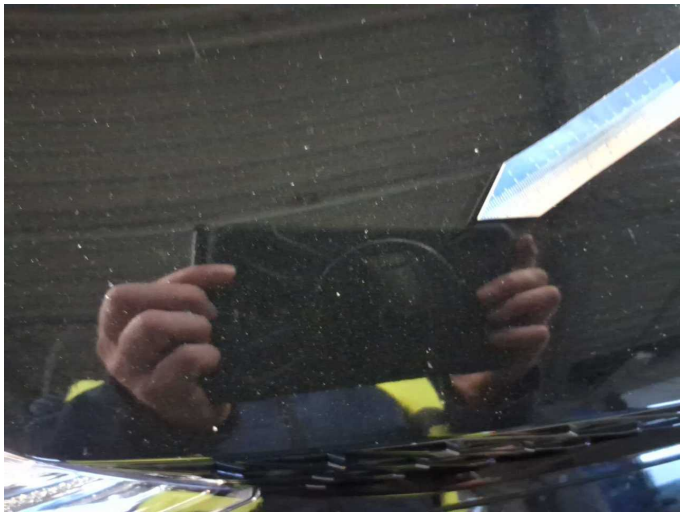
Damage 5: Bonnet: Bonnet - Stone chips - Paint

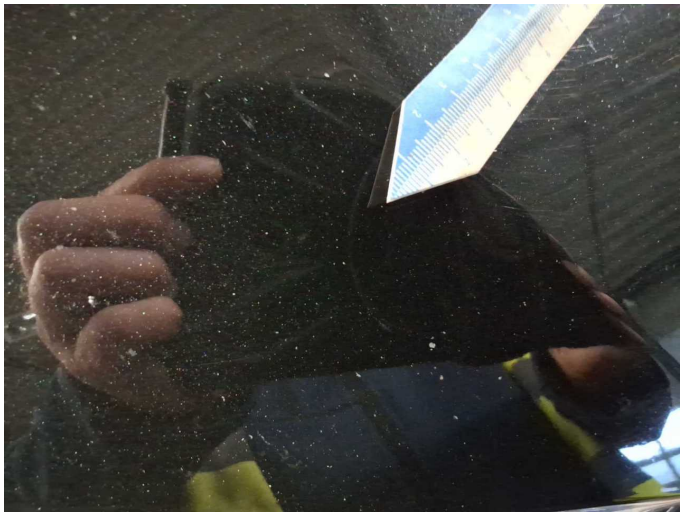
Damage 5: Bonnet: Bonnet - Stone chips - Paint

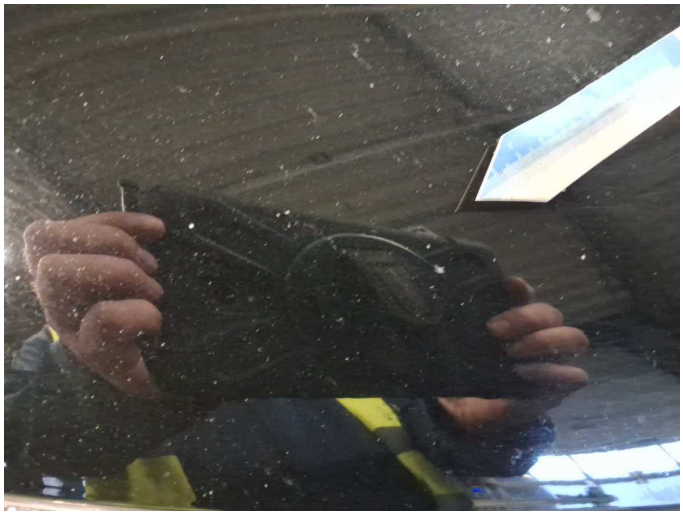
Damage 5: Bonnet: Bonnet - Stone chips - Paint
